**RE : DEMOLITION WORK PLAN MD - 2753**  
**AT : JOHN HUNTER HEALTH & INNOVATION PRECINCT**

## Demolition Work Plan (DWP)

JHHIP – Stage 1

# HAZARDOUS MATERIALS SURVEY REPORT

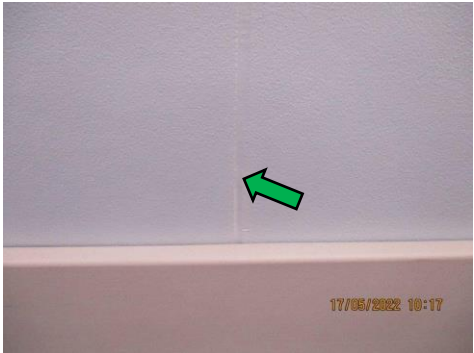
<table border="1"> <tr> <td colspan="2">Sample No.: PRJ000914-AS015</td> </tr> <tr> <td>Asb Detected:</td> <td>No</td> </tr> <tr> <td>Location:</td> <td>Internal</td> </tr> <tr> <td colspan="2">Level 1, Central Sterilisation Department, construction joint mastic between wall seams, beige, rubbery mastic.</td> </tr> </table>	Sample No.: PRJ000914-AS015		Asb Detected:	No	Location:	Internal	Level 1, Central Sterilisation Department, construction joint mastic between wall seams, beige, rubbery mastic.			
Sample No.: PRJ000914-AS015											
Asb Detected:	No										
Location:	Internal										
Level 1, Central Sterilisation Department, construction joint mastic between wall seams, beige, rubbery mastic.

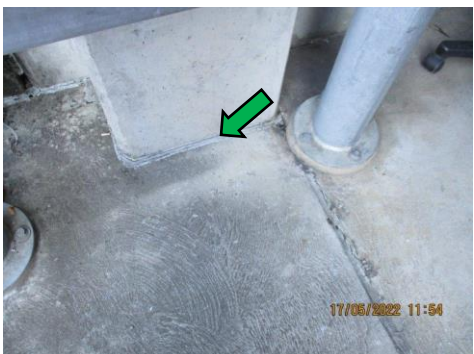
<table border="1"> <tr> <td colspan="2">Sample No.: PRJ000914-AS022</td> </tr> <tr> <td>Asb Detected:</td> <td>No</td> </tr> <tr> <td>Location:</td> <td>External</td> </tr> <tr> <td colspan="2">Level 1, Back of House, throughout, at base of concrete walls and columns – grey construction mastic, grey rubbery mastic.</td> </tr> </table>	Sample No.: PRJ000914-AS022		Asb Detected:	No	Location:	External	Level 1, Back of House, throughout, at base of concrete walls and columns – grey construction mastic, grey rubbery mastic.			
Sample No.: PRJ000914-AS022											
Asb Detected:	No										
Location:	External										
Level 1, Back of House, throughout, at base of concrete walls and columns – grey construction mastic, grey rubbery mastic.

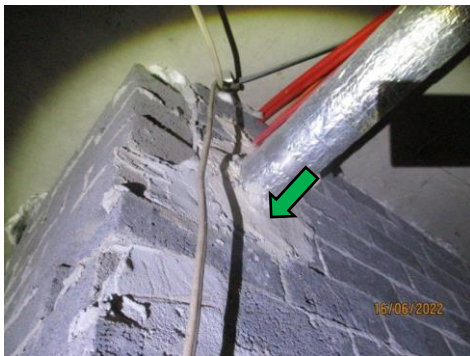
Sample No.: Same as: PRJ000914-AS012	
Asb Detected:	Assume No
Location:	Internal
Level 1, H1, ceiling space – vermiculite within service penetrations.  Similar vermiculite observed throughout hospital, around and within service penetrations.

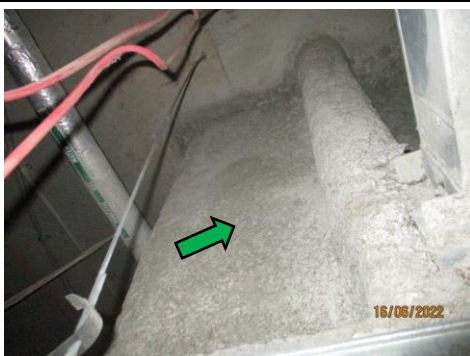
Sample No.: Same as: PRJ000914-AS017	
Asb Detected:	Assume No
Location:	Internal
Level 1, H1 Ceiling space – sprayed SMF insulation to structure and ductwork.  Similar sprayed SMF insulation present to ductwork, beams columns and ceilings throughout hospital.

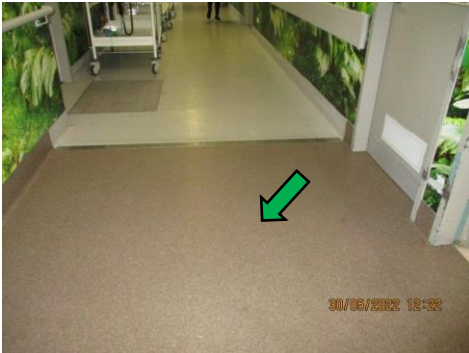
<table border="1"> <thead> <tr> <th colspan="2">Visual Assessment</th> </tr> </thead> <tbody> <tr> <td>Asb Detected:</td> <td>No</td> </tr> <tr> <td>Location:</td> <td>Internal</td> </tr> <tr> <td colspan="2">Level 1, Ward H1, entrance, modern vinyl floor coverings. Various modern non-asbestos floor coverings observed throughout K1.</td> </tr> </tbody> </table>	Visual Assessment		Asb Detected:	No	Location:	Internal	Level 1, Ward H1, entrance, modern vinyl floor coverings. Various modern non-asbestos floor coverings observed throughout K1.	
Visual Assessment									
Asb Detected:	No								
Location:	Internal								
Level 1, Ward H1, entrance, modern vinyl floor coverings. Various modern non-asbestos floor coverings observed throughout K1.

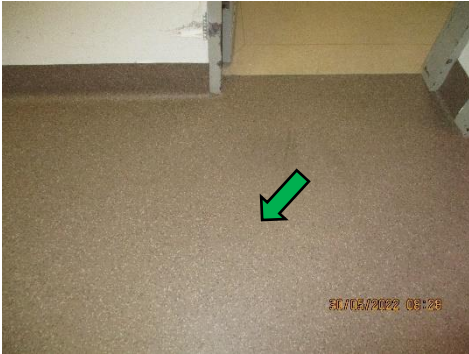
<table border="1"> <thead> <tr> <th colspan="2">Visual Assessment</th> </tr> </thead> <tbody> <tr> <td>Asb Detected:</td> <td>No</td> </tr> <tr> <td>Location:</td> <td>Internal</td> </tr> <tr> <td colspan="2">Level 1, Ward K1, entrance, modern vinyl floor coverings. Various modern non-asbestos floor coverings observed throughout K1.</td> </tr> </tbody> </table>	Visual Assessment		Asb Detected:	No	Location:	Internal	Level 1, Ward K1, entrance, modern vinyl floor coverings. Various modern non-asbestos floor coverings observed throughout K1.

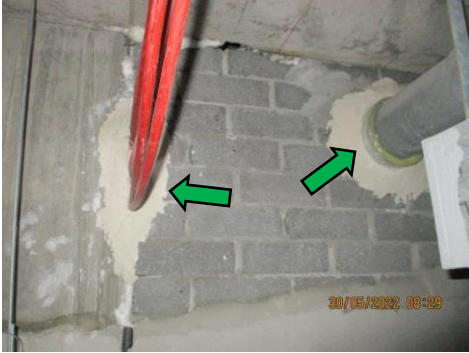
<table border="1"> <thead> <tr> <th colspan="2">Sample No.: Same as: PRJ000914-AS012</th> </tr> </thead> <tbody> <tr> <td>Asb Detected:</td> <td>No</td> </tr> <tr> <td>Location:</td> <td>Internal</td> </tr> <tr> <td colspan="2">Level 1, Ward K1, ceiling space – vermiculite fire stopping  Similar vermiculite observed throughout hospital, around and within service penetrations.</td> </tr> </tbody> </table>	Sample No.: Same as: PRJ000914-AS012		Asb Detected:	No	Location:	Internal	Level 1, Ward K1, ceiling space – vermiculite fire stopping  Similar vermiculite observed throughout hospital, around and within service penetrations.	
Sample No.: Same as: PRJ000914-AS012									
Asb Detected:	No

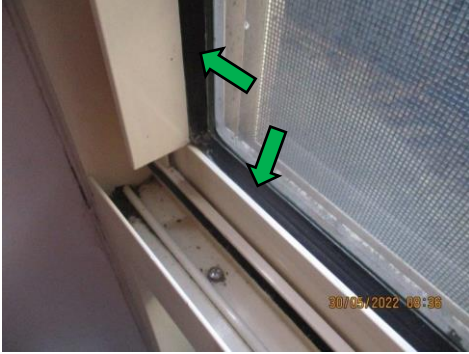
<table border="1"> <thead> <tr> <th colspan="2">Visual Assessment</th> </tr> </thead> <tbody> <tr> <td>Asb Detected:</td> <td>No</td> </tr> <tr> <td>Location:</td> <td>Internal</td> </tr> <tr> <td colspan="2">Level 1, Ward K1, windows frames throughout – rubber surrounding glass  Similar windows observed throughout hospital</td> </tr> </tbody> </table>	Visual Assessment		Asb Detected:	No	Location:	Internal	Level 1, Ward K1, windows frames throughout – rubber surrounding glass  Similar windows observed throughout hospital	
Visual Assessment									
Asb Detected:	No								
Location:	Internal								
Level 1, Ward K1, windows frames throughout – rubber surrounding glass  Similar windows observed throughout hospital

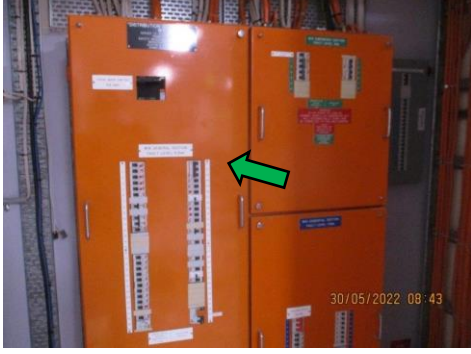
<table border="1"> <tr> <td colspan="2">Visual Assessment – Live electrical hazard</td> </tr> <tr> <td>Asb Detected:</td> <td>Assume No</td> </tr> <tr> <td>Location:</td> <td>Internal</td> </tr> <tr> <td colspan="2">Level 1, Internal, Ward K1, Electrical Switch cupboard, Modern electrical equipment</td> </tr> </table>	Visual Assessment – Live electrical hazard		Asb Detected:	Assume No	Location:	Internal	Level 1, Internal, Ward K1, Electrical Switch cupboard, Modern electrical equipment	
Visual Assessment – Live electrical hazard									
Asb Detected:	Assume No								
Location:	Internal								
Level 1, Internal, Ward K1, Electrical Switch cupboard, Modern electrical equipment									
 	<table border="1"> <tr> <td colspan="2">Visual Assessment – Live electrical hazard</td> </tr> <tr> <td>Asb Detected:</td> <td>Assume No</td> </tr> <tr> <td>Location:</td> <td>Internal</td> </tr> <tr> <td colspan="2">Level 1, Internal, Ward K1, Electrical Switch cupboard, Modern electrical equipment</td> </tr> </table>	Visual Assessment – Live electrical hazard		Asb Detected:	Assume No	Location:	Internal	Level 1, Internal, Ward K1, Electrical Switch cupboard, Modern electrical equipment

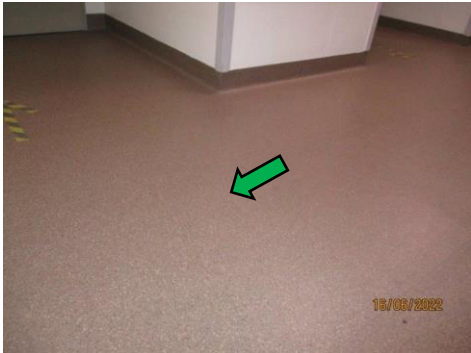
<table border="1"> <tr> <td colspan="2"><b>Sample No: PRJ000914-AS093</b></td> </tr> <tr> <td><b>Asb Detected:</b></td> <td>No</td> </tr> <tr> <td><b>Location:</b></td> <td>Internal</td> </tr> <tr> <td colspan="2">Level 1, Internal, Circulation Space, Lift Lobby adjacent Ward H1, Brown vinyl floor covering and amber adhesive</td> </tr> </table>	<b>Sample No: PRJ000914-AS093</b>		<b>Asb Detected:</b>	No	<b>Location:</b>	Internal	Level 1, Internal, Circulation Space, Lift Lobby adjacent Ward H1, Brown vinyl floor covering and amber adhesive			
<b>Sample No: PRJ000914-AS093</b>											
<b>Asb Detected:</b>	No										
<b>Location:</b>	Internal										
Level 1, Internal, Circulation Space, Lift Lobby adjacent Ward H1, Brown vinyl floor covering and amber adhesive

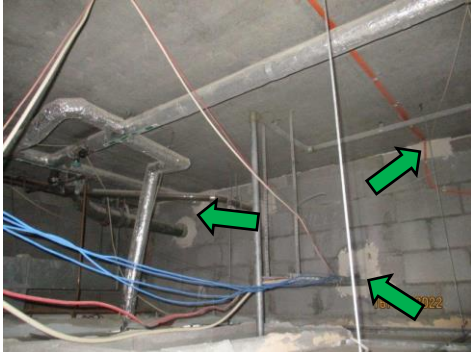
<table border="1"> <tr> <td colspan="2"><b>Sample No.: Same as: PRJ000914-AS012</b></td> </tr> <tr> <td><b>Asb Detected:</b></td> <td>No</td> </tr> <tr> <td><b>Location:</b></td> <td>Internal</td> </tr> <tr> <td colspan="2">Level 1, Male and female changing areas, ceiling space – vermiculite fire stopping</td> </tr> <tr> <td colspan="2">Similar vermiculite observed throughout hospital, around and within service penetrations.</td> </tr> </table>	<b>Sample No.: Same as: PRJ000914-AS012</b>		<b>Asb Detected:</b>	No	<b>Location:</b>	Internal	Level 1, Male and female changing areas, ceiling space – vermiculite fire stopping		Similar vermiculite observed throughout hospital, around and within service penetrations.

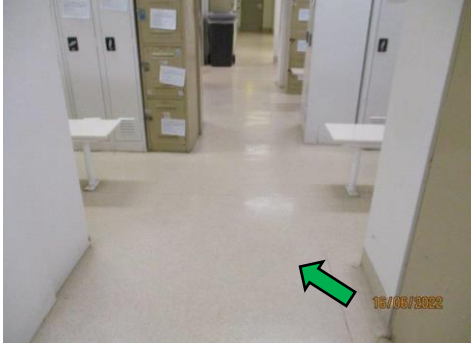
<table border="1"> <tr> <td colspan="2"><b>Visual assessment</b></td> </tr> <tr> <td><b>Asb Detected:</b></td> <td>No</td> </tr> <tr> <td><b>Location:</b></td> <td>Internal</td> </tr> <tr> <td colspan="2">Level 1, Male and female changing areas, beige vinyl floor covering, modern vinyl floor coverings.</td> </tr> </table>	<b>Visual assessment</b>		<b>Asb Detected:</b>	No	<b>Location:</b>	Internal	Level 1, Male and female changing areas, beige vinyl floor covering, modern vinyl floor coverings.			
<b>Visual assessment</b>											
<b>Asb Detected:</b>	No										
<b>Location:</b>	Internal

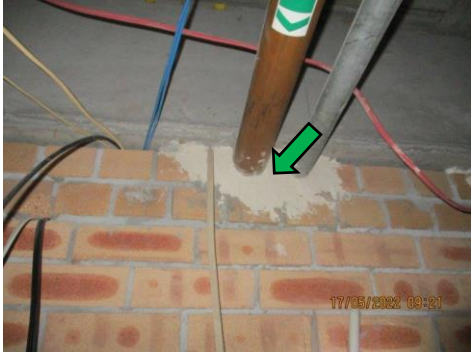
<table border="1"> <tr> <td colspan="2">Sample No.: PRJ000914-AS011</td> </tr> <tr> <td>Asb Detected:</td> <td>No</td> </tr> <tr> <td>Location:</td> <td>Internal</td> </tr> <tr> <td colspan="2">Level 2, Emergency Department, Room 2065 (Storeroom 4), ceiling space, penetrations, vermiculite.</td> </tr> <tr> <td colspan="2">Similar vermiculite observed throughout hospital around and within service penetrations.</td> </tr> </table>	Sample No.: PRJ000914-AS011		Asb Detected:	No	Location:	Internal	Level 2, Emergency Department, Room 2065 (Storeroom 4), ceiling space, penetrations, vermiculite.		Similar vermiculite observed throughout hospital around and within service penetrations.

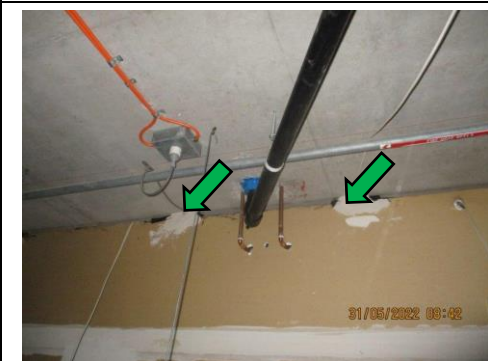
Same as Sample No.: PRJ000914-AS011	
Asb Detected:	No
Location:	Internal
Level 2, Pathology Department, ceiling space, vermiculite around penetrations.	
Similar vermiculite observed throughout hospital around and within service penetrations.

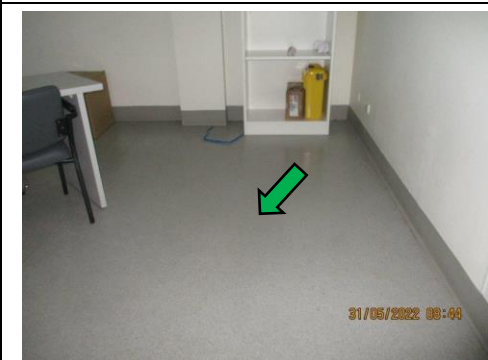
Visual Assessment – Modern Material	
Asb Detected:	No
Location:	Internal
Level 2, Pathology Department, modern vinyl floor coverings

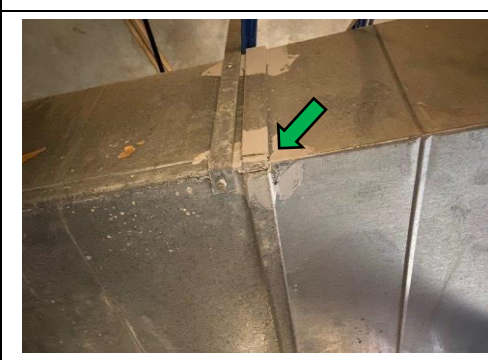
Sample No.: PRJ000914-AS007	
Asb Detected:	No
Location:	Internal
Level 2, Executive Suite, Room 2340 (Storeroom), ceiling space, air conditioning ductwork, between flanges – mastic, grey rubbery mastic.

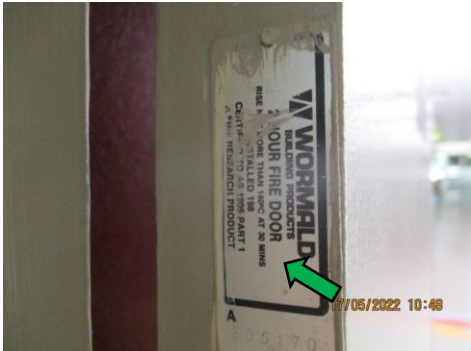
<table border="1"> <tr> <td colspan="2">Sample No.: PRJ000914-AS018</td> </tr> <tr> <td>Asb Detected:</td> <td>No</td> </tr> <tr> <td>Location:</td> <td>Internal</td> </tr> <tr> <td colspan="2">Internal, Level 2, Ward H2, Storeroom, corridor, Wormald fire door – Manufactured 198_ according to door tags.</td> </tr> <tr> <td colspan="2">Similar single and double fire doors observed throughout hospital.</td> </tr> </table>	Sample No.: PRJ000914-AS018		Asb Detected:	No	Location:	Internal	Internal, Level 2, Ward H2, Storeroom, corridor, Wormald fire door – Manufactured 198_ according to door tags.		Similar single and double fire doors observed throughout hospital.	
Sample No.: PRJ000914-AS018											
Asb Detected:	No										
Location:	Internal										
Internal, Level 2, Ward H2, Storeroom, corridor, Wormald fire door – Manufactured 198_ according to door tags.											
Similar single and double fire doors observed throughout hospital.

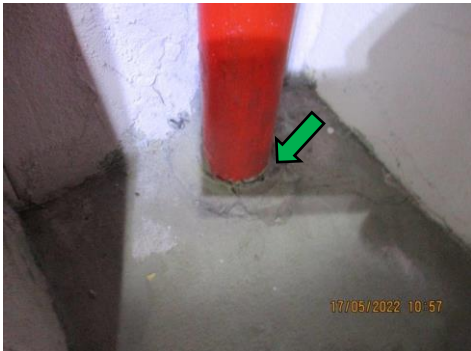
<table border="1"> <tr> <td colspan="2">Sample No.: PRJ000914-AS019</td> </tr> <tr> <td>Asb Detected:</td> <td>No</td> </tr> <tr> <td>Location:</td> <td>Internal</td> </tr> <tr> <td colspan="2">Level 2, Ward H2, Storeroom, adjacent corridor, fire hose reel cupboard, on ground around penetrations, clear mastic.</td> </tr> </table>	Sample No.: PRJ000914-AS019		Asb Detected:	No	Location:	Internal	Level 2, Ward H2, Storeroom, adjacent corridor, fire hose reel cupboard, on ground around penetrations, clear mastic.			
Sample No.: PRJ000914-AS019											
Asb Detected:	No										
Location:	Internal										
Level 2, Ward H2, Storeroom, adjacent corridor, fire hose reel cupboard, on ground around penetrations, clear mastic.

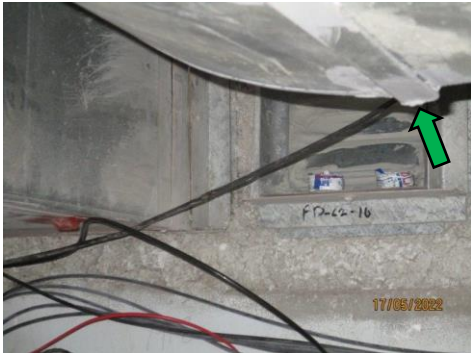
<table border="1"> <tr> <td colspan="2">Sample No.: Same as: PRJ000914-AS016</td> </tr> <tr> <td>Asb Detected:</td> <td>Assume No</td> </tr> <tr> <td>Location:</td> <td>Internal</td> </tr> <tr> <td colspan="2">Level 2, Pharmacy, ceiling space, air conditioning ductwork – mastic, grey rubbery mastic.</td> </tr> </table>	Sample No.: Same as: PRJ000914-AS016		Asb Detected:	Assume No	Location:	Internal	Level 2, Pharmacy, ceiling space, air conditioning ductwork – mastic, grey rubbery mastic.			
Sample No.: Same as: PRJ000914-AS016											
Asb Detected:	Assume No										
Location:	Internal										
Level 2, Pharmacy, ceiling space, air conditioning ductwork – mastic, grey rubbery mastic.

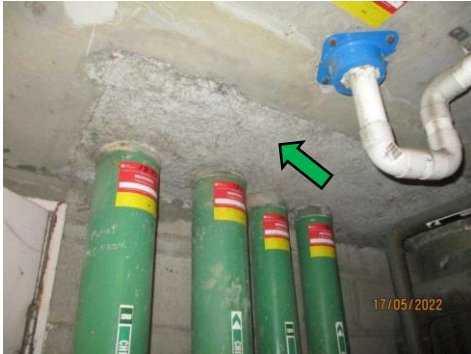
<table border="1"> <tr> <td colspan="2">Sample No.: Same as: PRJ000914-AS020</td> </tr> <tr> <td>Asb Detected:</td> <td>Assume No</td> </tr> <tr> <td>Location:</td> <td>Internal</td> </tr> <tr> <td colspan="2">Level 2, Pharmacy, ceiling space, within service penetrations – sprayed SMF insulation.</td> </tr> <tr> <td colspan="2">Similar sprayed SMF insulation observed throughout hospital around and within service penetrations.</td> </tr> </table>	Sample No.: Same as: PRJ000914-AS020		Asb Detected:	Assume No	Location:	Internal	Level 2, Pharmacy, ceiling space, within service penetrations – sprayed SMF insulation.		Similar sprayed SMF insulation observed throughout hospital around and within service penetrations.

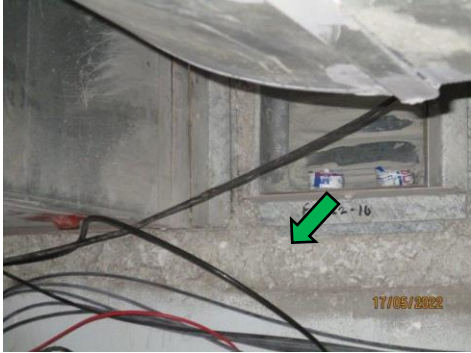
<table border="1"> <tr> <td colspan="2">Sample No.: Same as: PRJ000914-AS020</td> </tr> <tr> <td>Asb Detected:</td> <td>Assume No</td> </tr> <tr> <td>Location:</td> <td>Internal</td> </tr> <tr> <td colspan="2">Level 2, Pharmacy, Drug Information Room (2662), ceiling space, cable and duct penetrations – sprayed SMF insulation.</td> </tr> <tr> <td colspan="2">Similar sprayed SMF insulation observed throughout hospital around and within service penetrations.</td> </tr> </table>	Sample No.: Same as: PRJ000914-AS020		Asb Detected:	Assume No	Location:	Internal	Level 2, Pharmacy, Drug Information Room (2662), ceiling space, cable and duct penetrations – sprayed SMF insulation.		Similar sprayed SMF insulation observed throughout hospital around and within service penetrations.

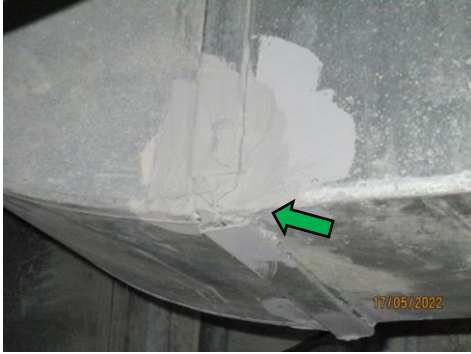
<table border="1"> <tr> <td colspan="2">Sample No.: Same as: PRJ000914-AS016</td> </tr> <tr> <td>Asb Detected:</td> <td>Assume No</td> </tr> <tr> <td>Location:</td> <td>Internal</td> </tr> <tr> <td colspan="2">Level 2, Pharmacy, Drug Information Room (2662), ceiling space, ductwork – mastic, grey rubbery mastic.</td> </tr> </table>	Sample No.: Same as: PRJ000914-AS016		Asb Detected:	Assume No	Location:	Internal	Level 2, Pharmacy, Drug Information Room (2662), ceiling space, ductwork – mastic, grey rubbery mastic.			
Sample No.: Same as: PRJ000914-AS016

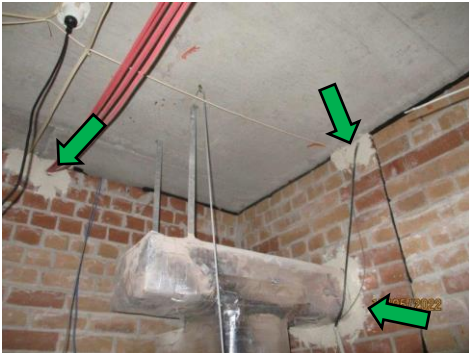
<table border="1"> <tr> <td colspan="2">Sample No.: Same as: PRJ000914-AS011</td> </tr> <tr> <td>Asb Detected:</td> <td>Assume No</td> </tr> <tr> <td>Location:</td> <td>Internal</td> </tr> <tr> <td colspan="2">Level 2, Pharmacy, Drug Information Room (2662), ceiling space – cable and duct penetrations, vermiculite.</td> </tr> <tr> <td colspan="2">Similar vermiculite observed throughout hospital around and within service penetrations.</td> </tr> </table>	Sample No.: Same as: PRJ000914-AS011		Asb Detected:	Assume No	Location:	Internal	Level 2, Pharmacy, Drug Information Room (2662), ceiling space – cable and duct penetrations, vermiculite.		Similar vermiculite observed throughout hospital around and within service penetrations.	
Sample No.: Same as: PRJ000914-AS011											
Asb Detected:	Assume No										
Location:	Internal										
Level 2, Pharmacy, Drug Information Room (2662), ceiling space – cable and duct penetrations, vermiculite.

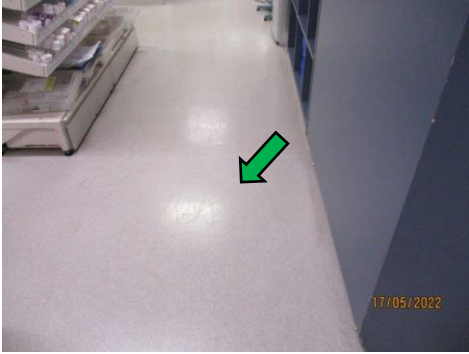
<table border="1"> <tr> <td colspan="2">Sample No.: PRJ000914-AS023</td> </tr> <tr> <td>Asb Detected:</td> <td>No</td> </tr> <tr> <td>Location:</td> <td>Internal</td> </tr> <tr> <td colspan="2">Level 2, Pharmacy, fire hose reel cupboard (2657), throughout, floor coverings – Mottled grey vinyl floor and amber adhesive.</td> </tr> </table>	Sample No.: PRJ000914-AS023		Asb Detected:	No	Location:	Internal	Level 2, Pharmacy, fire hose reel cupboard (2657), throughout, floor coverings – Mottled grey vinyl floor and amber adhesive.			
Sample No.: PRJ000914-AS023											
Asb Detected:	No										
Location:	Internal										
Level 2, Pharmacy, fire hose reel cupboard (2657), throughout, floor coverings – Mottled grey vinyl floor and amber adhesive.

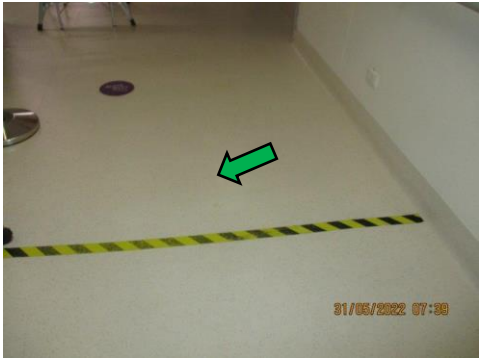
<table border="1"> <tr> <td colspan="2"><b>Visual assessment</b></td> </tr> <tr> <td><b>Asb Detected:</b></td> <td>No</td> </tr> <tr> <td><b>Location:</b></td> <td>Internal</td> </tr> <tr> <td colspan="2">Level 2, Outpatients Department, Modern vinyl floor coverings observed throughout Outpatients Department</td> </tr> </table>	<b>Visual assessment</b>		<b>Asb Detected:</b>	No	<b>Location:</b>	Internal	Level 2, Outpatients Department, Modern vinyl floor coverings observed throughout Outpatients Department	
<b>Visual assessment</b>									
<b>Asb Detected:</b>	No								
<b>Location:</b>	Internal								
Level 2, Outpatients Department, Modern vinyl floor coverings observed throughout Outpatients Department

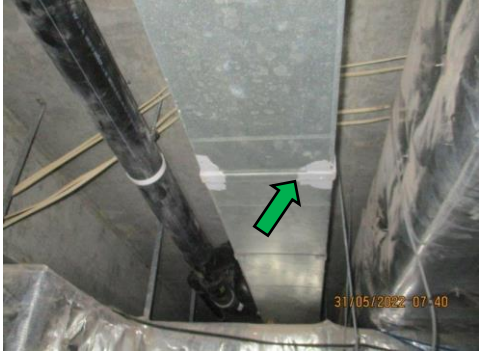
<table border="1"> <tr> <td colspan="2"><b>Same as Sample No.: PRJ000914-AS091</b></td> </tr> <tr> <td><b>Asb Detected:</b></td> <td>No</td> </tr> <tr> <td><b>Location:</b></td> <td>Internal</td> </tr> <tr> <td colspan="2">Level 2, Outpatients Department, Above ceiling, Duct mastic, grey rubbery mastic.</td> </tr> </table>	<b>Same as Sample No.: PRJ000914-AS091</b>		<b>Asb Detected:</b>	No	<b>Location:</b>	Internal	Level 2, Outpatients Department, Above ceiling, Duct mastic, grey rubbery mastic.

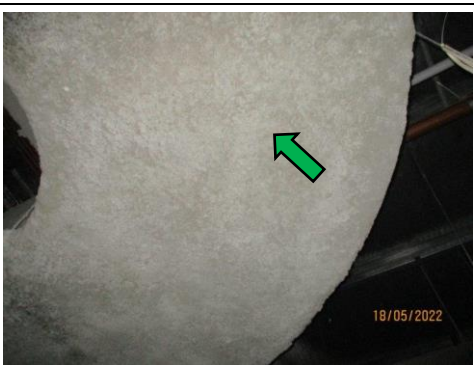
<table border="1"> <tr> <td colspan="2">Sample No.: Same as: PRJ000914-AS012</td> </tr> <tr> <td>Asb Detected:</td> <td>Assume No</td> </tr> <tr> <td>Location:</td> <td>Internal</td> </tr> <tr> <td colspan="2">Level 3, Intensive Care Unit, corridor adjacent retrieval service room, ceiling space, air conditioning ductwork – sprayed SMF insulation.</td> </tr> </table>	Sample No.: Same as: PRJ000914-AS012		Asb Detected:	Assume No	Location:	Internal	Level 3, Intensive Care Unit, corridor adjacent retrieval service room, ceiling space, air conditioning ductwork – sprayed SMF insulation.	
Sample No.: Same as: PRJ000914-AS012									
Asb Detected:	Assume No								
Location:	Internal								
Level 3, Intensive Care Unit, corridor adjacent retrieval service room, ceiling space, air conditioning ductwork – sprayed SMF insulation.

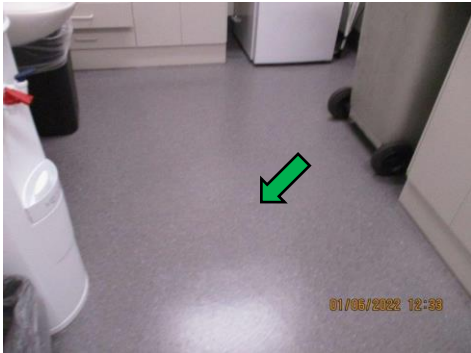
<table border="1"> <tr> <th colspan="2">Visual Observation – Modern Material</th> </tr> <tr> <td>Asb Detected:</td> <td>Assume No</td> </tr> <tr> <td>Location:</td> <td>Internal</td> </tr> <tr> <td colspan="2">Level 3, Acute General Surgery Unit, modern vinyl floor coverings throughout.</td> </tr> </table>	Visual Observation – Modern Material		Asb Detected:	Assume No	Location:	Internal	Level 3, Acute General Surgery Unit, modern vinyl floor coverings throughout.	
Visual Observation – Modern Material									
Asb Detected:	Assume No								
Location:	Internal								
Level 3, Acute General Surgery Unit, modern vinyl floor coverings throughout.									
 	<table border="1"> <tr> <th colspan="2">Same as Sample No.: PRJ000914-AS044</th> </tr> <tr> <td>Asb Detected:</td> <td>No</td> </tr> <tr> <td>Location:</td> <td>Internal</td> </tr> <tr> <td colspan="2">Level 3, Ward G3, ceiling space – vermiculite to structural beams and within service penetrations.</td> </tr> </table>	Same as Sample No.: PRJ000914-AS044		Asb Detected:	No	Location:	Internal	Level 3, Ward G3, ceiling space – vermiculite to structural beams and within service penetrations.

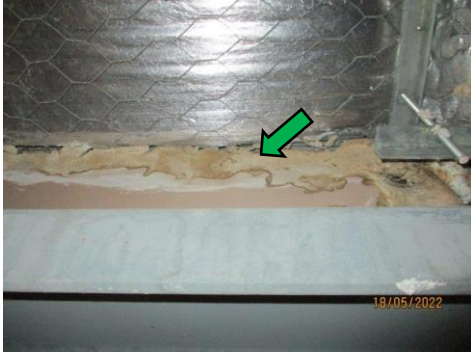
<table border="1"> <tr> <th colspan="2">Sample No.: PRJ000914-AS044</th> </tr> <tr> <td>Asb Detected:</td> <td>No</td> </tr> <tr> <td>Location:</td> <td>Internal</td> </tr> <tr> <td colspan="2">Level 3, Ward H3, corridor adjacent fire doors and Garbage/Dirty Linen Room, ceiling space – vermiculite within cable penetrations.</td> </tr> </table>	Sample No.: PRJ000914-AS044		Asb Detected:	No	Location:	Internal	Level 3, Ward H3, corridor adjacent fire doors and Garbage/Dirty Linen Room, ceiling space – vermiculite within cable penetrations.	
Sample No.: PRJ000914-AS044									
Asb Detected:	No								
Location:	Internal								
Level 3, Ward H3, corridor adjacent fire doors and Garbage/Dirty Linen Room, ceiling space – vermiculite within cable penetrations.

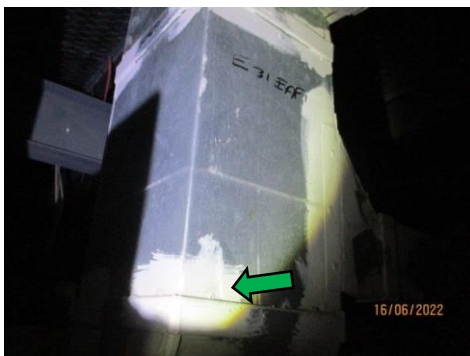
<b>Same as Sample No.: PRJ000914-AS043</b>	
<b>Asb Detected:</b>	No
<b>Location:</b>	Internal
Level 3, Ward K3, ceiling space, air conditioning ductwork – mastic, grey rubbery mastic.

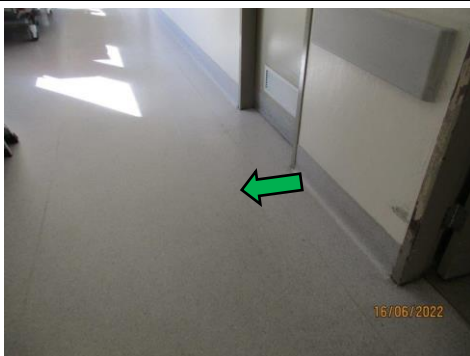
<b>Sample No.: Modern Appearance</b>	
<b>Asb Detected:</b>	No
<b>Location:</b>	Internal
Level 3, Ward K3, grey vinyl floor covering

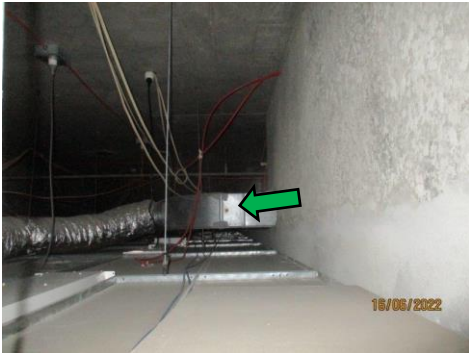
<table border="1"> <tr> <td colspan="2">Same as Sample No.: PRJ000914-AS043</td> </tr> <tr> <td>Asb Detected:</td> <td>No</td> </tr> <tr> <td>Location:</td> <td>Internal</td> </tr> <tr> <td colspan="2">Level 3, Circulation space adjacent Ward G3 lifts, ceiling space, air conditioning ductwork – mastic, grey rubbery mastic.</td> </tr> </table>	Same as Sample No.: PRJ000914-AS043		Asb Detected:	No	Location:	Internal	Level 3, Circulation space adjacent Ward G3 lifts, ceiling space, air conditioning ductwork – mastic, grey rubbery mastic.	
Same as Sample No.: PRJ000914-AS043									
Asb Detected:	No								
Location:	Internal								
Level 3, Circulation space adjacent Ward G3 lifts, ceiling space, air conditioning ductwork – mastic, grey rubbery mastic.

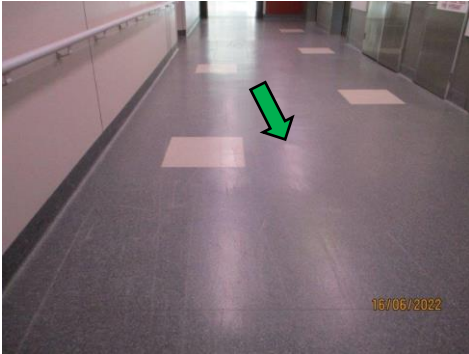
<table border="1"> <tr> <td colspan="2">Visual Assessment – Modern Appearance</td> </tr> <tr> <td>Asb Detected:</td> <td>No</td> </tr> <tr> <td>Location:</td> <td>Internal</td> </tr> <tr> <td colspan="2">Level 3, Circulation space adjacent Ward G3 lifts, grey vinyl floor covering</td> </tr> </table>	Visual Assessment – Modern Appearance		Asb Detected:	No	Location:	Internal	Level 3, Circulation space adjacent Ward G3 lifts, grey vinyl floor covering

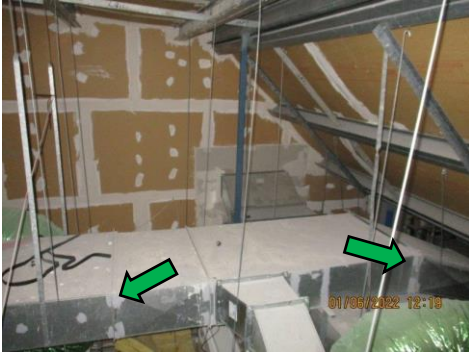
<table border="1"> <tr> <td colspan="2">Same as Sample No.: PRJ000914-AS043</td> </tr> <tr> <td>Asb Detected:</td> <td>No</td> </tr> <tr> <td>Location:</td> <td>Internal</td> </tr> <tr> <td colspan="2">Level 3, Above AGSU, Admin, Transplant and Research Department – Accessed via gantry walkway, air conditioning ductwork – mastic, grey rubbery mastic.</td> </tr> </table>	Same as Sample No.: PRJ000914-AS043		Asb Detected:	No	Location:	Internal	Level 3, Above AGSU, Admin, Transplant and Research Department – Accessed via gantry walkway, air conditioning ductwork – mastic, grey rubbery mastic.	
Same as Sample No.: PRJ000914-AS043									
Asb Detected:	No								
Location:	Internal								
Level 3, Above AGSU, Admin, Transplant and Research Department – Accessed via gantry walkway, air conditioning ductwork – mastic, grey rubbery mastic.

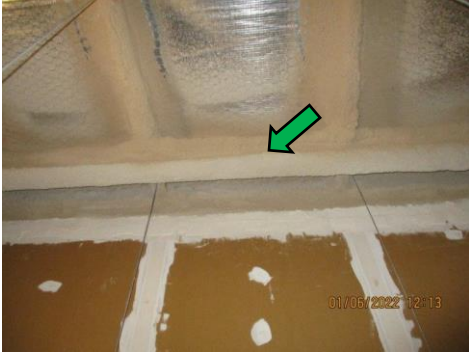
<table border="1"> <tr> <td colspan="2">Same as Sample No.: PRJ000914-AS042</td> </tr> <tr> <td>Asb Detected:</td> <td>No</td> </tr> <tr> <td>Location:</td> <td>Internal</td> </tr> <tr> <td colspan="2">Level 3, Above AGSU, Admin, Transplant and Research Department – Accessed via gantry walkway, ceiling space, structural beams – vermiculite.</td> </tr> </table>	Same as Sample No.: PRJ000914-AS042		Asb Detected:	No	Location:	Internal	Level 3, Above AGSU, Admin, Transplant and Research Department – Accessed via gantry walkway, ceiling space, structural beams – vermiculite.	
Same as Sample No.: PRJ000914-AS042									
Asb Detected:	No								
Location:	Internal								
Level 3, Above AGSU, Admin, Transplant and Research Department – Accessed via gantry walkway, ceiling space, structural beams – vermiculite.

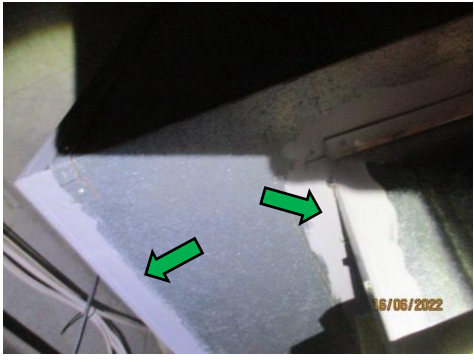
<table border="1"> <tr> <td colspan="2">Same as Sample No.: PRJ000914-AS043</td> </tr> <tr> <td>Asb Detected:</td> <td>No</td> </tr> <tr> <td>Location:</td> <td>Internal</td> </tr> <tr> <td colspan="2">Level 3, Coronary Care Unit, air conditioning ductwork – mastic, grey rubbery mastic.</td> </tr> </table>	Same as Sample No.: PRJ000914-AS043		Asb Detected:	No	Location:	Internal	Level 3, Coronary Care Unit, air conditioning ductwork – mastic, grey rubbery mastic.	
Same as Sample No.: PRJ000914-AS043									
Asb Detected:	No								
Location:	Internal								
Level 3, Coronary Care Unit, air conditioning ductwork – mastic, grey rubbery mastic.

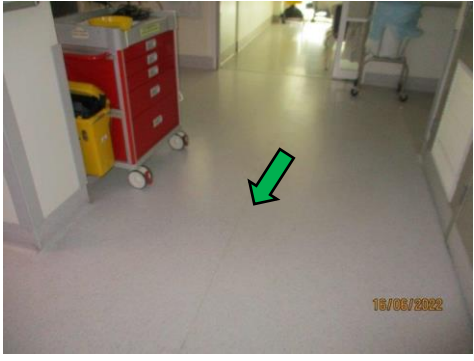
<table border="1"> <tr> <td colspan="2">Sample No.: Modern Appearance</td> </tr> <tr> <td>Asb Detected:</td> <td>No</td> </tr> <tr> <td>Location:</td> <td>Internal</td> </tr> <tr> <td colspan="2">Level 3, Coronary Care Unit, grey vinyl floor covering</td> </tr> </table>	Sample No.: Modern Appearance		Asb Detected:	No	Location:	Internal	Level 3, Coronary Care Unit, grey vinyl floor covering

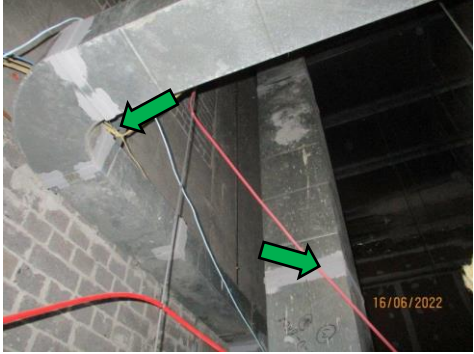
<table border="1"> <tr> <td colspan="2">Same as Sample No.: PRJ000914-AS043</td> </tr> <tr> <td>Asb Detected:</td> <td>No</td> </tr> <tr> <td>Location:</td> <td>Internal</td> </tr> <tr> <td colspan="2">Level 3, Cardiovascular Department, air conditioning ductwork – mastic, grey rubbery mastic.</td> </tr> </table>	Same as Sample No.: PRJ000914-AS043		Asb Detected:	No	Location:	Internal	Level 3, Cardiovascular Department, air conditioning ductwork – mastic, grey rubbery mastic.

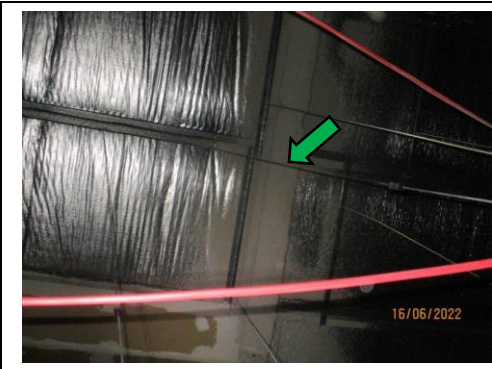
Same as Sample No.: PRJ000914-AS042	
Asb Detected:	No
Location:	Internal
Level 3, Maternity, Gynaecology and Endocrinology Department, throughout, ceiling space, structural beams – vermiculite.

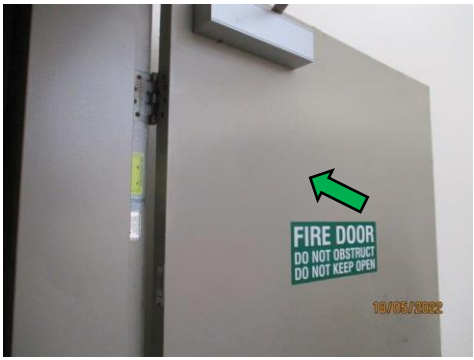
<table border="1"> <tr> <td colspan="2">Sample No.: PRJ000914-AS026</td> </tr> <tr> <td>Asb Detected:</td> <td>No</td> </tr> <tr> <td>Location:</td> <td>Internal</td> </tr> <tr> <td colspan="2">Level 4, Plant Room, west end, fire door (manufactured 198_) – fire door core.</td> </tr> <tr> <td colspan="2">Similar fire doors and modern non asbestos replacements observed throughout the hospital.</td> </tr> </table>	Sample No.: PRJ000914-AS026		Asb Detected:	No	Location:	Internal	Level 4, Plant Room, west end, fire door (manufactured 198_) – fire door core.		Similar fire doors and modern non asbestos replacements observed throughout the hospital.	
Sample No.: PRJ000914-AS026											
Asb Detected:	No										
Location:	Internal										
Level 4, Plant Room, west end, fire door (manufactured 198_) – fire door core.											
Similar fire doors and modern non asbestos replacements observed throughout the hospital.

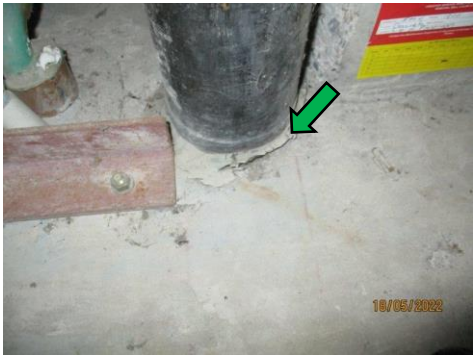
<table border="1"> <tr> <td colspan="2">Sample No.: PRJ000914-AS027</td> </tr> <tr> <td>Asb Detected:</td> <td>No</td> </tr> <tr> <td>Location:</td> <td>Internal</td> </tr> <tr> <td colspan="2">Level 4, Plant Room, soil vent pipe penetration, on ground – mastic, clear rubbery mastic.</td> </tr> </table>	Sample No.: PRJ000914-AS027		Asb Detected:	No	Location:	Internal	Level 4, Plant Room, soil vent pipe penetration, on ground – mastic, clear rubbery mastic.			
Sample No.: PRJ000914-AS027											
Asb Detected:	No										
Location:	Internal										
Level 4, Plant Room, soil vent pipe penetration, on ground – mastic, clear rubbery mastic.

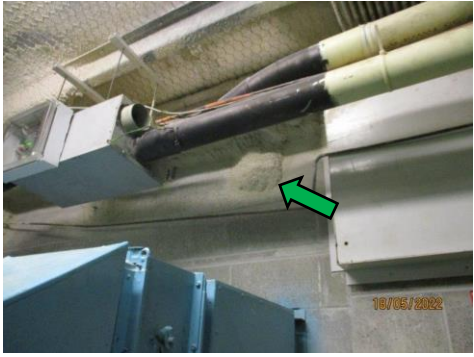
<table border="1"> <tr> <td colspan="2">Sample No.: PRJ000914-AS029</td> </tr> <tr> <td>Asb Detected:</td> <td>No</td> </tr> <tr> <td>Location:</td> <td>Internal</td> </tr> <tr> <td colspan="2">Level 4, Plant Room, throughout, ceiling – vermiculite.</td> </tr> <tr> <td colspan="2">Similar vermiculite observed throughout hospital around and within service penetrations and to structural elements such as brackets.</td> </tr> </table>	Sample No.: PRJ000914-AS029		Asb Detected:	No	Location:	Internal	Level 4, Plant Room, throughout, ceiling – vermiculite.		Similar vermiculite observed throughout hospital around and within service penetrations and to structural elements such as brackets.

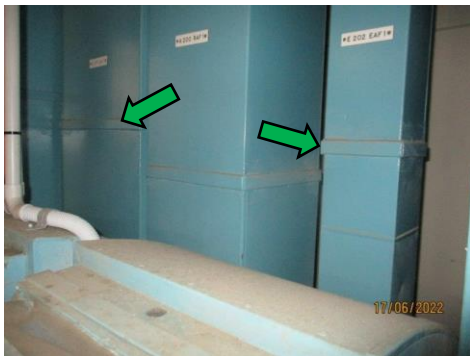
Same as Sample No.: PRJ000914-AS043	
Asb Detected:	No
Location:	Internal
Level 4, Internal, Plant Rooms, air conditioning ductwork – mastic.

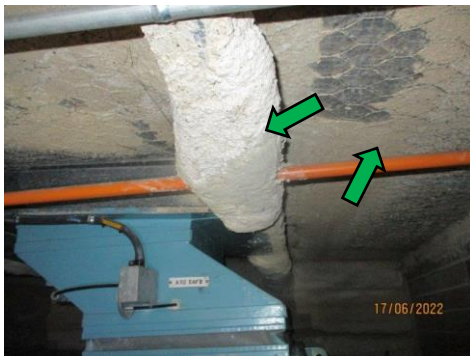
Same as Sample No.: PRJ000914-AS035	
Asb Detected:	No
Location:	Internal
Level 4, Internal, Small Plant Room adjacent roof access, sprayed vermiculite insulation to roof structure.

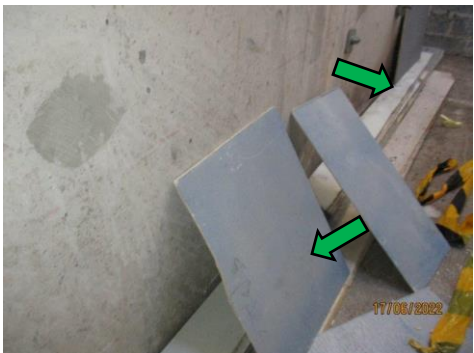
<table border="1"> <tr> <td colspan="2">Sample No.: PRJ000914-AS0100</td> </tr> <tr> <td>Asb Detected:</td> <td>No</td> </tr> <tr> <td>Location:</td> <td>Internal</td> </tr> <tr> <td colspan="2">Level 4, Internal, Roof access stairwell, loose panels, Compressed cement sheet</td> </tr> </table>	Sample No.: PRJ000914-AS0100		Asb Detected:	No	Location:	Internal	Level 4, Internal, Roof access stairwell, loose panels, Compressed cement sheet

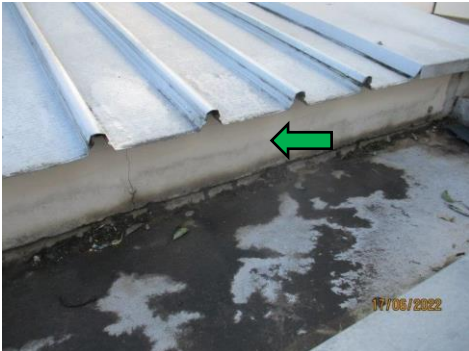
<table border="1"> <tr> <td colspan="2">Sample No.: PRJ000914-AS096</td> </tr> <tr> <td>Asb Detected:</td> <td>No</td> </tr> <tr> <td>Location:</td> <td>Internal</td> </tr> <tr> <td colspan="2">Level 4, External, Roof, panels beneath roof sheets, compressed cement sheet</td> </tr> </table>	Sample No.: PRJ000914-AS096		Asb Detected:	No	Location:	Internal	Level 4, External, Roof, panels beneath roof sheets, compressed cement sheet	
Sample No.: PRJ000914-AS096									
Asb Detected:	No								
Location:	Internal								
Level 4, External, Roof, panels beneath roof sheets, compressed cement sheet									
 	<table border="1"> <tr> <td colspan="2">Sample No.: PRJ000914-AS097</td> </tr> <tr> <td>Asb Detected:</td> <td>No</td> </tr> <tr> <td>Location:</td> <td>Internal</td> </tr> <tr> <td colspan="2">Level 4, External, Roof, mastic to AHU ducts and vents, mastic Typical across roof to plant and ducting.</td> </tr> </table>	Sample No.: PRJ000914-AS097		Asb Detected:	No	Location:	Internal	Level 4, External, Roof, mastic to AHU ducts and vents, mastic Typical across roof to plant and ducting.

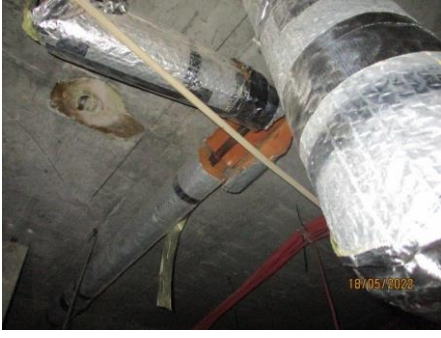
<table border="1"> <thead> <tr> <th colspan="2">Visual Inspection</th> </tr> </thead> <tbody> <tr> <td>SMF Identified:</td> <td>Yes</td> </tr> <tr> <td>Location:</td> <td>Internal</td> </tr> <tr> <td colspan="2">Level 1, Ward G1, throughout, ceiling space – pipework insulation.</td> </tr> </tbody> </table>	Visual Inspection		SMF Identified:	Yes	Location:	Internal	Level 1, Ward G1, throughout, ceiling space – pipework insulation.
