**RE : DEMOLITION WORK PLAN MD - 2753**  
**AT : JOHN HUNTER HEALTH & INNOVATION PRECINCT**

## Demolition Work Plan (DWP)

JHHIP – Stage 1

# HAZARDOUS MATERIALS SURVEY REPORT

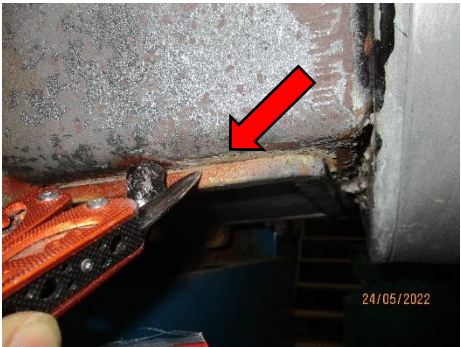
Sample No.: PRJ000914-AS065

Asbestos Detected:	Yes
	Friability:	Friable
	Location:	Internal
	Level 0, 0029 Boiler Room, Bunderus Boiler, gaskets to rear of 3 x boilers	
	Extent	3 Units
Sample No.: PRJ000914-AS068		
 	Asbestos Detected:	Yes
	Friability:	Friable
	Location:	Internal
	Level 0, 0024 Compressor Room, gaskets to No.1 & No.2 receiver tanks and pipework – 8 no. valve sets.	
	Extent	16 Units
Sample No.: PRJ000914-AS069

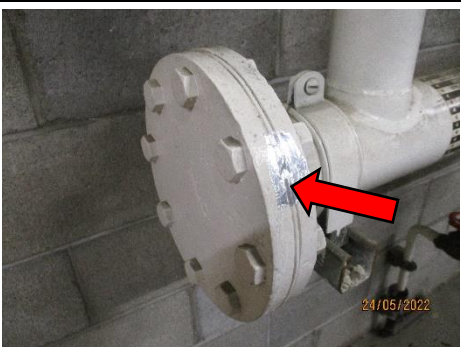
Asbestos Detected:	Yes
	Friability:	Friable
	Location:	Internal
	Level 0, 0024 Compressor Room, gasket to compressed air pipework flange Further similar gaskets are presumed to be present on this service line within the building.	
	Extent	1 Unit
Sample No.: PRJ000914-AS070

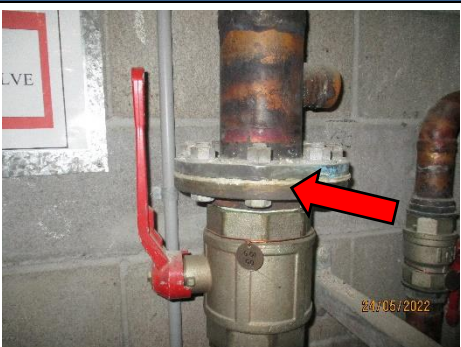
Asbestos Detected:	Yes
	Friability:	Friable
	Location:	Internal
	Level 0, 0025 Under Croft Plant area, gaskets to natural gas isolation valve Further similar gaskets are presumed to be present on this service line within the building.

Extent	1 Unit

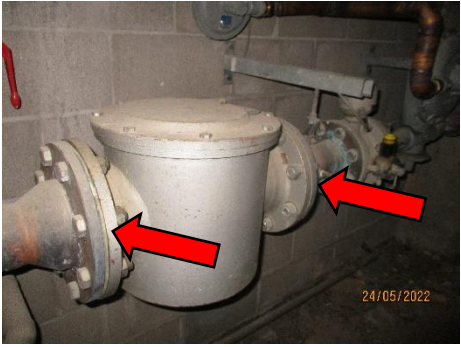
<b>Sample No.: PRJ000914-AS071</b>

<b>Asbestos Detected:</b> <b>Yes</b>
	<b>Friability:</b> Friable
	<b>Location:</b> Internal
	Level 0, 0025 Under Croft Plant area, gaskets to pipework Further similar gaskets are presumed to be present on this service line within the building.
<b>Extent</b>	6 Units

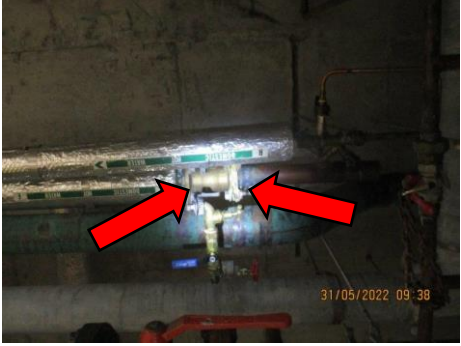
<b>Visual Assessment: Height Restricted.</b>

<b>Asbestos Detected:</b> <b>Presumed</b>
	<b>Friability:</b> Friable
	<b>Location:</b> Internal
	Level 1, Internal, Under Croft, NW end, gaskets to hot water valve sets – too high to sample. Further similar gaskets are presumed to be present on this service line within the building.
<b>Extent</b>	2 Units

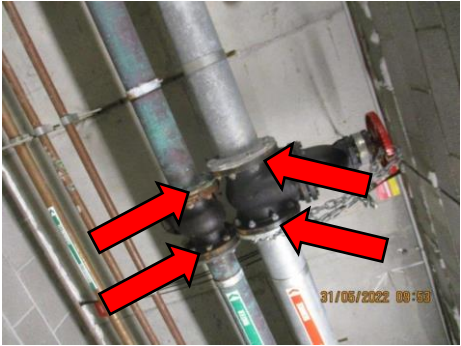
<b>Visual Assessment: Height Restricted.</b>

<b>Asbestos Detected:</b> <b>Presumed</b>
	<b>Friability:</b> Friable
	<b>Location:</b> Internal
	Level 1 (Mezzanine), Internal, Plant area back of CSSD, gaskets to fire and cold-water valve sets – too high to sample. Further similar gaskets are presumed to be present on this service line within the building.
<b>Extent</b>	4 Units

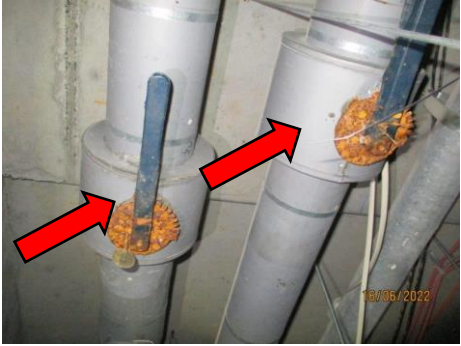
<b>Visual Assessment: Height Restricted.</b>

<b>Asbestos Detected:</b> <b>Presumed</b>
	<b>Friability:</b> Friable
	<b>Location:</b> Internal
	Level 1, Circulation areas adjacent G1 Lifts, presumed gaskets between encased valve sets – too high to sample, and metal casing riveted shut. Further similar gaskets are presumed to be present on this service line within the building.
<b>Extent</b>	4 Units

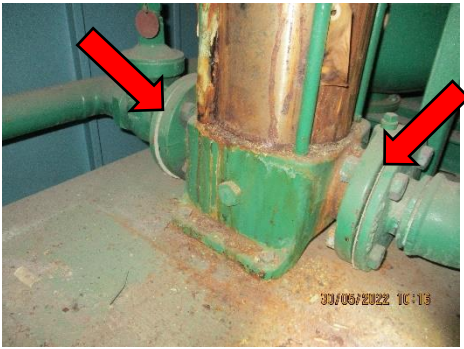
Sample No.: PRJ000914-AS080

Asbestos Detected:	Yes
	Friability:	Friable
	Location:	Internal
	Level 4, Internal, Plant Room, gasket to non-potable water pump valves. Further similar gaskets are presumed to be present on this service line within the building.	
Extent	2 Units	
Sample No.: PRJ000914-AS081

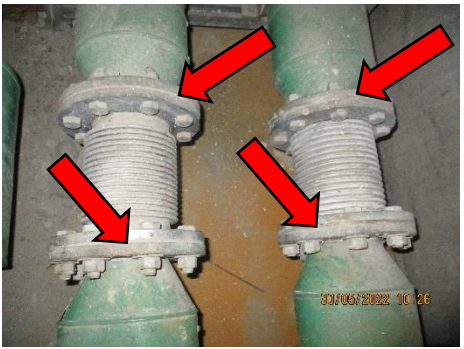
Asbestos Detected:	Yes
	Friability:	Friable
	Location:	Internal
	Level 4, Internal, Plant Room, gaskets to hot water pipework valve sets (2 gaskets per valve set). Further similar gaskets are presumed to be present on this service line within the building.	
Extent	16 Units	
Sample No.: Same as: PRJ000914-AS081

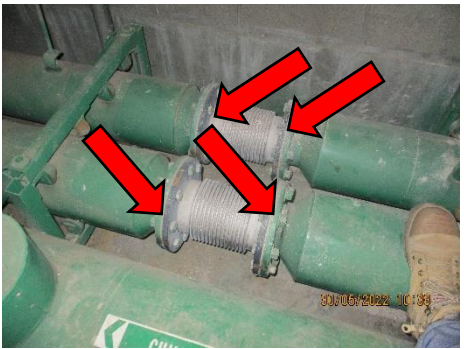
Asbestos Detected:	Yes
	Friability:	Friable
	Location:	Internal
	Level 4, Internal, Plant Room, gaskets to hot water pipework valve sets (2 gaskets per valve set). Further similar gaskets are presumed to be present on this service line within the building.	
Extent	16 Units	
Sample No.: Same as: PRJ000914-AS081

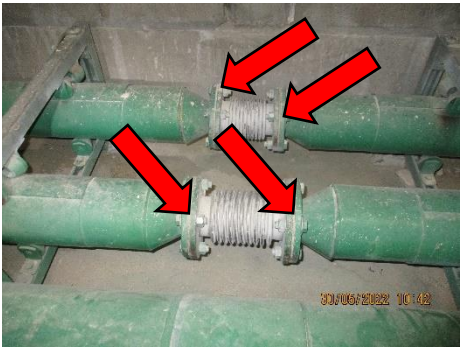
Asbestos Detected:	Yes
	Friability:	Friable
	Location:	Internal
	Level 4, Internal, Plant Room, gaskets to hot water pipework valve sets (2 gaskets per valve set). Further similar gaskets are presumed to be present on this service line within the building.	
Extent	16 Units

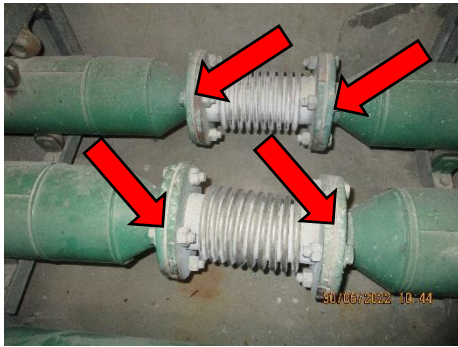
Sample No.: Same as: PRJ000914-AS081

Asbestos Detected:	Yes
Friability:	Friable
Location:	Internal
Level 4, Internal, Plant Room, gaskets to hot water pipework valve sets (2 gaskets per valve set). Further similar gaskets are presumed to be present on this service line within the building.	
Extent	16 Units

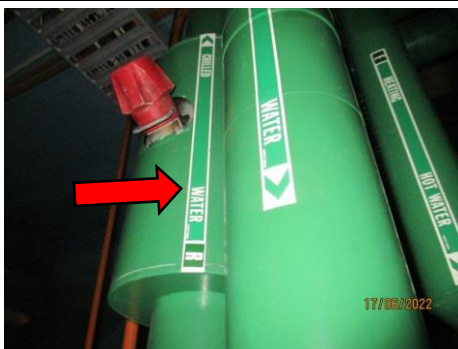
Sample No.: Same as: PRJ000914-AS081

Asbestos Detected:	Presumed
Friability:	Friable
Location:	Internal
Level 4, Internal, Plant Rooms, asbestos gaskets presumed to be present to pipework valve sets within riveted metal encased pipe insulation. Further similar gaskets are presumed to be present on this service line within the building.	
Extent	Unquantified

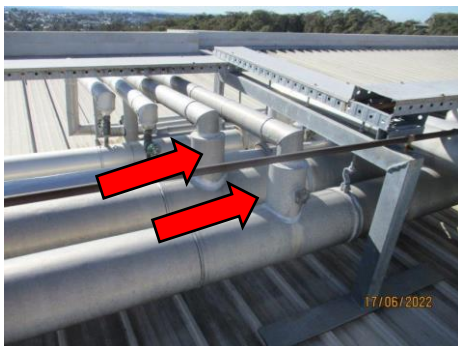
Sample No.: Same as: PRJ000914-AS081

Asbestos Detected:	Presumed
Friability:	Friable
Location:	External
Level 4, External, Roof, asbestos gaskets presumed to be present to pipework valve sets within riveted metal encased pipe insulation. Further similar gaskets are presumed to be present on this service line within the building.	
Extent	Unquantified

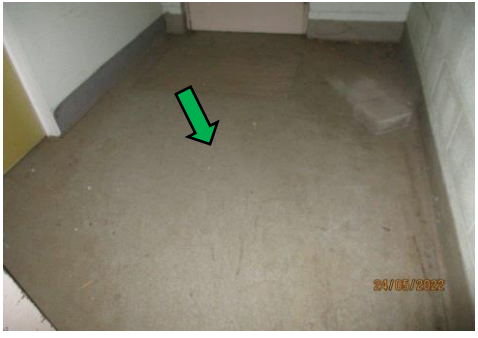
<table border="1"> <tr> <td colspan="2">Sample No.: PRJ000914-AS051</td> </tr> <tr> <td>Asb Detected:</td> <td>No</td> </tr> <tr> <td>Location:</td> <td>Internal</td> </tr> <tr> <td colspan="2">Level 0, Internal, Plantroom (0020) lobby, grey floor covering, no adhesive present</td> </tr> </table>	Sample No.: PRJ000914-AS051		Asb Detected:	No	Location:	Internal	Level 0, Internal, Plantroom (0020) lobby, grey floor covering, no adhesive present	
Sample No.: PRJ000914-AS051									
Asb Detected:	No								
Location:	Internal								
Level 0, Internal, Plantroom (0020) lobby, grey floor covering, no adhesive present

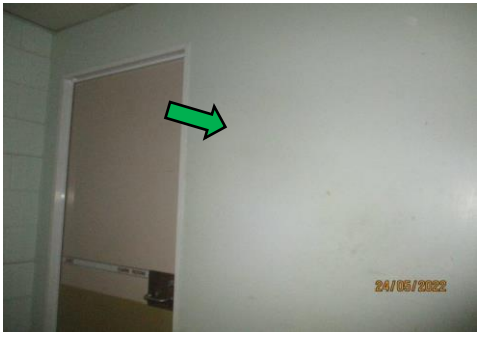
<table border="1"> <tr> <td colspan="2">Sample No.: PRJ000914-AS052</td> </tr> <tr> <td>Asb Detected:</td> <td>No</td> </tr> <tr> <td>Location:</td> <td>Internal</td> </tr> <tr> <td colspan="2">Level 0, Internal, Plantroom (0020) lobby, darkroom partition wall, fibre cement</td> </tr> </table>	Sample No.: PRJ000914-AS052		Asb Detected:	No	Location:	Internal	Level 0, Internal, Plantroom (0020) lobby, darkroom partition wall, fibre cement

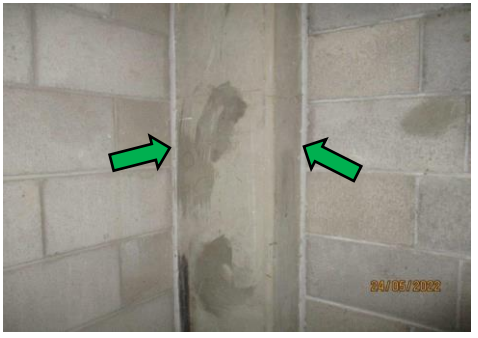
<table border="1"> <tr> <td colspan="2">Sample No.: PRJ000914-AS053</td> </tr> <tr> <td>Asb Detected:</td> <td>No</td> </tr> <tr> <td>Location:</td> <td>Internal</td> </tr> <tr> <td colspan="2">Level 0, Internal, 0020 Plantroom, adjacent roller shutter, expansion joint in walls, Grey rubbery mastic</td> </tr> </table>	Sample No.: PRJ000914-AS053		Asb Detected:	No	Location:	Internal	Level 0, Internal, 0020 Plantroom, adjacent roller shutter, expansion joint in walls, Grey rubbery mastic	
Sample No.: PRJ000914-AS053									
Asb Detected:	No								
Location:	Internal								
Level 0, Internal, 0020 Plantroom, adjacent roller shutter, expansion joint in walls, Grey rubbery mastic

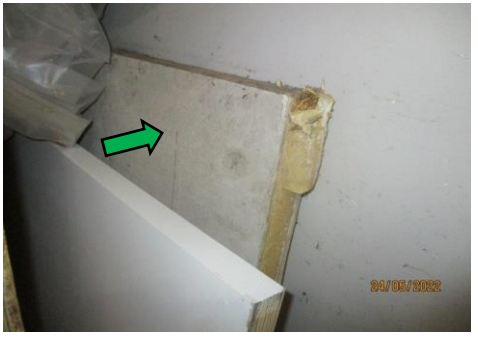
<table border="1"> <tr> <td colspan="2">Sample No.: PRJ000914-AS054</td> </tr> <tr> <td>Asb Detected:</td> <td>No</td> </tr> <tr> <td>Location:</td> <td>Internal</td> </tr> <tr> <td colspan="2">Level 0, Internal, 0020 Plantroom, adjacent chiller room, panel to stored door, fibre cement.</td> </tr> </table>	Sample No.: PRJ000914-AS054		Asb Detected:	No	Location:	Internal	Level 0, Internal, 0020 Plantroom, adjacent chiller room, panel to stored door, fibre cement.

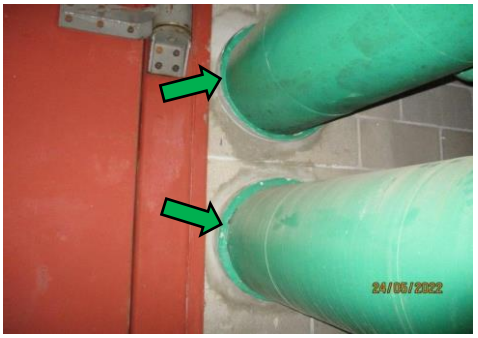
<table border="1"> <tr> <td colspan="2">Sample No.: PRJ000914-AS055</td> </tr> <tr> <td>Asb Detected:</td> <td>No</td> </tr> <tr> <td>Location:</td> <td>Internal</td> </tr> <tr> <td colspan="2">Level 0, Internal, 0020 Plantroom, mastic around chilled water pipework penetration, grey rubbery mastic</td> </tr> </table>	Sample No.: PRJ000914-AS055		Asb Detected:	No	Location:	Internal	Level 0, Internal, 0020 Plantroom, mastic around chilled water pipework penetration, grey rubbery mastic	
Sample No.: PRJ000914-AS055									
Asb Detected:	No								
Location:	Internal								
Level 0, Internal, 0020 Plantroom, mastic around chilled water pipework penetration, grey rubbery mastic

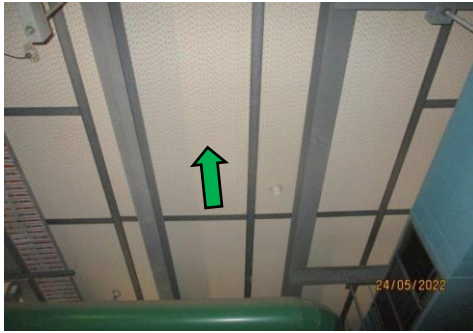
Sample No.: PRJ000914-AS056

Asb Detected: No

Level 0, Internal, 0020 Plantroom, perforated ceiling panels

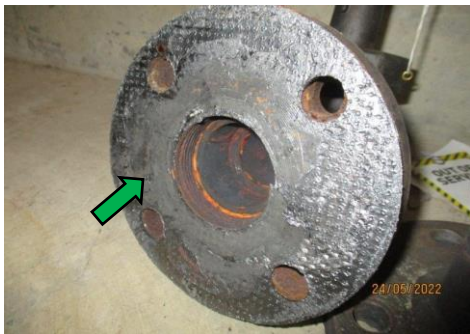
Sample No.: PRJ000914-AS057

Asb Detected: No

Level 0, Internal, 0029 Boiler Room, SW wall, gasket residue to redundant pipe flanges

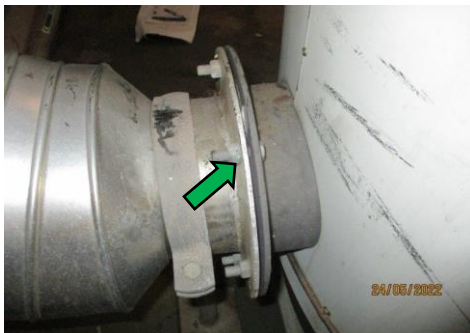
Sample No.: PRJ000914-AS058

Asb Detected: No

Level 0, Internal, 0029 Boiler Room, Steam Boiler No.1, gasket to rear

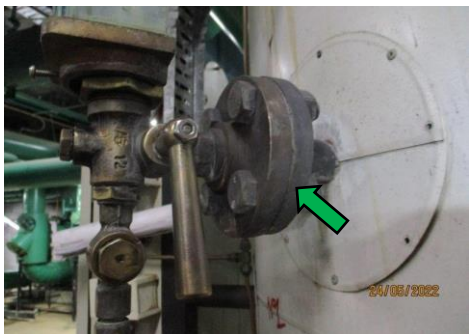
Sample No.: PRJ000914-AS059

Asb Detected: No

Level 0, Internal, 0029 Boiler Room, Steam Boiler No.1, north side, gaskets to flanges

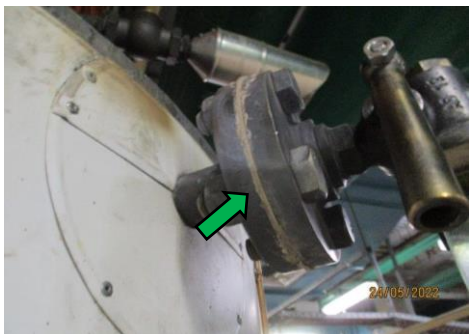
Sample No.: PRJ000914-AS060

Asb Detected: No

Level 0, Internal, 0029 Boiler Room, Steam Boiler No.1, NE side, gaskets to flanges

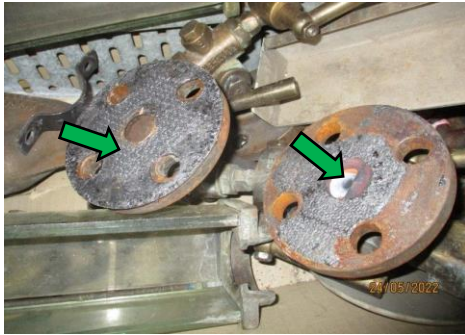
Sample No.: PRJ000914-AS061

Asb Detected: No

Level 0, Internal, 0029 Boiler Room, Adj Fire door to 0025, gasket residue to redundant flanges

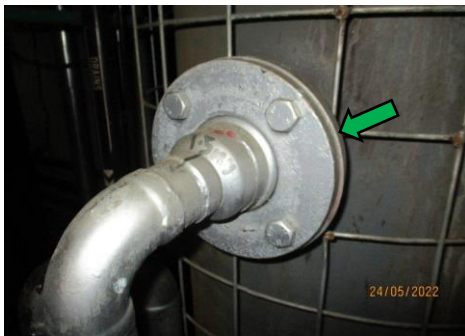
Sample No.: PRJ000914-AS077

Asb Detected: No

Level 0, Internal, 0029 Boiler Room, Gaskets to grey tank

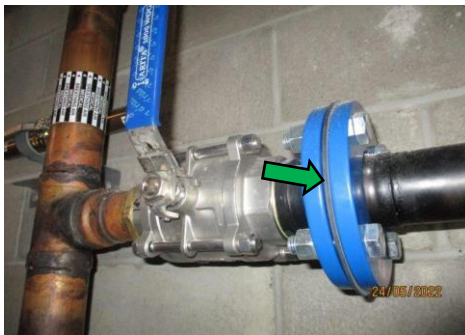
Asb Detected: No

Level 0, Internal, 0029 Boiler Room, rubber gaskets to medical air plant

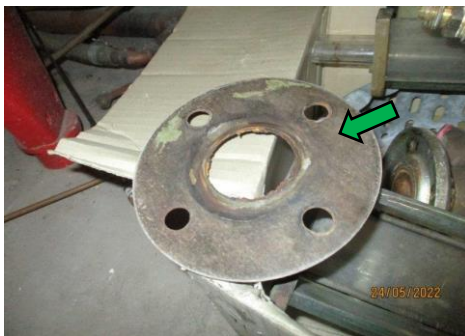
Sample No.: PRJ000914-AS062

Asb Detected: No

Level 0, Internal, 0029 Boiler Room, Adj Fire door to 0025, loose gasket (taken away as sample)

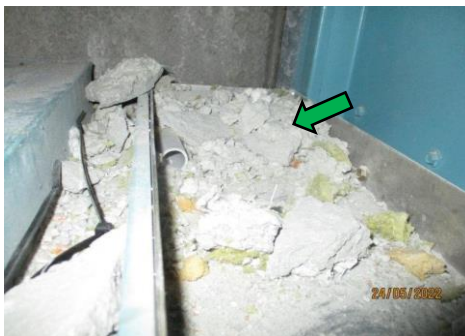
Sample No.: PRJ000914-AS063

Asb Detected: No

Level 0, Internal, 0029 Boiler Room, penetration packing on AHU

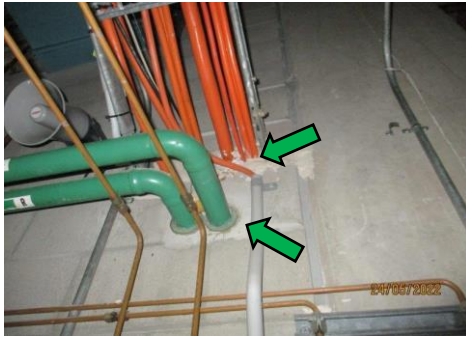
Similar to Sample No.: PRJ000914-AS063

Asb Detected: No

Level 0, Internal, 0029 Boiler Room, penetration packing

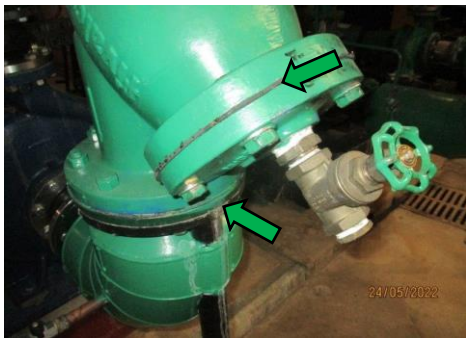
Sample No.: PRJ000914-AS064

Asb Detected: No

Level 0, Internal, 0029 Boiler Room, black gaskets to secondary water heating pumps

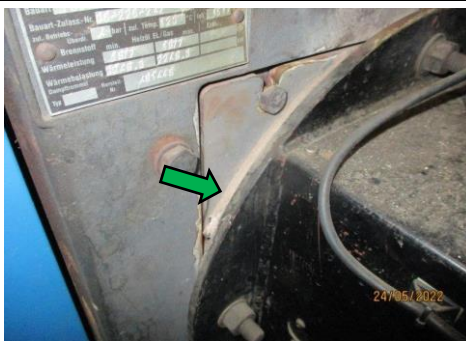
Sample No.: PRJ000914-AS066

Asb Detected: No

Level 0, Internal, 0029 Boiler Room, Bunderus Boiler, gasket to end cap

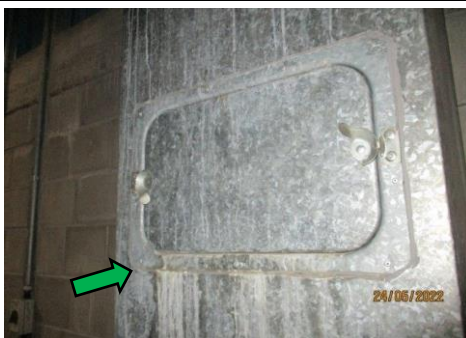
Sample No.: PRJ000914-AS067

Asb Detected: No

Level 0, Internal, 0029 Boiler Room, mastic to AC duct, grey rubbery mastic

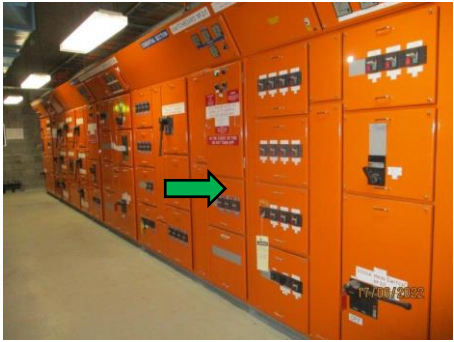
<table border="1"> <tr> <th colspan="2">Visual Assessment – Modern Appearance</th> </tr> <tr> <td>Asb Detected:</td> <td>Assume No</td> </tr> <tr> <td>Location:</td> <td>Internal</td> </tr> <tr> <td colspan="2">Level 0, Substation 2, Modern electrical equipment, presume non-asbestos backing boards and components.</td> </tr> </table>	Visual Assessment – Modern Appearance		Asb Detected:	Assume No	Location:	Internal	Level 0, Substation 2, Modern electrical equipment, presume non-asbestos backing boards and components.	
Visual Assessment – Modern Appearance									
Asb Detected:	Assume No								
Location:	Internal								
Level 0, Substation 2, Modern electrical equipment, presume non-asbestos backing boards and components.

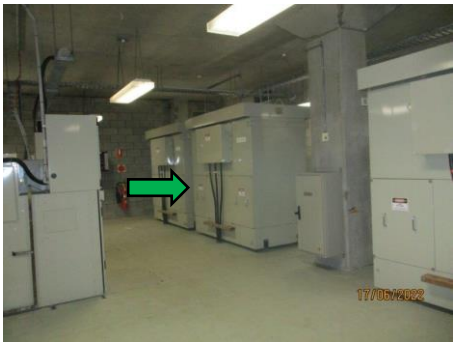
<table border="1"> <tr> <th colspan="2">Visual Assessment – Modern Appearance</th> </tr> <tr> <td>Asb Detected:</td> <td>Assume No</td> </tr> <tr> <td>Location:</td> <td>Internal</td> </tr> <tr> <td colspan="2">Level 0, Substation 2, High voltage area, Modern electrical equipment, presume non-asbestos backing boards and components.</td> </tr> </table>	Visual Assessment – Modern Appearance		Asb Detected:	Assume No	Location:	Internal	Level 0, Substation 2, High voltage area, Modern electrical equipment, presume non-asbestos backing boards and components.

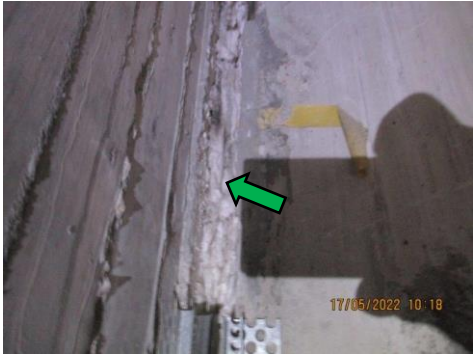
<table border="1"> <tr> <td colspan="2">Similar to Sample No.: PRJ000914-AS005</td> </tr> <tr> <td>Asb Detected:</td> <td>No</td> </tr> <tr> <td>Location:</td> <td>Internal</td> </tr> <tr> <td colspan="2">Level 1, Central Sterilisation Department, between ceiling slab and brick and concrete walls – “Kaowool” SMF.</td> </tr> </table>	Similar to Sample No.: PRJ000914-AS005		Asb Detected:	No	Location:	Internal	Level 1, Central Sterilisation Department, between ceiling slab and brick and concrete walls – “Kaowool” SMF.

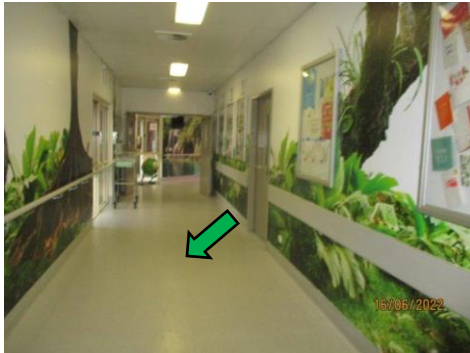
Sample No.: Same as: PRJ000914-AS014	
Asb Detected:	No
Location:	Internal
Level 1, Ward H1, floor coverings – grey vinyl floor covering. Typical throughout Ward H1.

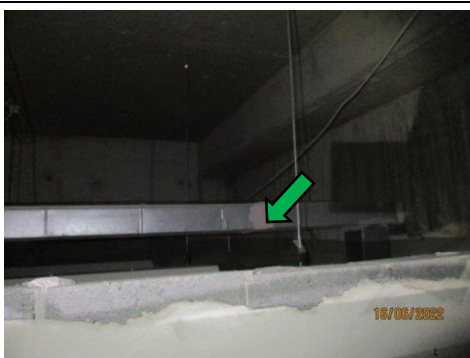
Sample No.: Same as PRJ000914-AS037	
Asb Detected:	No
Location:	Internal
Level 1, H1 Ceiling space, Air Handling Units – duct mastic.

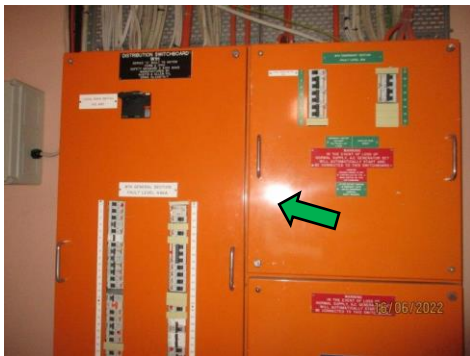
Sample No.: Visual Inspection – Live electrics

Asb Detected: Assume No

Level 1, H1, Electrical Distribution Board Cupboard electrical backing board (modern appearance).

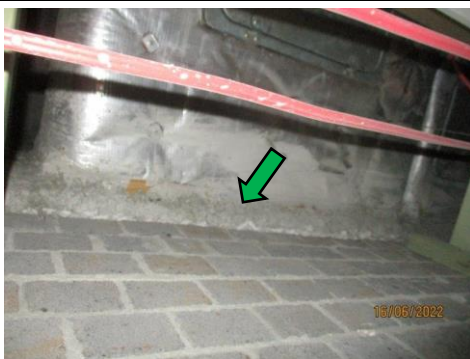
Sample No.: Same as: PRJ000914-AS017

Asb Detected: Assume No

Level 1, Circulation space adjacent H1 Lifts, Ceiling space – sprayed SMF insulation to structure and ductwork.

Similar sprayed SMF insulation present to ductwork, beams columns and ceilings throughout hospital.

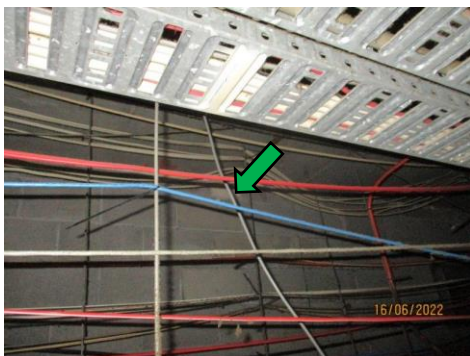
Sample No.: Same as: PRJ000914-AS012

Asb Detected: Assume No

Level 1, Circulation space adjacent H1 Lifts - vermiculite within service penetrations.

Similar vermiculite observed throughout hospital, around and within service penetrations.

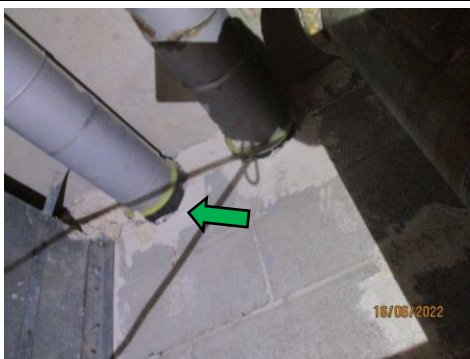
Sample No.: Same as: PRJ000914-AS012

Asb Detected: Assume No

Level 1, Circulation space adjacent G1 Lifts - vermiculite within service penetrations.

Similar vermiculite observed throughout hospital, around and within service penetrations.

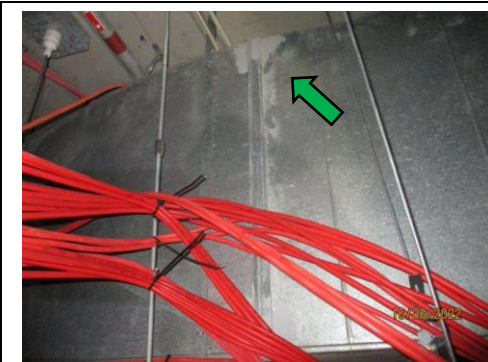
Sample No.: Same as PRJ000914-AS037

Asb Detected: No

Level 1, Circulation space adjacent G1 Lifts, Air Handling Units – duct mastic.

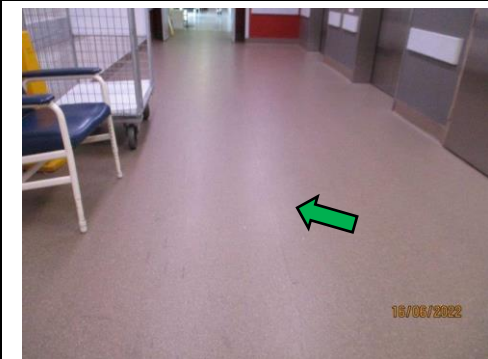
Sample No.: Visual Inspection

Asb Detected: Assume No

Level 1, Circulation space adjacent G1 Lifts, Modern brown vinyl floor covering

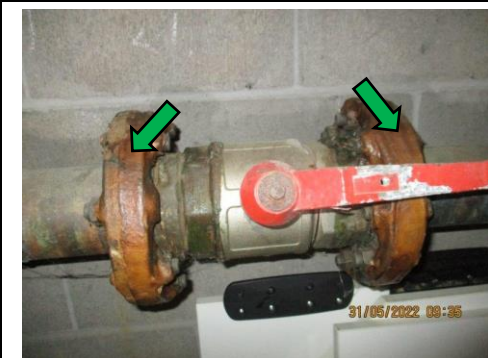
Sample No.: PRJ000914-AS086

Asb Detected: No

Level 1, Internal, Under croft, NW end, gaskets to natural gas valve sets.

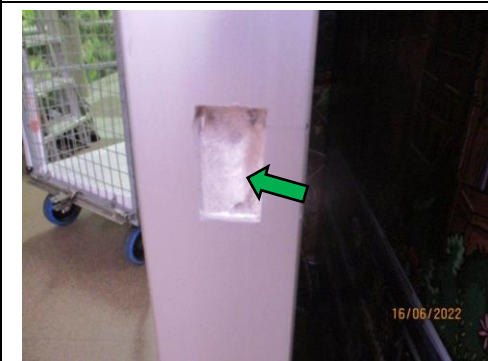
Sample No: PRJ000914-AS092

Asb Detected: No

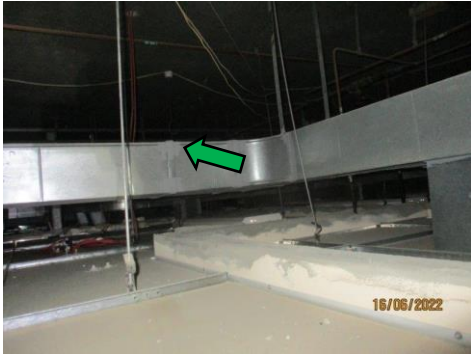
<table border="1"> <tr> <td colspan="2"><b>Sample No.: Same as: PRJ000914-AS037</b></td> </tr> <tr> <td><b>Asb Detected:</b></td> <td>No</td> </tr> <tr> <td><b>Location:</b></td> <td>Internal</td> </tr> <tr> <td colspan="2">Level 1, Male and female changing areas, ceiling space, Air Handling Units – duct mastic, grey rubbery mastic.</td> </tr> </table>	<b>Sample No.: Same as: PRJ000914-AS037</b>		<b>Asb Detected:</b>	No	<b>Location:</b>	Internal	Level 1, Male and female changing areas, ceiling space, Air Handling Units – duct mastic, grey rubbery mastic.

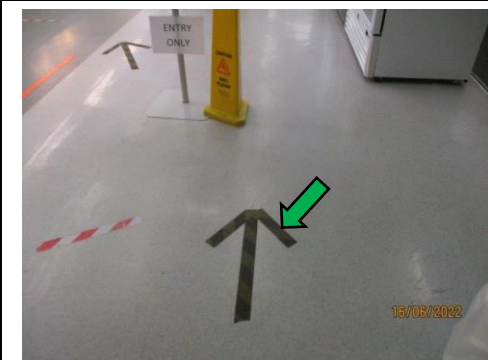
Asb Detected: No

Level 1, Cafeteria, modern grey vinyl floor coverings.

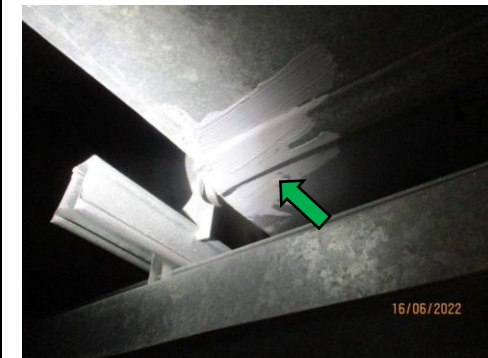
Sample No.: Same as: PRJ000914-AS037

Asb Detected: No

Level 1, Cafeteria, above ceiling, ductwork mastic, grey rubbery mastic.

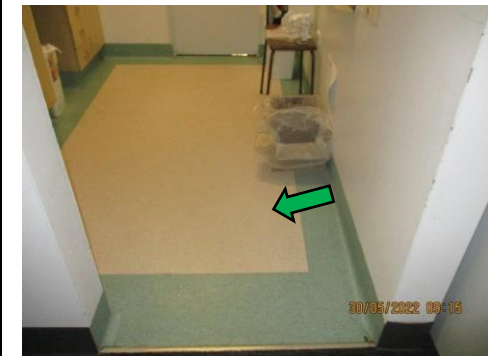
Visual Assessment – Modern material

Asb Detected: No

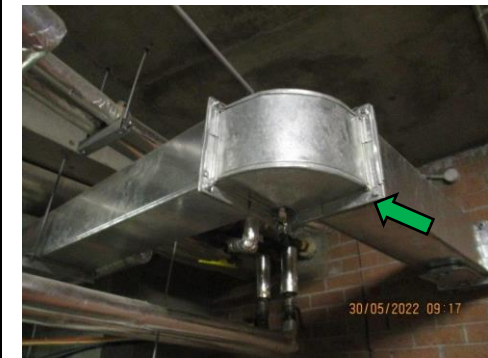
Visual Assessment – Modern material

Asb Detected: No

Location: Internal

Level 1, Nexus plant room, modern air handling units – no mastic on joints.

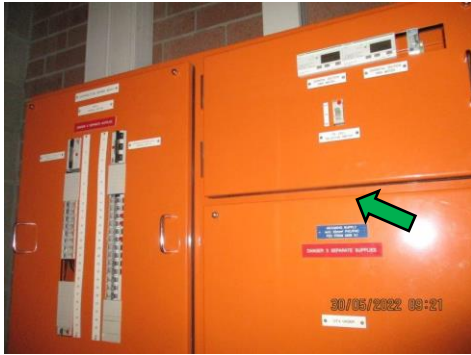
Visual Assessment – Live Electrics

Asb Detected: Assume No

Location: Internal

Level 1, Nexus plant room, modern electrical equipment

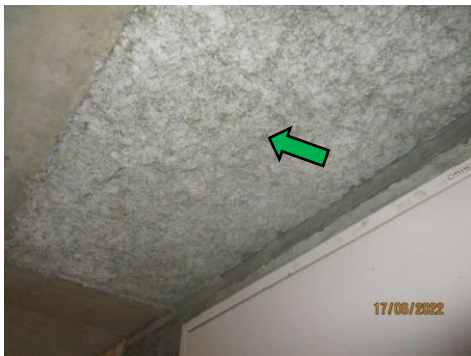
Sample No.: Same as: PRJ000914-AS012

Asb Detected: No

Location: Internal

Level 1, Fire Escape Stairwells, sprayed SMF insulation above fire door

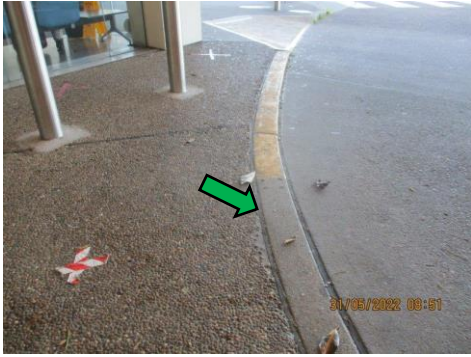
<table border="1"> <tr> <td colspan="2">Sample No.: PRJ000914-AS085</td> </tr> <tr> <td>Asb Detected:</td> <td>No</td> </tr> <tr> <td>Location:</td> <td>External</td> </tr> <tr> <td colspan="2">Level 2, External Emergency Department drop off area, expansion joint in floor, bitumen.</td> </tr> </table>	Sample No.: PRJ000914-AS085		Asb Detected:	No	Location:	External	Level 2, External Emergency Department drop off area, expansion joint in floor, bitumen.	
Sample No.: PRJ000914-AS085									
Asb Detected:	No								
Location:	External								
Level 2, External Emergency Department drop off area, expansion joint in floor, bitumen.

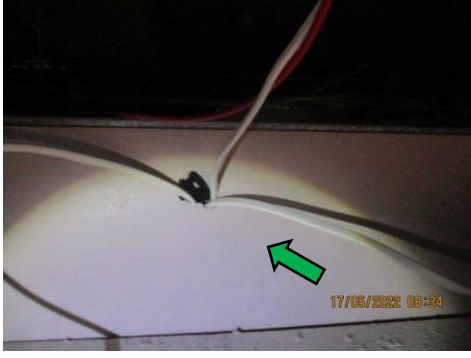
<table border="1"> <tr> <td colspan="2">Sample No.: PRJ000914-AS008</td> </tr> <tr> <td>Asb Detected:</td> <td>No</td> </tr> <tr> <td>Location:</td> <td>Internal</td> </tr> <tr> <td colspan="2">Level 2, Emergency Department, Room 2073 (Disposal Room) ceiling space, partition walls – fibre cement sheeting</td> </tr> </table>	Sample No.: PRJ000914-AS008		Asb Detected:	No	Location:	Internal	Level 2, Emergency Department, Room 2073 (Disposal Room) ceiling space, partition walls – fibre cement sheeting

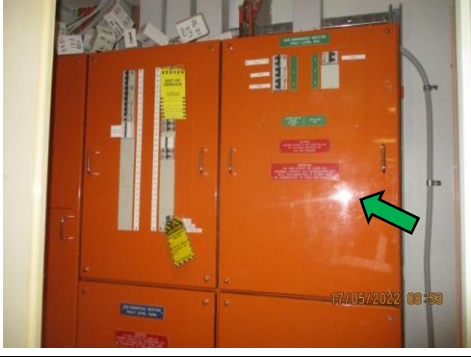
<table border="1"> <tr> <td colspan="2">Sample No.: Visual inspection (Live electrics)</td> </tr> <tr> <td>Asb Detected:</td> <td>Assume No</td> </tr> <tr> <td>Location:</td> <td>Internal</td> </tr> <tr> <td colspan="2">Level 2, Emergency Department, DB S2B, modern electrical backing boards.</td> </tr> </table>	Sample No.: Visual inspection (Live electrics)		Asb Detected:	Assume No	Location:	Internal	Level 2, Emergency Department, DB S2B, modern electrical backing boards.	
Sample No.: Visual inspection (Live electrics)									
Asb Detected:	Assume No								
Location:	Internal								
Level 2, Emergency Department, DB S2B, modern electrical backing boards.

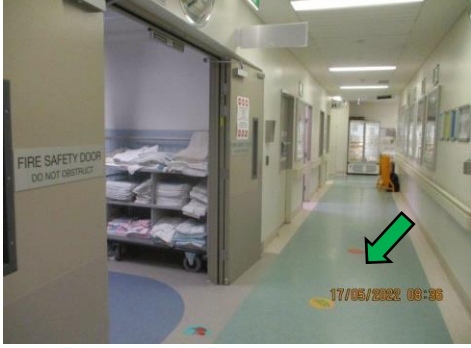
<table border="1"> <tr> <td colspan="2">Sample No.: PRJ000914-AS009</td> </tr> <tr> <td>Asb Detected:</td> <td>No</td> </tr> <tr> <td>Location:</td> <td>Internal</td> </tr> <tr> <td colspan="2">Level 2, Emergency Department, Room 2100 (Dirty Utility Room), vinyl floor coverings and amber adhesive.</td> </tr> </table>	Sample No.: PRJ000914-AS009		Asb Detected:	No	Location:	Internal	Level 2, Emergency Department, Room 2100 (Dirty Utility Room), vinyl floor coverings and amber adhesive.

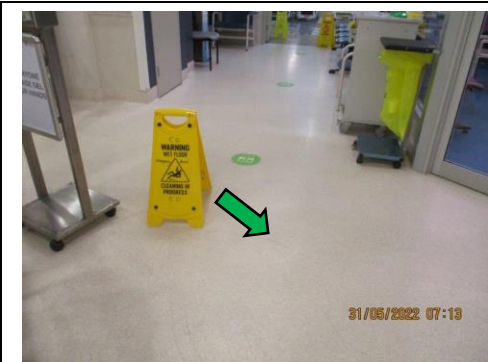
Visual Assessment	
Asb Detected:	No
Location:	External
Level 2, Internal, Emergency Department waiting area, modern floor coverings.	
Emergency Department waiting room recently renovated.

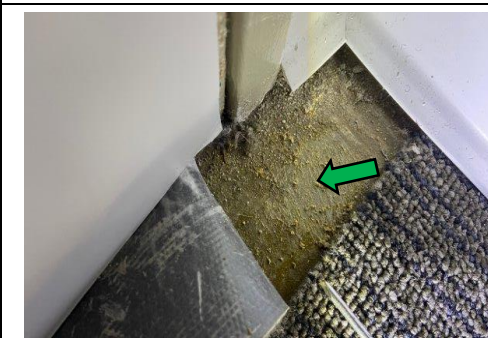
Sample No.: PRJ000914-AS006	
Asb Detected:	No
Location:	Internal
Level 2, Executive Suite, Room 2340 (Storeroom), throughout, beneath carpet tiles – amber adhesive.	
Note: Anecdotal evidence from JHH staff suggest that Executive Suite was completely refurbished <10 years ago.

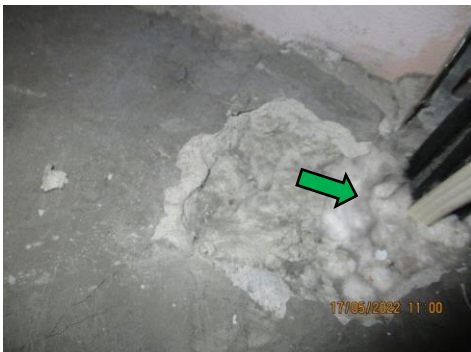
<table border="1"> <tr> <td colspan="2">Sample No.: PRJ000914-AS020</td> </tr> <tr> <td>Asb Detected:</td> <td>No</td> </tr> <tr> <td>Location:</td> <td>Internal</td> </tr> <tr> <td colspan="2">Level 2, Ward H2, Room 2808, (Electrical Distribution Cupboard), within service penetrations – insulation material.</td> </tr> </table>	Sample No.: PRJ000914-AS020		Asb Detected:	No	Location:	Internal	Level 2, Ward H2, Room 2808, (Electrical Distribution Cupboard), within service penetrations – insulation material.

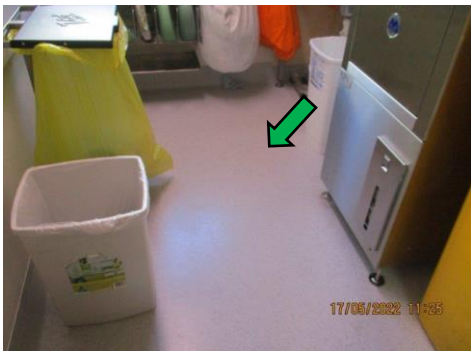
<table border="1"> <tr> <td colspan="2">Sample No.: PRJ000914-AS021</td> </tr> <tr> <td>Asb Detected:</td> <td>No</td> </tr> <tr> <td>Location:</td> <td>Internal</td> </tr> <tr> <td colspan="2">Level 2, Ward H2, Room 2846 (Dirty Laundry/Toilet Utility Room), throughout, floor coverings – mottled grey vinyl floor covering and amber adhesive.</td> </tr> </table>	Sample No.: PRJ000914-AS021		Asb Detected:	No	Location:	Internal	Level 2, Ward H2, Room 2846 (Dirty Laundry/Toilet Utility Room), throughout, floor coverings – mottled grey vinyl floor covering and amber adhesive.			
Sample No.: PRJ000914-AS021											
Asb Detected:	No										
Location:	Internal										
Level 2, Ward H2, Room 2846 (Dirty Laundry/Toilet Utility Room), throughout, floor coverings – mottled grey vinyl floor covering and amber adhesive.

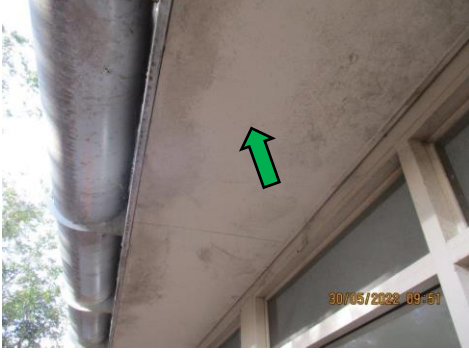
<table border="1"> <tr> <td colspan="2">Sample No.: PRJ000914-AS078</td> </tr> <tr> <td>Asb Detected:</td> <td>No</td> </tr> <tr> <td>Location:</td> <td>External</td> </tr> <tr> <td colspan="2">Level 2, External, Corridor to Nexus, eaves, fibre cement</td> </tr> </table>	Sample No.: PRJ000914-AS078		Asb Detected:	No	Location:	External	Level 2, External, Corridor to Nexus, eaves, fibre cement

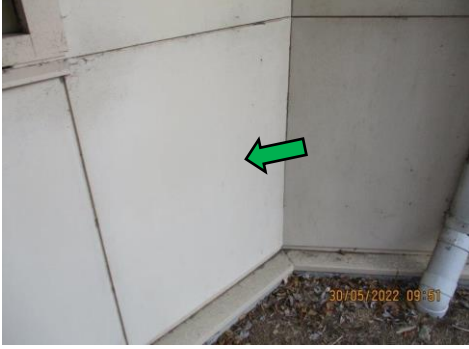
<table border="1"> <tr> <td colspan="2">Sample No.: PRJ000914-AS079</td> </tr> <tr> <td>Asb Detected:</td> <td>No</td> </tr> <tr> <td>Location:</td> <td>External</td> </tr> <tr> <td colspan="2">Level 2, External, Corridor to Nexus, wall sheets, fibre cement</td> </tr> </table>	Sample No.: PRJ000914-AS079		Asb Detected:	No	Location:	External	Level 2, External, Corridor to Nexus, wall sheets, fibre cement			
Sample No.: PRJ000914-AS079											
Asb Detected:	No										
Location:	External										
Level 2, External, Corridor to Nexus, wall sheets, fibre cement

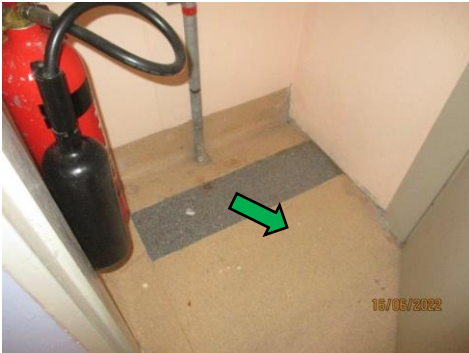
<table border="1"> <tr> <td colspan="2">Sample No.: PRJ000914-AS090</td> </tr> <tr> <td>Asb Detected:</td> <td>No</td> </tr> <tr> <td>Location:</td> <td>Internal</td> </tr> <tr> <td colspan="2">Level 2, Medical Imaging, Short Stay, Fire hose cupboard, beige floor covering and amber adhesive</td> </tr> </table>	Sample No.: PRJ000914-AS090		Asb Detected:	No	Location:	Internal	Level 2, Medical Imaging, Short Stay, Fire hose cupboard, beige floor covering and amber adhesive	
Sample No.: PRJ000914-AS090									
Asb Detected:	No								
Location:	Internal								
Level 2, Medical Imaging, Short Stay, Fire hose cupboard, beige floor covering and amber adhesive

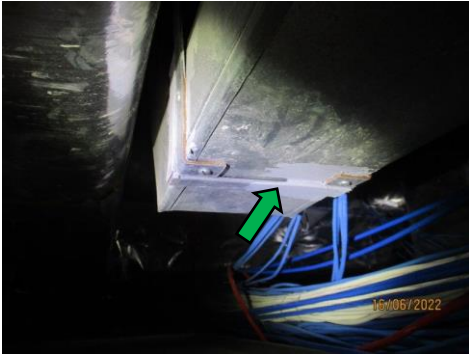
<table border="1"> <tr> <td colspan="2">Sample No.: PRJ000914-AS091</td> </tr> <tr> <td>Asb Detected:</td> <td>No</td> </tr> <tr> <td>Location:</td> <td>Internal</td> </tr> <tr> <td colspan="2">Level 2, Medical Imaging, Corridor to Short Stay, Above ceiling, Duct mastic, grey rubbery mastic.</td> </tr> </table>	Sample No.: PRJ000914-AS091		Asb Detected:	No	Location:	Internal	Level 2, Medical Imaging, Corridor to Short Stay, Above ceiling, Duct mastic, grey rubbery mastic.

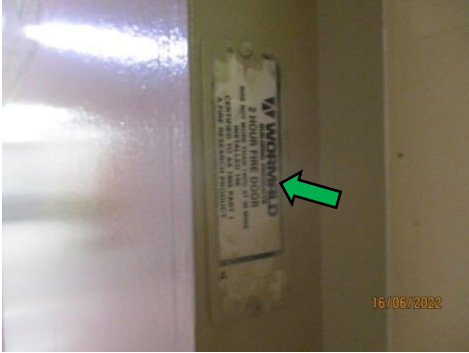
<table border="1"> <tr> <td colspan="2">Sample No: Same as PRJ000914-AS092</td> </tr> <tr> <td>Asb Detected:</td> <td>No</td> </tr> <tr> <td>Location:</td> <td>Internal</td> </tr> <tr> <td colspan="2">Level 2, Internal, Medical Imaging, Corridor to short stay, Wormald Fire door core (Manufactured 198_)</td> </tr> </table>	Sample No: Same as PRJ000914-AS092		Asb Detected:	No	Location:	Internal	Level 2, Internal, Medical Imaging, Corridor to short stay, Wormald Fire door core (Manufactured 198_)	
Sample No: Same as PRJ000914-AS092									
Asb Detected:	No								
Location:	Internal								
Level 2, Internal, Medical Imaging, Corridor to short stay, Wormald Fire door core (Manufactured 198_)

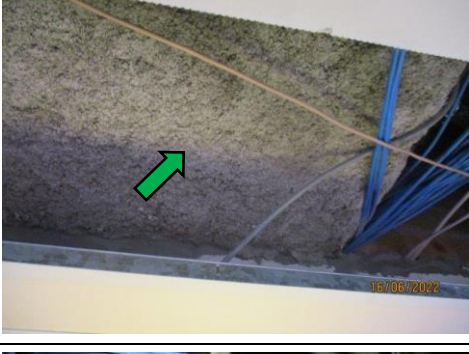
<table border="1"> <tr> <td colspan="2">Sample No.: Same as PRJ000914-AS049</td> </tr> <tr> <td>Asb Detected:</td> <td>No</td> </tr> <tr> <td>Location:</td> <td>Internal</td> </tr> <tr> <td colspan="2">Level 2, Medical Imaging, sprayed SMF insulation to beam and ducting</td> </tr> </table>	Sample No.: Same as PRJ000914-AS049		Asb Detected:	No	Location:	Internal	Level 2, Medical Imaging, sprayed SMF insulation to beam and ducting	
Sample No.: Same as PRJ000914-AS049									
Asb Detected:	No								
Location:	Internal								
Level 2, Medical Imaging, sprayed SMF insulation to beam and ducting

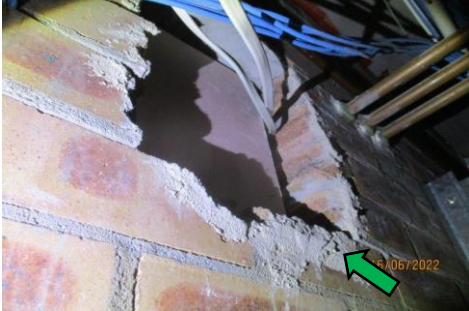
<table border="1"> <tr> <td colspan="2">Sample No.: Same as: PRJ000914-AS011</td> </tr> <tr> <td>Asb Detected:</td> <td>No</td> </tr> <tr> <td>Location:</td> <td>Internal</td> </tr> <tr> <td colspan="2">Level 2, Medical Imaging, vermiculite insulation around penetrations.</td> </tr> </table>	Sample No.: Same as: PRJ000914-AS011		Asb Detected:	No	Location:	Internal	Level 2, Medical Imaging, vermiculite insulation around penetrations.

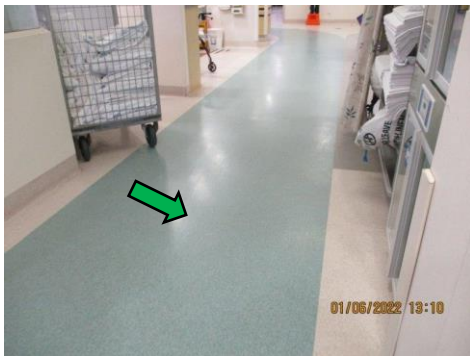
Visual Assessment

Asb Detected: No

Location: Internal

Level 2, Medical Imaging, various modern vinyl floor coverings.

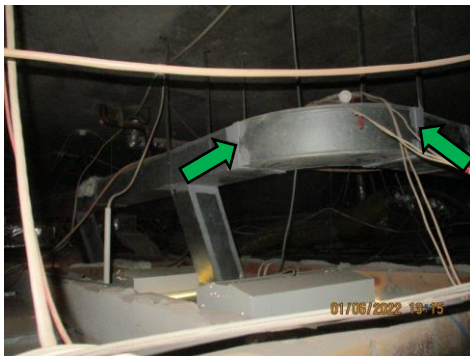
Same as Sample No.: PRJ000914-AS091

Asb Detected: No

Location: Internal

Level 2, Medical Imaging, Above ceiling, Duct mastic, grey rubbery mastic.

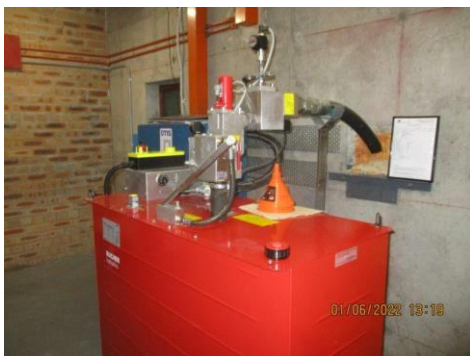
Visual Assessment – Modern equipment.

Asb Detected: No

Location: Internal

Level 2, Medical Imaging, Lift Motor Room, Modern pneumatic lift motor, no brake pads present.

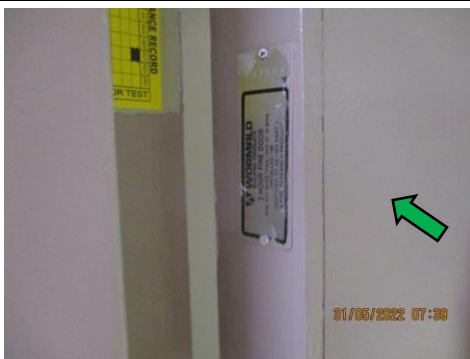
Sample No: Same as PRJ000914-AS092

Asb Detected: No

Similar fire doors observed throughout the hospital.

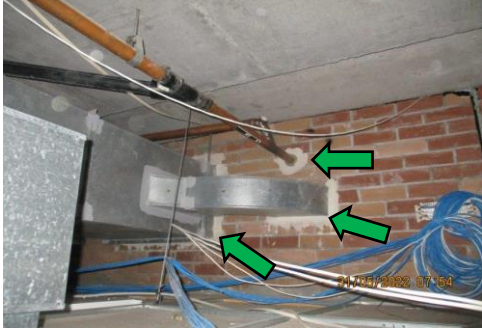
<table border="1"> <tr> <td colspan="2"><b>Sample No.: Same as: PRJ000914-AS011</b></td> </tr> <tr> <td><b>Asb Detected:</b></td> <td>No</td> </tr> <tr> <td><b>Location:</b></td> <td>Internal</td> </tr> <tr> <td colspan="2">Level 2, Outpatients Department, vermiculite insulation around penetrations.</td> </tr> </table>	<b>Sample No.: Same as: PRJ000914-AS011</b>		<b>Asb Detected:</b>	No	<b>Location:</b>	Internal	Level 2, Outpatients Department, vermiculite insulation around penetrations.	
<b>Sample No.: Same as: PRJ000914-AS011</b>									
<b>Asb Detected:</b>	No								
<b>Location:</b>	Internal								
Level 2, Outpatients Department, vermiculite insulation around penetrations.

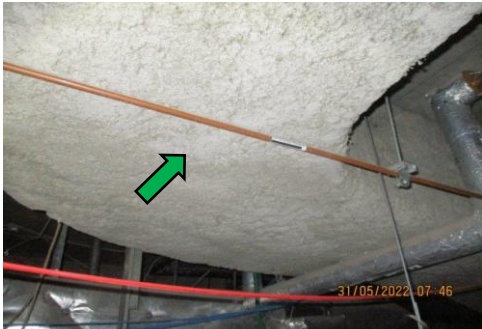
<table border="1"> <tr> <td colspan="2"><b>Sample No.: Same as PRJ000914-AS049</b></td> </tr> <tr> <td><b>Asb Detected:</b></td> <td>No</td> </tr> <tr> <td><b>Location:</b></td> <td>Internal</td> </tr> <tr> <td colspan="2">Level 2, Outpatients Department, sprayed SMF insulation to beams and ducting</td> </tr> </table>	<b>Sample No.: Same as PRJ000914-AS049</b>		<b>Asb Detected:</b>	No	<b>Location:</b>	Internal	Level 2, Outpatients Department, sprayed SMF insulation to beams and ducting	
<b>Sample No.: Same as PRJ000914-AS049</b>									
<b>Asb Detected:</b>	No								
<b>Location:</b>	Internal								
Level 2, Outpatients Department, sprayed SMF insulation to beams and ducting

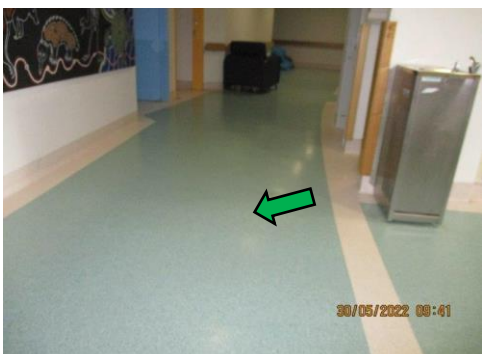
<table border="1"> <tr> <td colspan="2"><b>Visual Assessment – Modern material</b></td> </tr> <tr> <td><b>Asb Detected:</b></td> <td>No</td> </tr> <tr> <td><b>Location:</b></td> <td>Internal</td> </tr> <tr> <td colspan="2">Level 2, Nexus, modern floor coverings</td> </tr> </table>	<b>Visual Assessment – Modern material</b>		<b>Asb Detected:</b>	No	<b>Location:</b>	Internal	Level 2, Nexus, modern floor coverings

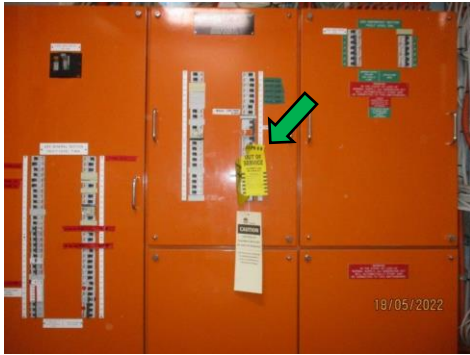
Sample No.: Visual Inspection – Live electrics

Asb Detected: Assume No

Location: Internal

Level 3, Birthing Suite, Electrical distribution Cupboard (3524) modern electrical backing board.

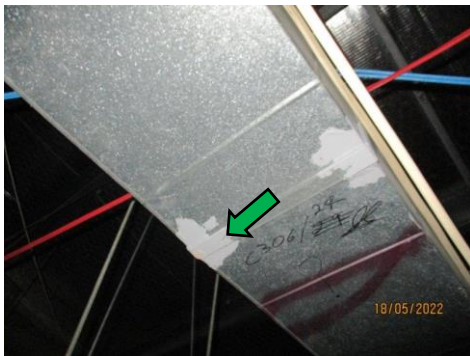
Sample No.: PRJ000914-AS038

Asb Detected: No

Location: Internal

Level 3, Birthing Suite, Lobby adjacent Room 9, duct joints – mastic, grey rubbery mastic.

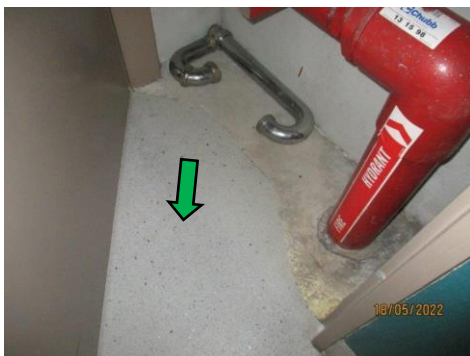
Sample No.: PRJ000914-AS039

Asb Detected: No

Location: Internal

Level 3, Birthing Suite, fire hose reel cupboard 3519, floor covering – grey vinyl floor covering and clear adhesive.

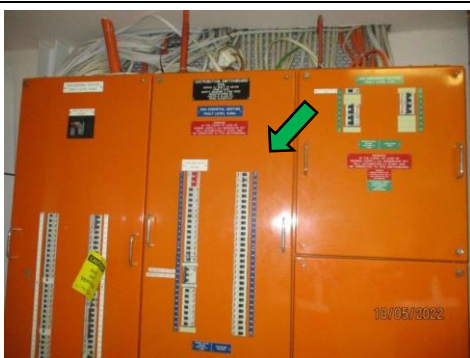
Sample No.: Visual Inspection – Live electrics

Asb Detected: Assume No

Location: Internal

Level 3, Birthing Suite, Electrical distribution boards, modern appearance.

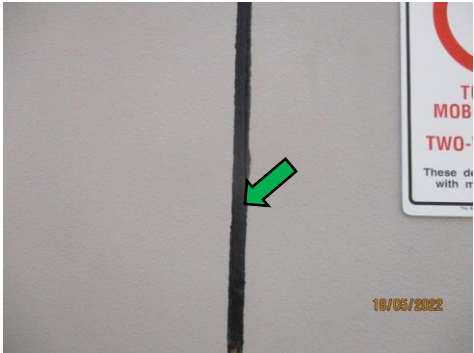
<table border="1"> <tr> <td colspan="2">Sample No.: PRJ000914-AS040</td> </tr> <tr> <td>Asb Detected:</td> <td>No</td> </tr> <tr> <td>Location:</td> <td>Internal</td> </tr> <tr> <td colspan="2">Level 3, Intensive Care Unit, corridor outside ICU, expansion joints between walls– black construction mastic.</td> </tr> </table>	Sample No.: PRJ000914-AS040		Asb Detected:	No	Location:	Internal	Level 3, Intensive Care Unit, corridor outside ICU, expansion joints between walls– black construction mastic.	
Sample No.: PRJ000914-AS040									
Asb Detected:	No								
Location:	Internal								
Level 3, Intensive Care Unit, corridor outside ICU, expansion joints between walls– black construction mastic.

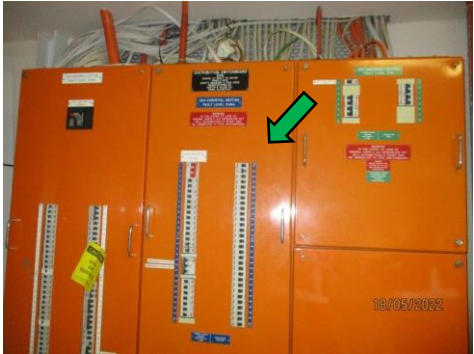
<table border="1"> <tr> <td colspan="2">Sample No.: Visual Inspection</td> </tr> <tr> <td>Asb Detected:</td> <td>Assume No</td> </tr> <tr> <td>Location:</td> <td>Internal</td> </tr> <tr> <td colspan="2">Level 3, Intensive Care Unit, corridor, Electrical Distribution Board Cupboard (3079), electrical backing board (modern).</td> </tr> </table>	Sample No.: Visual Inspection		Asb Detected:	Assume No	Location:	Internal	Level 3, Intensive Care Unit, corridor, Electrical Distribution Board Cupboard (3079), electrical backing board (modern).

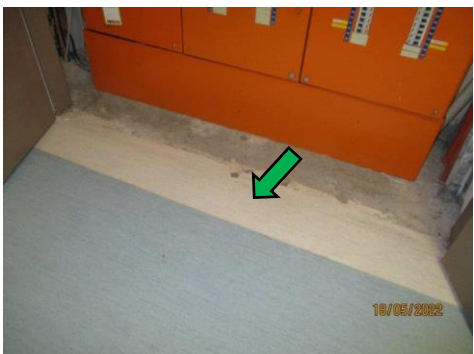
<table border="1"> <tr> <td colspan="2">Sample No.: PRJ000914-AS041</td> </tr> <tr> <td>Asb Detected:</td> <td>No</td> </tr> <tr> <td>Location:</td> <td>Internal</td> </tr> <tr> <td colspan="2">Level 3, Intensive Care Unit, Communication Cupboard (3079), floor covering, white vinyl floor covering and amber adhesive.</td> </tr> </table>	Sample No.: PRJ000914-AS041		Asb Detected:	No	Location:	Internal	Level 3, Intensive Care Unit, Communication Cupboard (3079), floor covering, white vinyl floor covering and amber adhesive.	
Sample No.: PRJ000914-AS041									
Asb Detected:	No								
Location:	Internal								
Level 3, Intensive Care Unit, Communication Cupboard (3079), floor covering, white vinyl floor covering and amber adhesive.

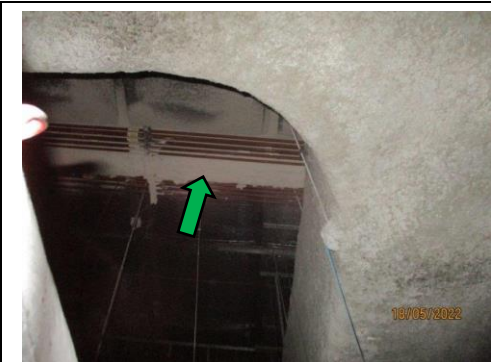
Sample No.: Same as: PRJ000914-AS013

Asb Detected: Assume No

Level 3, Intensive Care Unit, corridor adjacent retrieval service room, ceiling space – vermiculite.

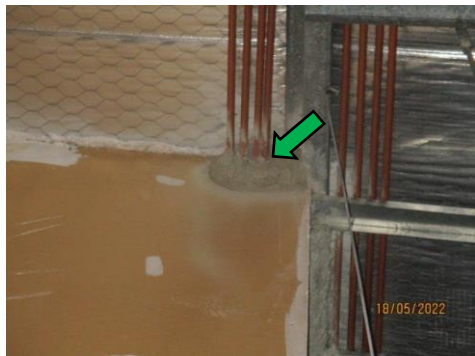
Sample No.: PRJ000914-AS042

Asb Detected: No

Level 3, Intensive Care Unit, adjacent ICU high risk area, corridor, ceiling space, structural beams and penetrations – vermiculite.

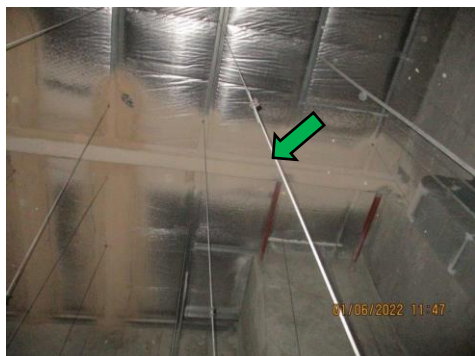
Same as Sample No.: PRJ000914-AS042

Asb Detected: No

Level 3, Research Laboratory, ceiling space, structural beams – vermiculite.

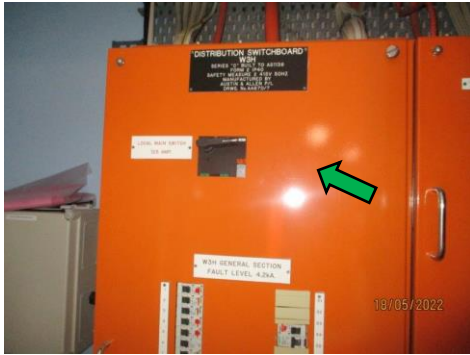
<b>Sample No.: Visual Inspection / Live Electrics</b>	
<b>Asb Detected:</b>	Assume No
<b>Location:</b>	Internal
Level 3, Ward H3, Electrical Distribution Board Cupboard (3800) electrical backing boards (modern).

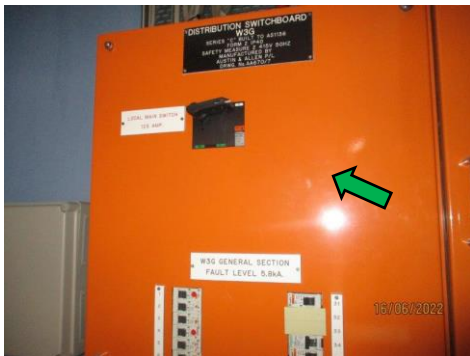
<b>Sample No.: Visual Inspection / Live Electrics</b>	
<b>Asb Detected:</b>	Assume No
<b>Location:</b>	Internal
Level 3, Ward G3, Electrical Distribution Board Cupboard electrical backing boards (modern).

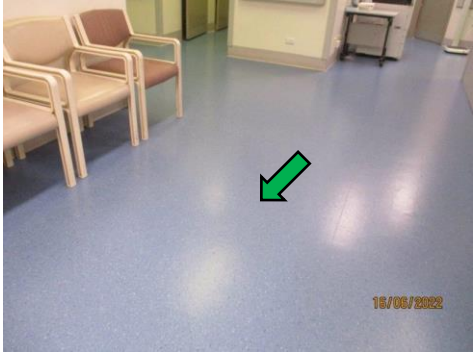
<table border="1"> <tr> <td colspan="2">Visual Observation – Modern Material</td> </tr> <tr> <td>Asb Detected:</td> <td>Assume No</td> </tr> <tr> <td>Location:</td> <td>Internal</td> </tr> <tr> <td colspan="2">Level 3, Cardiovascular Department, modern vinyl floor coverings throughout.</td> </tr> </table>	Visual Observation – Modern Material		Asb Detected:	Assume No	Location:	Internal	Level 3, Cardiovascular Department, modern vinyl floor coverings throughout.	
Visual Observation – Modern Material									
Asb Detected:	Assume No								
Location:	Internal								
Level 3, Cardiovascular Department, modern vinyl floor coverings throughout.
