**RE : DEMOLITION WORK PLAN MD - 2753**  
**AT : JOHN HUNTER HEALTH & INNOVATION PRECINCT**

## Demolition Work Plan (DWP)

JHHIP – Stage 1

# HAZARDOUS MATERIALS SURVEY REPORT

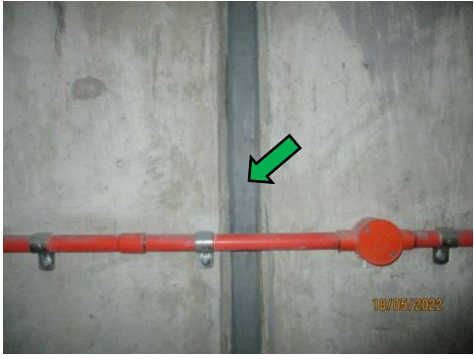
<table border="1"> <tr> <td colspan="2">Sample No.: PRJ000914-AS028</td> </tr> <tr> <td>Asb Detected:</td> <td>No</td> </tr> <tr> <td>Location:</td> <td>Internal</td> </tr> <tr> <td colspan="2">Level 4, Plant Room, adjacent soil vent pipe, between expansion joint – construction mastic, grey rubbery mastic.</td> </tr> </table>	Sample No.: PRJ000914-AS028		Asb Detected:	No	Location:	Internal	Level 4, Plant Room, adjacent soil vent pipe, between expansion joint – construction mastic, grey rubbery mastic.

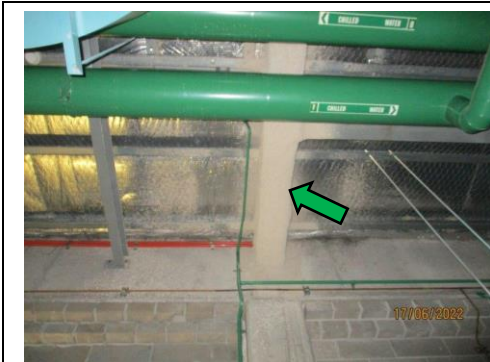
Same as Sample No.: PRJ000914-AS029

Asb Detected: No

Level 4, Plant Room, throughout, ceiling, to structural beams – vermiculite.

Similar vermiculite observed throughout hospital

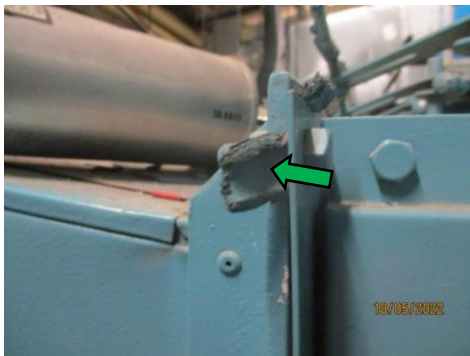
Sample No.: Visual Inspection

Asb Detected: No

Level 4, Plant Room, throughout Air Handling Unit, rubber seals.

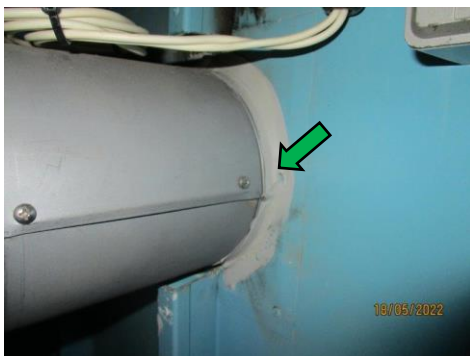
Sample No.: PRJ000914-AS030

Asb Detected: No

Level 4, Plant Room, Air Handling Units, surrounding pipe penetrations entering AHU – mastic, grey rubbery mastic.

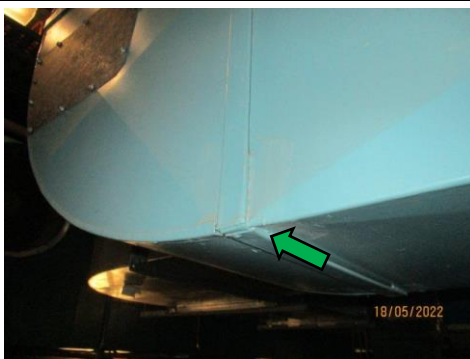
Sample No.: PRJ000914-AS031

Asb Detected: No

Level 4, Plant Room, throughout, Air handling Units, between flanges – blue mastic, grey rubbery mastic.

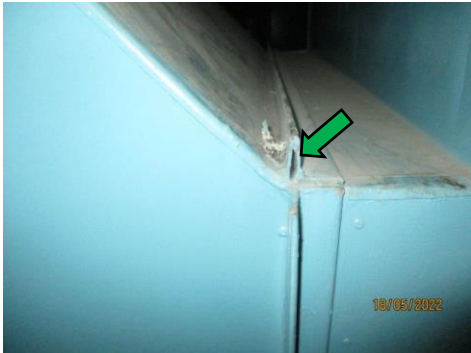
<table border="1"> <tr> <td colspan="2">Sample No.: PRJ000914-AS032</td> </tr> <tr> <td>Asb Detected:</td> <td>No</td> </tr> <tr> <td>Location:</td> <td>Internal</td> </tr> <tr> <td colspan="2">Level 4, Plant Room, throughout, Air handling Units, between flanges – blue mastic, grey rubbery mastic.</td> </tr> </table>	Sample No.: PRJ000914-AS032		Asb Detected:	No	Location:	Internal	Level 4, Plant Room, throughout, Air handling Units, between flanges – blue mastic, grey rubbery mastic.	
Sample No.: PRJ000914-AS032									
Asb Detected:	No								
Location:	Internal								
Level 4, Plant Room, throughout, Air handling Units, between flanges – blue mastic, grey rubbery mastic.

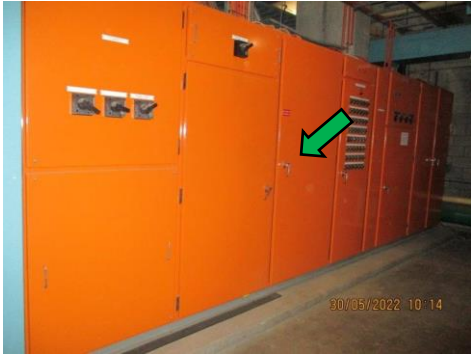
<table border="1"> <tr> <td colspan="2">Visual Assessment – Live Electrics</td> </tr> <tr> <td>Asb Detected:</td> <td>No</td> </tr> <tr> <td>Location:</td> <td>Internal</td> </tr> <tr> <td colspan="2">Level 4, Plant Room, Modern electrical equipment</td> </tr> </table>	Visual Assessment – Live Electrics		Asb Detected:	No	Location:	Internal	Level 4, Plant Room, Modern electrical equipment

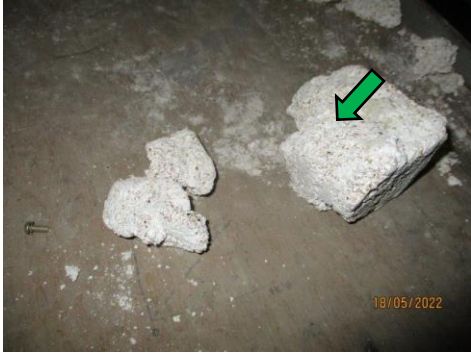
<table border="1"> <tr> <td colspan="2">Sample No.: PRJ000914-AS033</td> </tr> <tr> <td>Asb Detected:</td> <td>No</td> </tr> <tr> <td>Location:</td> <td>Internal</td> </tr> <tr> <td colspan="2">Level 4, Plant Room, behind access panel, adjacent Air Handling Units 28 &amp; 29 – sprayed insulation debris.</td> </tr> </table>	Sample No.: PRJ000914-AS033		Asb Detected:	No	Location:	Internal	Level 4, Plant Room, behind access panel, adjacent Air Handling Units 28 & 29 – sprayed insulation debris.	
Sample No.: PRJ000914-AS033									
Asb Detected:	No								
Location:	Internal								
Level 4, Plant Room, behind access panel, adjacent Air Handling Units 28 & 29 – sprayed insulation debris.

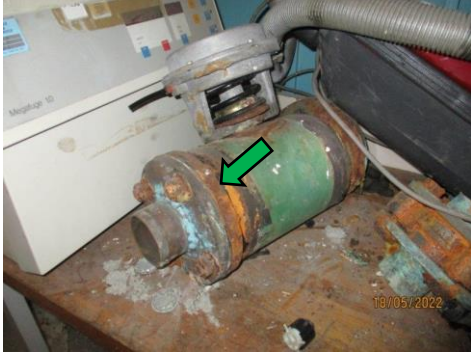
<table border="1"> <tr> <td colspan="2">Sample No.: PRJ000914-AS034</td> </tr> <tr> <td>Asb Detected:</td> <td>No</td> </tr> <tr> <td>Location:</td> <td>Internal</td> </tr> <tr> <td colspan="2">Level 4, Plant Room, west end, adjacent Air Handling Unit and hot water heater pipework, flanges – redundant black gasket.</td> </tr> </table>	Sample No.: PRJ000914-AS034		Asb Detected:	No	Location:	Internal	Level 4, Plant Room, west end, adjacent Air Handling Unit and hot water heater pipework, flanges – redundant black gasket.

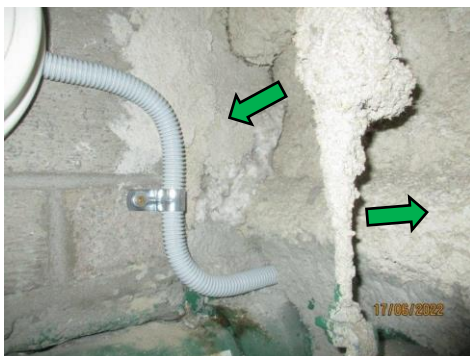
Same as Sample No.: PRJ000914-AS035	
Asb Detected:	No
Location:	Internal
Level 4, Internal, Small Plant Room adjacent roof access, sprayed vermiculite insulation to roof structure and within penetrations.

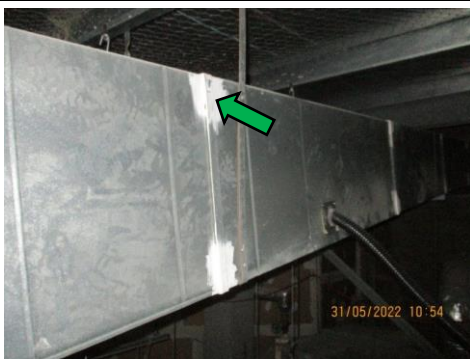
Sample No.: PRJ000914-AS087	
Asb Detected:	No
Location:	Internal
Level 4, Internal, Roof space above Level 3 theatres, mastic to ductwork

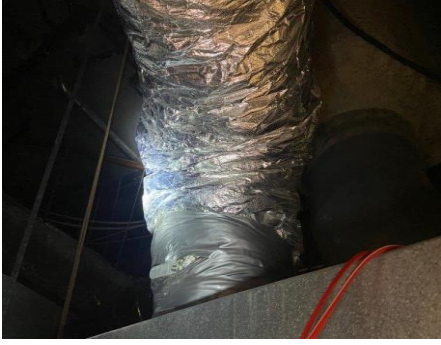
<table border="1"> <thead> <tr> <th colspan="2">Visual Inspection</th> </tr> </thead> <tbody> <tr> <td>SMF Identified:</td> <td>Yes</td> </tr> <tr> <td>Location:</td> <td>Internal</td> </tr> <tr> <td colspan="2">Level 0, Mortuary, ceiling space – flexible ductwork.</td> </tr> </tbody> </table>	Visual Inspection		SMF Identified:	Yes	Location:	Internal	Level 0, Mortuary, ceiling space – flexible ductwork.	
Visual Inspection									
SMF Identified:	Yes								
Location:	Internal								
Level 0, Mortuary, ceiling space – flexible ductwork.

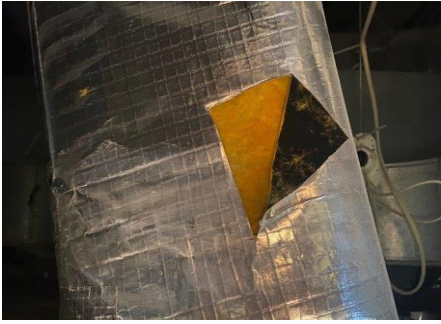
<table border="1"> <thead> <tr> <th colspan="2">Visual Inspection</th> </tr> </thead> <tbody> <tr> <td>SMF Identified:</td> <td>Yes</td> </tr> <tr> <td>Location:</td> <td>Internal</td> </tr> <tr> <td colspan="2">Level 0, Mortuary, ceiling space – air conditioning ductwork insulation.</td> </tr> </tbody> </table>	Visual Inspection		SMF Identified:	Yes	Location:	Internal	Level 0, Mortuary, ceiling space – air conditioning ductwork insulation.

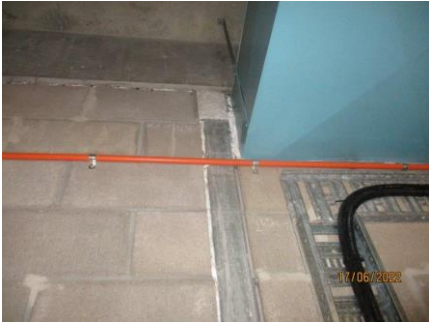
<table border="1"> <thead> <tr> <th colspan="2">Visual Inspection</th> </tr> </thead> <tbody> <tr> <td>SMF Identified:</td> <td>Yes</td> </tr> <tr> <td>Location:</td> <td>Internal</td> </tr> <tr> <td colspan="2">Level 0, Substation 2, "Kaowool" between walls</td> </tr> </tbody> </table>	Visual Inspection		SMF Identified:	Yes	Location:	Internal	Level 0, Substation 2, "Kaowool" between walls	
Visual Inspection									
SMF Identified:	Yes								
Location:	Internal								
Level 0, Substation 2, "Kaowool" between walls

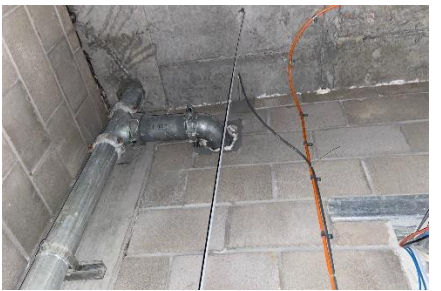
<table border="1"> <thead> <tr> <th colspan="2">Visual Inspection</th> </tr> </thead> <tbody> <tr> <td>SMF Identified:</td> <td>Yes</td> </tr> <tr> <td>Location:</td> <td>Internal</td> </tr> <tr> <td colspan="2">Level 0, Back of House, Engineering department, "Kaowool" between walls and ceiling slab</td> </tr> </tbody> </table>	Visual Inspection		SMF Identified:	Yes	Location:	Internal	Level 0, Back of House, Engineering department, "Kaowool" between walls and ceiling slab

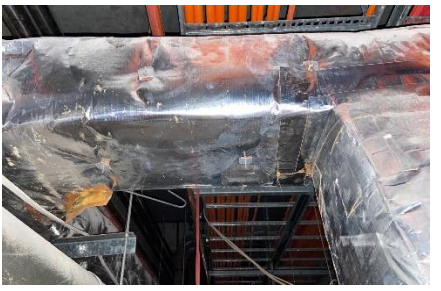
<table border="1"> <thead> <tr> <th colspan="2">Visual Inspection</th> </tr> </thead> <tbody> <tr> <td>SMF Identified:</td> <td>Yes</td> </tr> <tr> <td>Location:</td> <td>Internal</td> </tr> <tr> <td colspan="2">Level 0, Back of House, Engineering department, ductwork insulation</td> </tr> </tbody> </table>	Visual Inspection		SMF Identified:	Yes	Location:	Internal	Level 0, Back of House, Engineering department, ductwork insulation	
Visual Inspection									
SMF Identified:	Yes								
Location:	Internal								
Level 0, Back of House, Engineering department, ductwork insulation

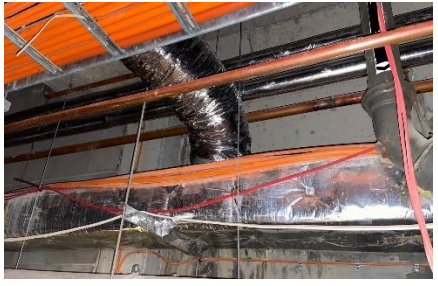
<table border="1"> <thead> <tr> <th colspan="2">Visual Inspection</th> </tr> </thead> <tbody> <tr> <td>SMF Identified:</td> <td>Yes</td> </tr> <tr> <td>Location:</td> <td>Internal</td> </tr> <tr> <td colspan="2">Level 0, Back of House, Engineering department, flexible ductwork insulation</td> </tr> </tbody> </table>	Visual Inspection		SMF Identified:	Yes	Location:	Internal	Level 0, Back of House, Engineering department, flexible ductwork insulation	
Visual Inspection									
SMF Identified:	Yes								
Location:	Internal								
Level 0, Back of House, Engineering department, flexible ductwork insulation

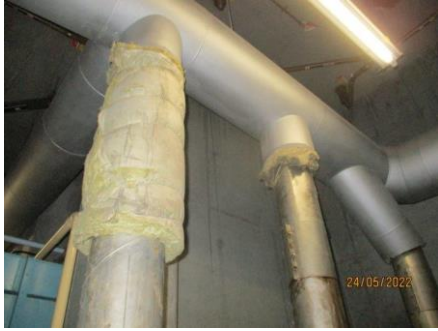
<table border="1"> <thead> <tr> <th colspan="2">Visual Inspection</th> </tr> </thead> <tbody> <tr> <td>SMF Identified:</td> <td>Yes</td> </tr> <tr> <td>Location:</td> <td>Internal</td> </tr> <tr> <td colspan="2">Level 0, Plant Room, SMF pipe insulation to flue pipes within metal cladding.</td> </tr> </tbody> </table>	Visual Inspection		SMF Identified:	Yes	Location:	Internal	Level 0, Plant Room, SMF pipe insulation to flue pipes within metal cladding.

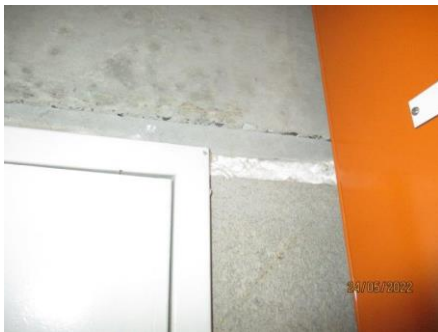
<table border="1"> <thead> <tr> <th colspan="2">Visual Inspection</th> </tr> </thead> <tbody> <tr> <td>SMF Identified:</td> <td>Yes</td> </tr> <tr> <td>Location:</td> <td>Internal</td> </tr> <tr> <td colspan="2">Level 0, Plant Room, Kaowool behind mastic – between walls and ceiling slab.</td> </tr> </tbody> </table>	Visual Inspection		SMF Identified:	Yes	Location:	Internal	Level 0, Plant Room, Kaowool behind mastic – between walls and ceiling slab.	
Visual Inspection									
SMF Identified:	Yes								
Location:	Internal								
Level 0, Plant Room, Kaowool behind mastic – between walls and ceiling slab.

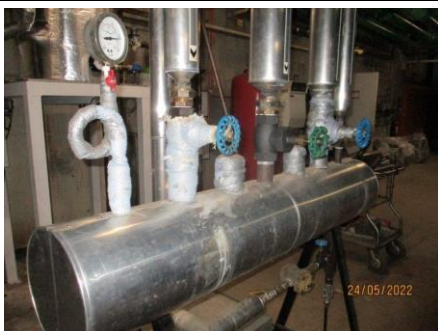
<table border="1"> <thead> <tr> <th colspan="2">Visual Inspection</th> </tr> </thead> <tbody> <tr> <td>SMF Identified:</td> <td>Yes</td> </tr> <tr> <td>Location:</td> <td>Internal</td> </tr> <tr> <td colspan="2">Level 0, Plant Room, woven wrap around pipework</td> </tr> </tbody> </table>	Visual Inspection		SMF Identified:	Yes	Location:	Internal	Level 0, Plant Room, woven wrap around pipework

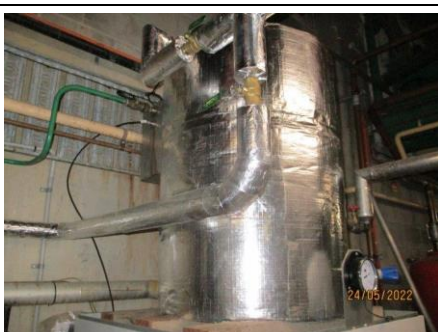
<table border="1"> <thead> <tr> <th colspan="2">Visual Inspection</th> </tr> </thead> <tbody> <tr> <td>SMF Identified:</td> <td>Yes</td> </tr> <tr> <td>Location:</td> <td>Internal</td> </tr> <tr> <td colspan="2">Level 0, Plant Room, foil lined insulation to boiler and pipes</td> </tr> </tbody> </table>	Visual Inspection		SMF Identified:	Yes	Location:	Internal	Level 0, Plant Room, foil lined insulation to boiler and pipes	
Visual Inspection									
SMF Identified:	Yes								
Location:	Internal								
Level 0, Plant Room, foil lined insulation to boiler and pipes

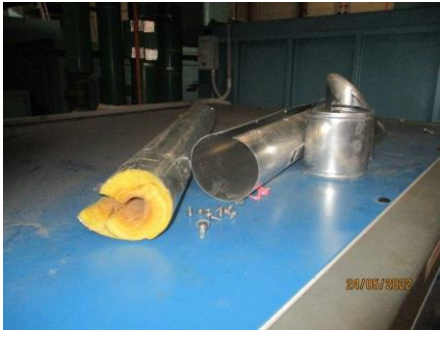
<table border="1"> <thead> <tr> <th colspan="2">Visual Inspection</th> </tr> </thead> <tbody> <tr> <td>SMF Identified:</td> <td>Yes</td> </tr> <tr> <td>Location:</td> <td>Internal</td> </tr> <tr> <td colspan="2">Level 0, Plant Room, SMF insulation beneath aluminium cladding to pipework</td> </tr> </tbody> </table>	Visual Inspection		SMF Identified:	Yes	Location:	Internal	Level 0, Plant Room, SMF insulation beneath aluminium cladding to pipework	
Visual Inspection									
SMF Identified:	Yes								
Location:	Internal								
Level 0, Plant Room, SMF insulation beneath aluminium cladding to pipework

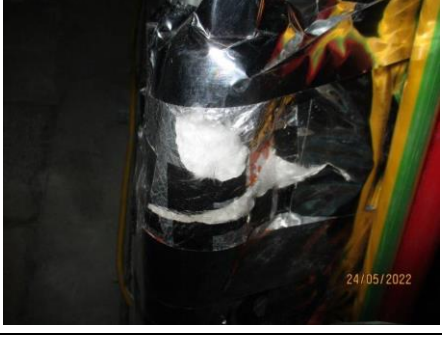
Visual Inspection									
SMF Identified:	Yes								
Location:	Internal								
Level 0, Plant Room, Kaowool within various penetrations

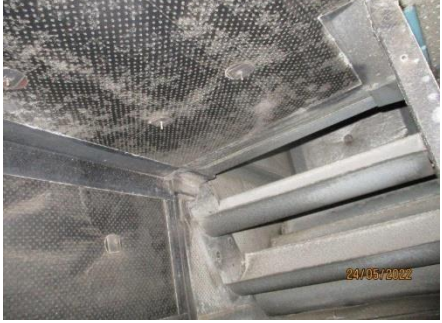
Visual Inspection									
SMF Identified:	Yes								
Location:	Internal								
Level 0, Plant r Room oom, SMF insulation to Bunderus Boilers

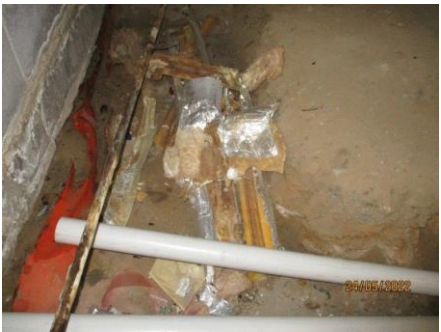
<table border="1"> <thead> <tr> <th colspan="2">Visual Inspection</th> </tr> </thead> <tbody> <tr> <td>SMF Identified:</td> <td>Yes</td> </tr> <tr> <td>Location:</td> <td>Internal</td> </tr> <tr> <td colspan="2">Level 0, Fire escape, SMF and Kaowool and blue SMF fire pillows within penetrations</td> </tr> </tbody> </table>	Visual Inspection		SMF Identified:	Yes	Location:	Internal	Level 0, Fire escape, SMF and Kaowool and blue SMF fire pillows within penetrations	
Visual Inspection									
SMF Identified:	Yes								
Location:	Internal								
Level 0, Fire escape, SMF and Kaowool and blue SMF fire pillows within penetrations

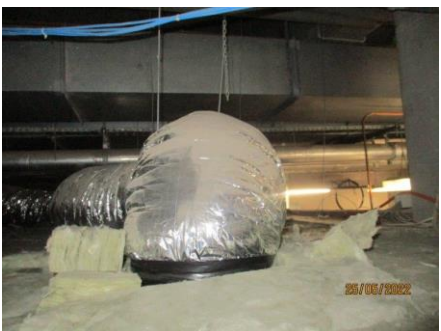
<table border="1"> <thead> <tr> <th colspan="2">Visual Inspection</th> </tr> </thead> <tbody> <tr> <td>SMF Identified:</td> <td>Yes</td> </tr> <tr> <td>Location:</td> <td>Internal</td> </tr> <tr> <td colspan="2">Level 0, Room 0055, above ceiling SMF blanket insulation</td> </tr> </tbody> </table>	Visual Inspection		SMF Identified:	Yes	Location:	Internal	Level 0, Room 0055, above ceiling SMF blanket insulation	
Visual Inspection									
SMF Identified:	Yes								
Location:	Internal								
Level 0, Room 0055, above ceiling SMF blanket insulation

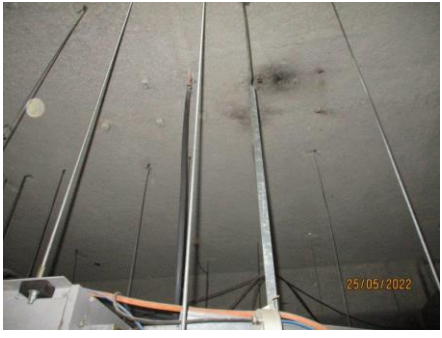
<table border="1"> <thead> <tr> <th colspan="2">Visual Inspection</th> </tr> </thead> <tbody> <tr> <td>SMF Identified:</td> <td>Yes</td> </tr> <tr> <td>Location:</td> <td>Internal</td> </tr> <tr> <td colspan="2">Level 0, Room 0055, above ceiling, pipe insulation</td> </tr> </tbody> </table>	Visual Inspection		SMF Identified:	Yes	Location:	Internal	Level 0, Room 0055, above ceiling, pipe insulation	
Visual Inspection									
SMF Identified:	Yes								
Location:	Internal								
Level 0, Room 0055, above ceiling, pipe insulation

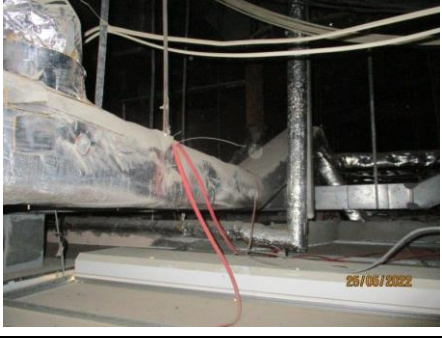
<table border="1"> <thead> <tr> <th colspan="2">Visual Inspection</th> </tr> </thead> <tbody> <tr> <td>SMF Identified:</td> <td>Yes</td> </tr> <tr> <td>Location:</td> <td>Internal</td> </tr> <tr> <td colspan="2">Level 0, Room 0055, above ceiling, SMF sprayed insulation to ceiling.</td> </tr> </tbody> </table>	Visual Inspection		SMF Identified:	Yes	Location:	Internal	Level 0, Room 0055, above ceiling, SMF sprayed insulation to ceiling.	
Visual Inspection									
SMF Identified:	Yes								
Location:	Internal								
Level 0, Room 0055, above ceiling, SMF sprayed insulation to ceiling.

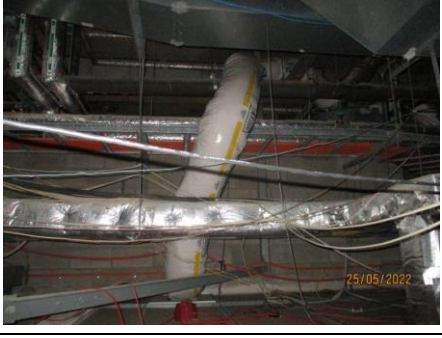
Visual Inspection									
SMF Identified:	Yes								
Location:	Internal								
Level 0, Circulation Spaces/corridors, above ceiling, SMF ductwork insulation.

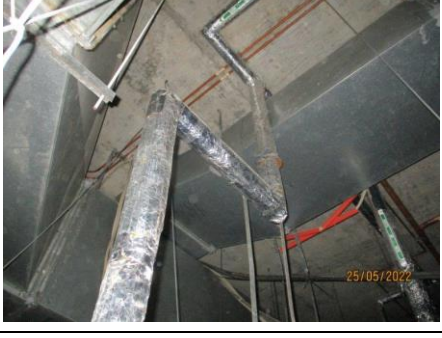
<table border="1"> <thead> <tr> <th colspan="2">Visual Inspection</th> </tr> </thead> <tbody> <tr> <td>SMF Identified:</td> <td>Yes</td> </tr> <tr> <td>Location:</td> <td>Internal</td> </tr> <tr> <td colspan="2">Level 0, Circulation Spaces/corridors, above ceiling, SMF flexi duct insulation.</td> </tr> </tbody> </table>	Visual Inspection		SMF Identified:	Yes	Location:	Internal	Level 0, Circulation Spaces/corridors, above ceiling, SMF flexi duct insulation.	
Visual Inspection									
SMF Identified:	Yes								
Location:	Internal								
Level 0, Circulation Spaces/corridors, above ceiling, SMF flexi duct insulation.

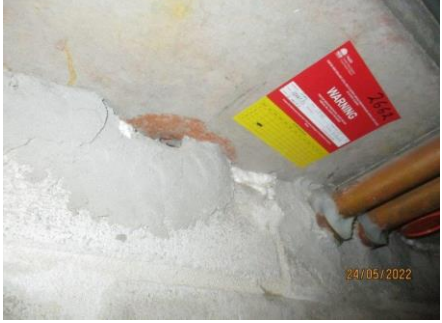
Visual Inspection									
SMF Identified:	Yes								
Location:	Internal								
Level 0, Circulation Spaces/corridors, above ceiling, SMF pipe insulation.

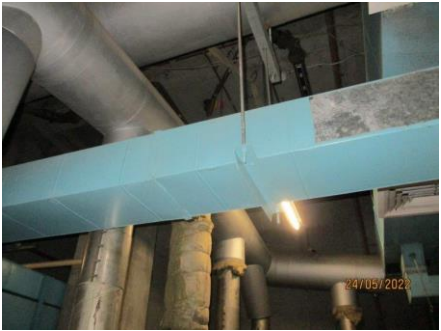
<table border="1"> <thead> <tr> <th colspan="2">Visual Inspection</th> </tr> </thead> <tbody> <tr> <td>SMF Identified:</td> <td>Yes</td> </tr> <tr> <td>Location:</td> <td>Internal</td> </tr> <tr> <td colspan="2">Level 0, Plant room above Mortuary, Kaowool and vermiculite within penetrations.</td> </tr> </tbody> </table>	Visual Inspection		SMF Identified:	Yes	Location:	Internal	Level 0, Plant room above Mortuary, Kaowool and vermiculite within penetrations.	
Visual Inspection									
SMF Identified:	Yes								
Location:	Internal								
Level 0, Plant room above Mortuary, Kaowool and vermiculite within penetrations.

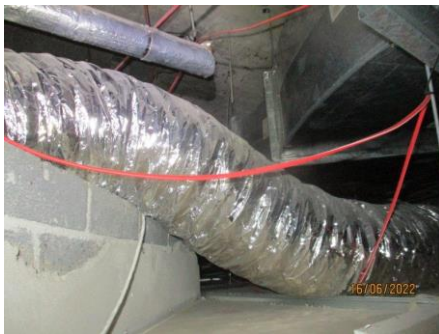
Visual Inspection	
SMF Identified:	Yes
Location:	Internal
Level 1, Ward H1, ceiling space – Ductwork insulation. Typical throughout Ward H1.

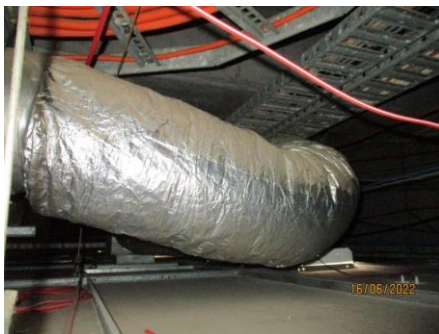
Visual Inspection	
SMF Identified:	Yes
Location:	Internal
Level 1, Ward H1, ceiling space – Flexible ductwork insulation. Typical throughout Ward H1.

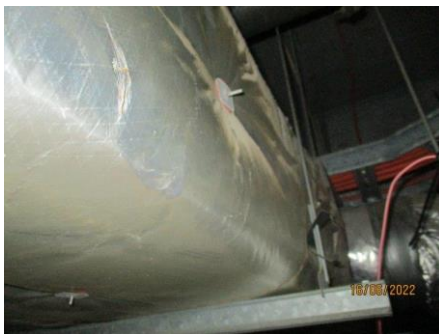
Visual Inspection	
SMF Identified:	Yes
Location:	Internal
Level 1, Circulation Spaces, adjacent H1 Lifts, ceiling space – Flexible ductwork insulation. Typical throughout Circulation Spaces.

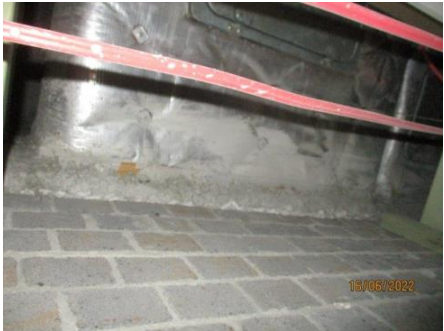
Visual Inspection	
SMF Identified:	Yes
Location:	Internal
Level 1, Circulation Spaces, adjacent H1 Lifts, ceiling space – ductwork insulation. Typical throughout Circulation Spaces.

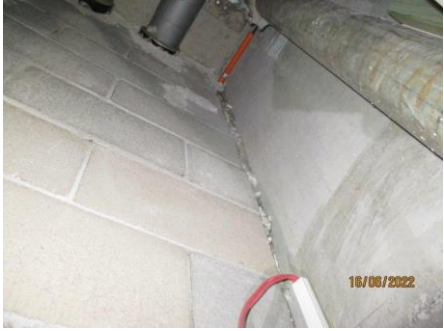
<table border="1"> <tr> <th colspan="2">Visual Inspection</th> </tr> <tr> <td>SMF Identified:</td> <td>Yes</td> </tr> <tr> <td>Location:</td> <td>Internal</td> </tr> <tr> <td colspan="2"> <p>Level 1, Circulation Spaces, adjacent H1 Lifts, ceiling space – SMF “Kaowool” insulation between top of walls and concrete slab and around duct penetrations. Typical throughout Circulation Spaces.</p> </td> </tr> </table>	Visual Inspection		SMF Identified:	Yes	Location:	Internal	<p>Level 1, Circulation Spaces, adjacent H1 Lifts, ceiling space – SMF “Kaowool” insulation between top of walls and concrete slab and around duct penetrations. Typical throughout Circulation Spaces.</p>	
Visual Inspection									
SMF Identified:	Yes								
Location:	Internal								
<p>Level 1, Circulation Spaces, adjacent H1 Lifts, ceiling space – SMF “Kaowool” insulation between top of walls and concrete slab and around duct penetrations. Typical throughout Circulation Spaces.</p>

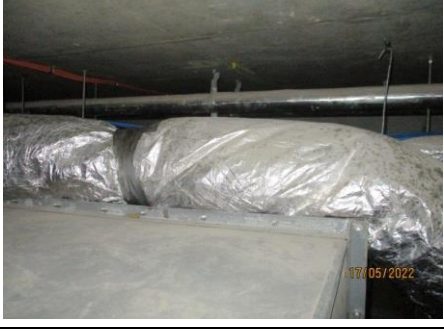
<table border="1"> <tr> <th colspan="2">Visual Inspection</th> </tr> <tr> <td>SMF Identified:</td> <td>Yes</td> </tr> <tr> <td>Location:</td> <td>Internal</td> </tr> <tr> <td colspan="2"> <p>Level 1, Circulation Spaces, adjacent K1 Lifts, ceiling space – ceiling space – Flexible ductwork insulation. Typical throughout Circulation Spaces.</p> </td> </tr> </table>	Visual Inspection		SMF Identified:	Yes	Location:	Internal	<p>Level 1, Circulation Spaces, adjacent K1 Lifts, ceiling space – ceiling space – Flexible ductwork insulation. Typical throughout Circulation Spaces.</p>	
Visual Inspection									
SMF Identified:	Yes								
Location:	Internal								
<p>Level 1, Circulation Spaces, adjacent K1 Lifts, ceiling space – ceiling space – Flexible ductwork insulation. Typical throughout Circulation Spaces.</p>

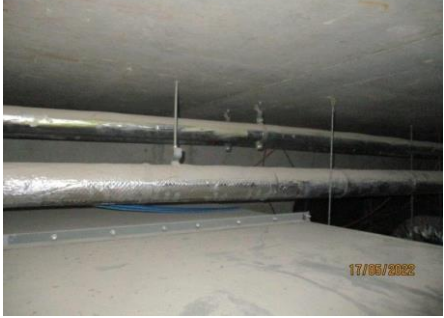
Visual Inspection									
SMF Identified:	Yes								
Location:	Internal								
<p>Level 1, Kitchen, ceiling space – flexible ductwork insulation. Typical throughout Kitchen.</p>

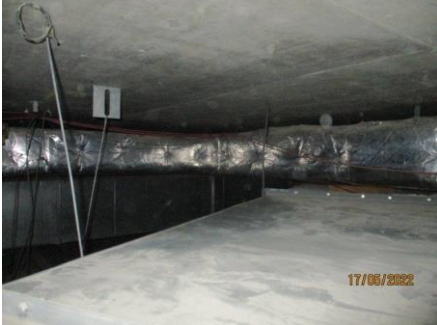
<table border="1"> <tr> <th colspan="2">Visual Inspection</th> </tr> <tr> <td>SMF Identified:</td> <td>Yes</td> </tr> <tr> <td>Location:</td> <td>Internal</td> </tr> <tr> <td colspan="2"> <p>Level 1, Kitchen, ceiling space – pipework insulation. Typical throughout Kitchen.</p> </td> </tr> </table>	Visual Inspection		SMF Identified:	Yes	Location:	Internal	<p>Level 1, Kitchen, ceiling space – pipework insulation. Typical throughout Kitchen.</p>	
Visual Inspection									
SMF Identified:	Yes								
Location:	Internal								
<p>Level 1, Kitchen, ceiling space – pipework insulation. Typical throughout Kitchen.</p>

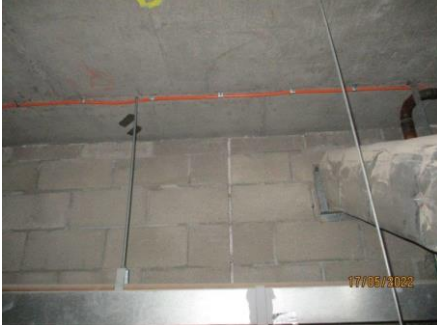
<table border="1"> <thead> <tr> <th colspan="2">Visual Inspection</th> </tr> </thead> <tbody> <tr> <td>SMF Identified:</td> <td>Yes</td> </tr> <tr> <td>Location:</td> <td>Internal</td> </tr> <tr> <td colspan="2">Level 1, Kitchen, ceiling space – air conditioning ductwork insulation. Typical throughout Kitchen.</td> </tr> </tbody> </table>	Visual Inspection		SMF Identified:	Yes	Location:	Internal	Level 1, Kitchen, ceiling space – air conditioning ductwork insulation. Typical throughout Kitchen.	
Visual Inspection									
SMF Identified:	Yes								
Location:	Internal								
Level 1, Kitchen, ceiling space – air conditioning ductwork insulation. Typical throughout Kitchen.

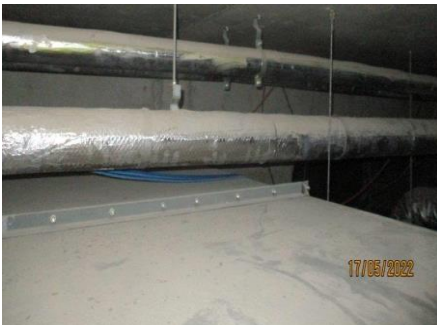
<table border="1"> <thead> <tr> <th colspan="2">Visual Inspection</th> </tr> </thead> <tbody> <tr> <td>SMF Identified:</td> <td>Yes</td> </tr> <tr> <td>Location:</td> <td>Internal</td> </tr> <tr> <td colspan="2">Level 1, Kitchen, Dry Storeroom (1041) ceiling space – flexible ductwork insulation. Typical throughout Kitchen.</td> </tr> </tbody> </table>	Visual Inspection		SMF Identified:	Yes	Location:	Internal	Level 1, Kitchen, Dry Storeroom (1041) ceiling space – flexible ductwork insulation. Typical throughout Kitchen.	
Visual Inspection									
SMF Identified:	Yes								
Location:	Internal								
Level 1, Kitchen, Dry Storeroom (1041) ceiling space – flexible ductwork insulation. Typical throughout Kitchen.

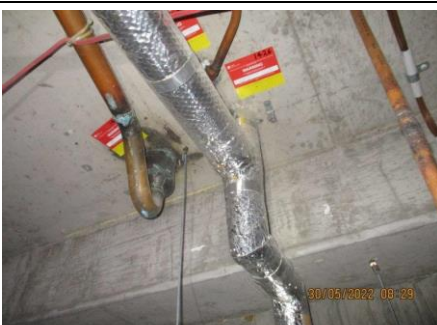
<table border="1"> <thead> <tr> <th colspan="2">Visual Inspection</th> </tr> </thead> <tbody> <tr> <td>SMF Identified:</td> <td>Yes</td> </tr> <tr> <td>Location:</td> <td>Internal</td> </tr> <tr> <td colspan="2">Level 1, Kitchen, Dry Storeroom (1041) ceiling space – pipework insulation. Typical throughout Kitchen.</td> </tr> </tbody> </table>	Visual Inspection		SMF Identified:	Yes	Location:	Internal	Level 1, Kitchen, Dry Storeroom (1041) ceiling space – pipework insulation. Typical throughout Kitchen.	
Visual Inspection									
SMF Identified:	Yes								
Location:	Internal								
Level 1, Kitchen, Dry Storeroom (1041) ceiling space – pipework insulation. Typical throughout Kitchen.

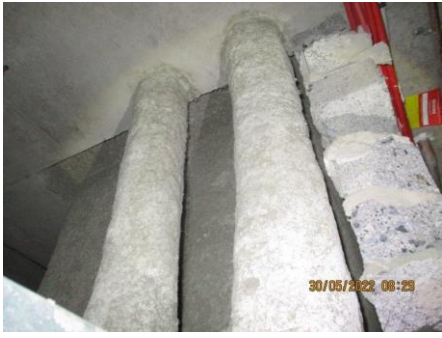
Visual Inspection									
SMF Identified:	Yes								
Location:	Internal								
Level 1, Ward K1 ceiling space – pipework insulation. Typical throughout K1.

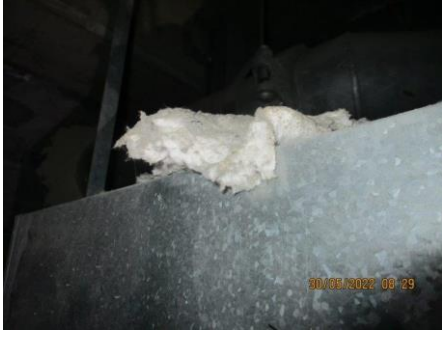
<table border="1"> <thead> <tr> <th colspan="2">Visual Inspection</th> </tr> </thead> <tbody> <tr> <td>SMF Identified:</td> <td>Yes</td> </tr> <tr> <td>Location:</td> <td>Internal</td> </tr> </tbody> </table> <p>Level 1, Ward K1 ceiling space – Sprayed SMF insulation to ducts and structural elements. Typical throughout K1.</p>	Visual Inspection		SMF Identified:	Yes	Location:	Internal
Visual Inspection							
SMF Identified:	Yes						
Location:	Internal

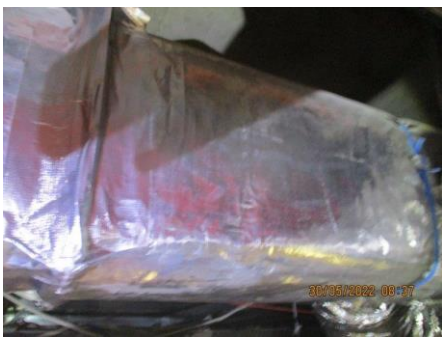
<table border="1"> <thead> <tr> <th colspan="2">Visual Inspection</th> </tr> </thead> <tbody> <tr> <td>SMF Identified:</td> <td>Yes</td> </tr> <tr> <td>Location:</td> <td>Internal</td> </tr> </tbody> </table> <p>Level 1, Ward K1, SMF “Kaowool” insulation between top of walls and concrete slab. Also present as debris on surfaces beneath. Typical throughout K1.</p>	Visual Inspection		SMF Identified:	Yes	Location:	Internal
Visual Inspection

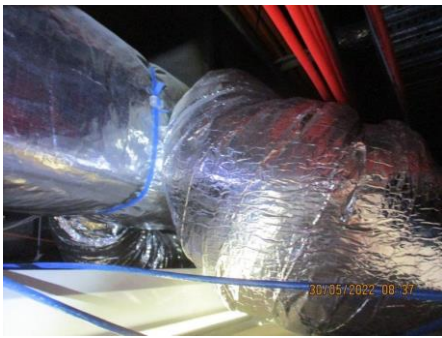
<table border="1"> <thead> <tr> <th colspan="2">Visual Inspection</th> </tr> </thead> <tbody> <tr> <td>SMF Identified:</td> <td>Yes</td> </tr> <tr> <td>Location:</td> <td>Internal</td> </tr> </tbody> </table> <p>Level 1, Ward K1 ceiling space – flexible ductwork insulation. Typical throughout K1.</p>	Visual Inspection		SMF Identified:	Yes	Location:	Internal
Visual Inspection							
SMF Identified:	Yes						
Location:	Internal

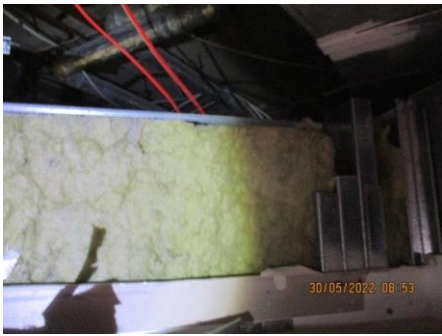
<table border="1"> <thead> <tr> <th colspan="2">Visual Inspection</th> </tr> </thead> <tbody> <tr> <td>SMF Identified:</td> <td>Yes</td> </tr> <tr> <td>Location:</td> <td>Internal</td> </tr> </tbody> </table> <p>Level 1, Ward K1 ceiling space – SMF batts between partition walls. Typical throughout K1.</p>	Visual Inspection		SMF Identified:	Yes	Location:	Internal
Visual Inspection							
SMF Identified:	Yes						
Location:	Internal

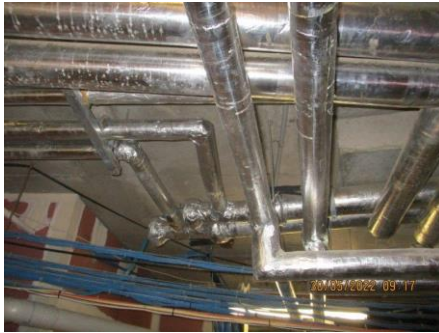
Visual Inspection	
SMF Identified:	Yes
Location:	Internal
Level 1, Nexus ceiling space – pipework insulation. Typical throughout Nexus.

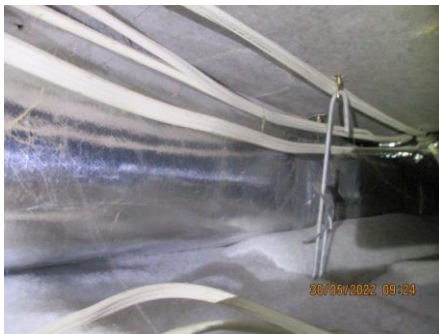
Visual Inspection	
SMF Identified:	Yes
Location:	Internal
Level 1, Nexus ceiling space – ductwork insulation. Typical throughout Nexus.

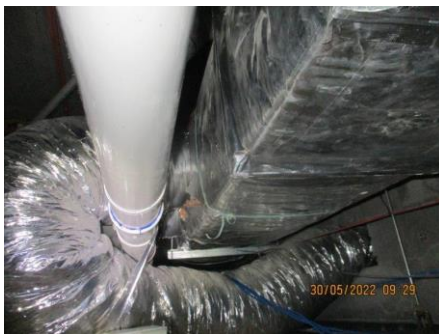
Visual Inspection	
SMF Identified:	Yes
Location:	Internal
Level 1, Nexus ceiling space – flexible ductwork insulation. Typical throughout Nexus.

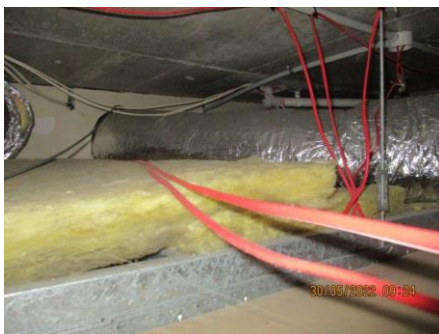
Visual Inspection	
SMF Identified:	Yes
Location:	Internal
Level 1, Nexus ceiling space – SMF batts on top of ceiling tiles. Typical throughout Nexus.

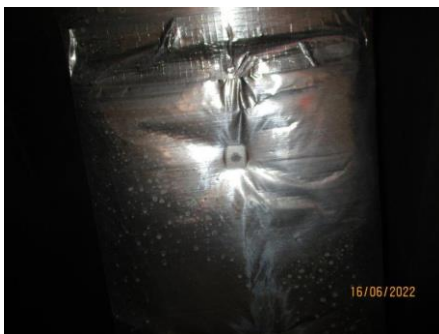
Visual Inspection	
SMF Identified:	Yes
Location:	Internal
Level 1, Male and Female Staff Changing Areas, ceiling space – SMF ductwork insulation. Typical throughout Changing Areas.

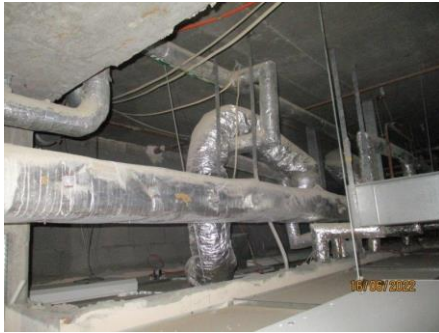
Visual Inspection	
SMF Identified:	Yes
Location:	Internal
Level 1, Male and Female Staff Changing Areas, ceiling space – SMF flexible ductwork insulation. Typical throughout Changing Areas.

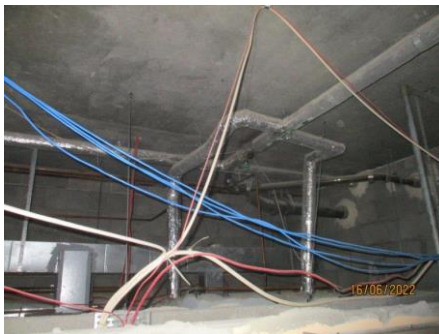
Visual Inspection	
SMF Identified:	Yes
Location:	Internal
Level 1, Male and Female Staff Changing Areas, ceiling space – pipe insulation. Typical throughout Changing Areas.

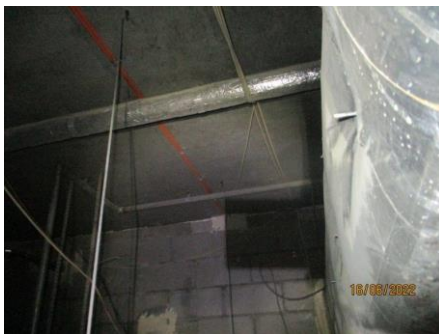
Visual Inspection	
SMF Identified:	Yes
Location:	Internal
Level 1, Male and Female Staff Changing Areas, ceiling space SMF “Kaowool” insulation between top of walls and concrete slab. Typical throughout Changing Areas.

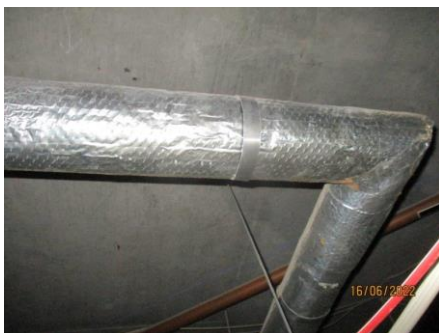
Visual Inspection	
SMF Identified:	Yes
Location:	Internal
Level 1, Cafeteria, ceiling space ceiling space – pipe insulation. Typical throughout Cafeteria.

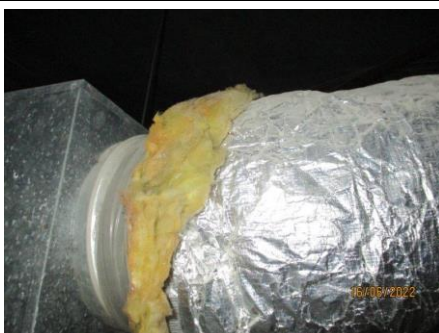
Visual Inspection	
SMF Identified:	Yes
Location:	Internal
Level 1, Cafeteria, ceiling space ceiling space – flexible duct insulation. Typical throughout Cafeteria.

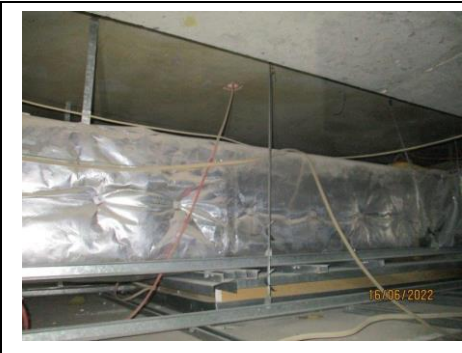
Visual Inspection	
SMF Identified:	Yes
Location:	Internal
Level 1, Cafeteria, ceiling space ceiling space –duct insulation. Typical throughout Cafeteria.

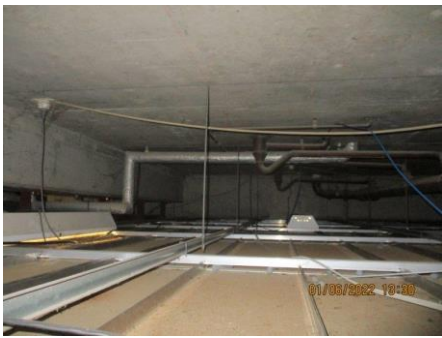
<table border="1"> <thead> <tr> <th colspan="2">Visual Inspection</th> </tr> </thead> <tbody> <tr> <td>SMF Identified:</td> <td>Yes</td> </tr> <tr> <td>Location:</td> <td>External</td> </tr> <tr> <td colspan="2">Level 2, Main Entrance, above metal ceiling – pipe insulation.</td> </tr> </tbody> </table>	Visual Inspection		SMF Identified:	Yes	Location:	External	Level 2, Main Entrance, above metal ceiling – pipe insulation.	
Visual Inspection									
SMF Identified:	Yes								
Location:	External								
Level 2, Main Entrance, above metal ceiling – pipe insulation.

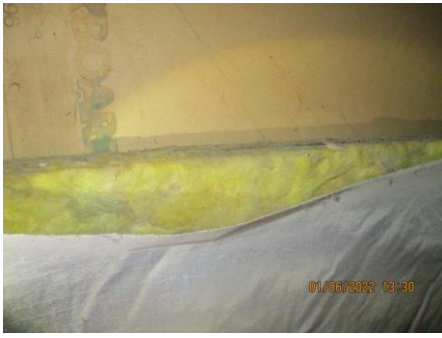
<table border="1"> <thead> <tr> <th colspan="2">Visual Inspection</th> </tr> </thead> <tbody> <tr> <td>SMF Identified:</td> <td>Yes</td> </tr> <tr> <td>Location:</td> <td>External</td> </tr> <tr> <td colspan="2">Level 2, Main Entrance, above metal ceiling – SMF batt insulation.</td> </tr> </tbody> </table>	Visual Inspection		SMF Identified:	Yes	Location:	External	Level 2, Main Entrance, above metal ceiling – SMF batt insulation.

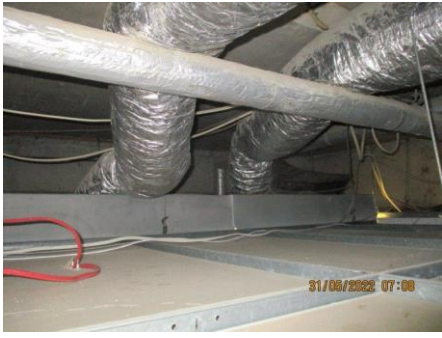
<table border="1"> <thead> <tr> <th colspan="2">Visual Inspection</th> </tr> </thead> <tbody> <tr> <td>SMF Identified:</td> <td>Yes</td> </tr> <tr> <td>Location:</td> <td>Internal</td> </tr> <tr> <td colspan="2">Level 2, Main Entrance ceiling space – flexible ductwork insulation. Typical throughout Main entrance.</td> </tr> </tbody> </table>	Visual Inspection		SMF Identified:	Yes	Location:	Internal	Level 2, Main Entrance ceiling space – flexible ductwork insulation. Typical throughout Main entrance.	
Visual Inspection									
SMF Identified:	Yes								
Location:	Internal								
Level 2, Main Entrance ceiling space – flexible ductwork insulation. Typical throughout Main entrance.

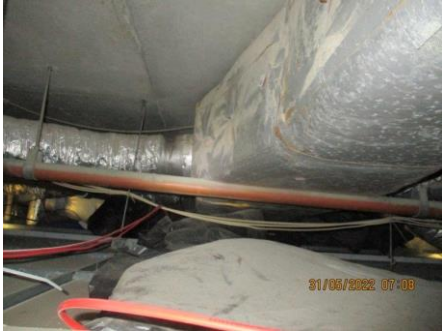
<table border="1"> <thead> <tr> <th colspan="2">Visual Inspection</th> </tr> </thead> <tbody> <tr> <td>SMF Identified:</td> <td>Yes</td> </tr> <tr> <td>Location:</td> <td>Internal</td> </tr> <tr> <td colspan="2">Level 2, Main Entrance ceiling space –ductwork insulation. Typical throughout Main entrance.</td> </tr> </tbody> </table>	Visual Inspection		SMF Identified:	Yes	Location:	Internal	Level 2, Main Entrance ceiling space –ductwork insulation. Typical throughout Main entrance.

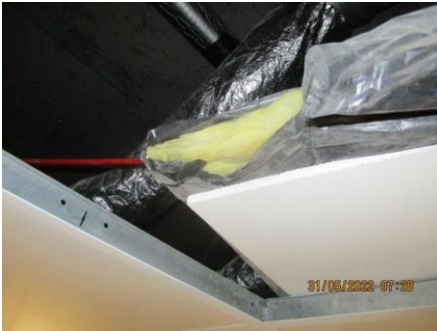
<table border="1"> <thead> <tr> <th colspan="2">Visual Inspection</th> </tr> </thead> <tbody> <tr> <td>SMF Identified:</td> <td>Yes</td> </tr> <tr> <td>Location:</td> <td>Internal</td> </tr> <tr> <td colspan="2">Level 2, Main Entrance ceiling space –SMF batt insulation. Typical throughout Main entrance.</td> </tr> </tbody> </table>	Visual Inspection		SMF Identified:	Yes	Location:	Internal	Level 2, Main Entrance ceiling space –SMF batt insulation. Typical throughout Main entrance.	
Visual Inspection									
SMF Identified:	Yes								
Location:	Internal								
Level 2, Main Entrance ceiling space –SMF batt insulation. Typical throughout Main entrance.

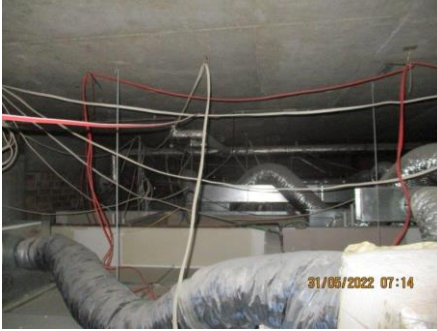
<table border="1"> <thead> <tr> <th colspan="2">Visual Inspection</th> </tr> </thead> <tbody> <tr> <td>SMF Identified:</td> <td>Yes</td> </tr> <tr> <td>Location:</td> <td>Internal</td> </tr> <tr> <td colspan="2">Level 2, Emergency Department Waiting Area, ceiling space – flexible ductwork insulation. Typical throughout Emergency Waiting Area.</td> </tr> </tbody> </table>	Visual Inspection		SMF Identified:	Yes	Location:	Internal	Level 2, Emergency Department Waiting Area, ceiling space – flexible ductwork insulation. Typical throughout Emergency Waiting Area.

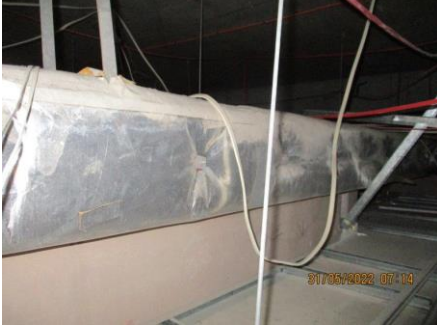
<table border="1"> <thead> <tr> <th colspan="2">Visual Inspection</th> </tr> </thead> <tbody> <tr> <td>SMF Identified:</td> <td>Yes</td> </tr> <tr> <td>Location:</td> <td>Internal</td> </tr> <tr> <td colspan="2">Level 2, Emergency Department Waiting Area, ceiling space – ductwork insulation. Typical throughout Emergency Waiting Area.</td> </tr> </tbody> </table>	Visual Inspection		SMF Identified:	Yes	Location:	Internal	Level 2, Emergency Department Waiting Area, ceiling space – ductwork insulation. Typical throughout Emergency Waiting Area.	
Visual Inspection									
SMF Identified:	Yes								
Location:	Internal								
Level 2, Emergency Department Waiting Area, ceiling space – ductwork insulation. Typical throughout Emergency Waiting Area.

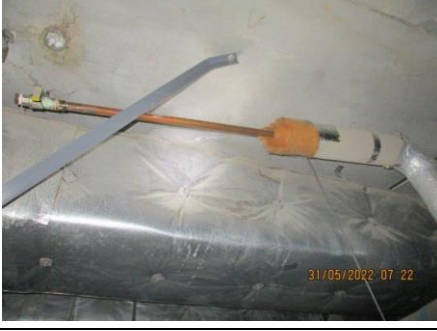
<table border="1"> <thead> <tr> <th colspan="2">Visual Inspection</th> </tr> </thead> <tbody> <tr> <td>SMF Identified:</td> <td>Yes</td> </tr> <tr> <td>Location:</td> <td>Internal</td> </tr> <tr> <td colspan="2">Level 2, Emergency Department Waiting Area, ceiling space – pipe insulation. Typical throughout Emergency Waiting Area.</td> </tr> </tbody> </table>	Visual Inspection		SMF Identified:	Yes	Location:	Internal	Level 2, Emergency Department Waiting Area, ceiling space – pipe insulation. Typical throughout Emergency Waiting Area.	
Visual Inspection									
SMF Identified:	Yes								
Location:	Internal								
Level 2, Emergency Department Waiting Area, ceiling space – pipe insulation. Typical throughout Emergency Waiting Area.

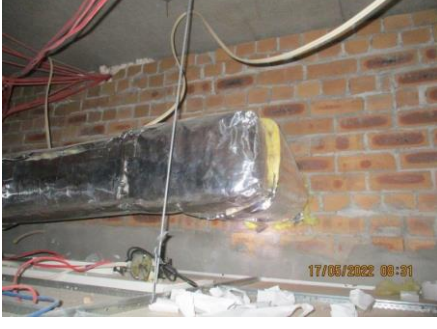
<table border="1"> <thead> <tr> <th colspan="2">Visual Inspection</th> </tr> </thead> <tbody> <tr> <td>SMF Identified:</td> <td>Yes</td> </tr> <tr> <td>Location:</td> <td>Internal</td> </tr> <tr> <td colspan="2">Level 2, Emergency Department, north-west end, Room 2073 (Disposal Room) ceiling space – air conditioning ductwork insulation. Typical throughout Emergency Department.</td> </tr> </tbody> </table>	Visual Inspection		SMF Identified:	Yes	Location:	Internal	Level 2, Emergency Department, north-west end, Room 2073 (Disposal Room) ceiling space – air conditioning ductwork insulation. Typical throughout Emergency Department.

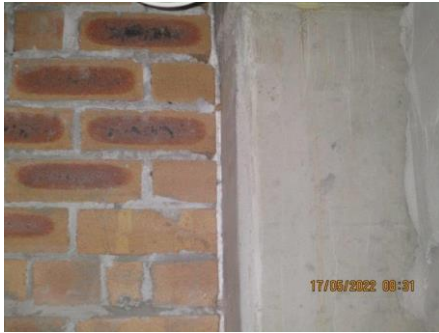
Visual Inspection	
SMF Identified:	Yes
Location:	Internal
Level 2, Emergency Department, SMF "Kaowool" insulation packing between walls. Typical throughout Emergency Department.

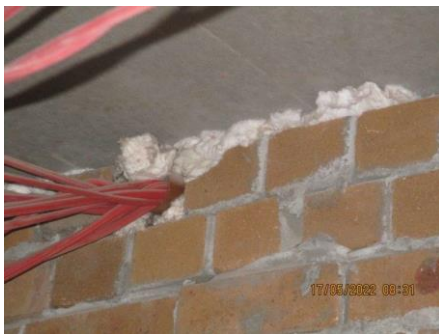
Visual Inspection	
SMF Identified:	Yes
Location:	Internal
Level 2, Emergency Department, SMF "Kaowool" insulation between top of walls and concrete slab. Typical throughout Emergency Department.

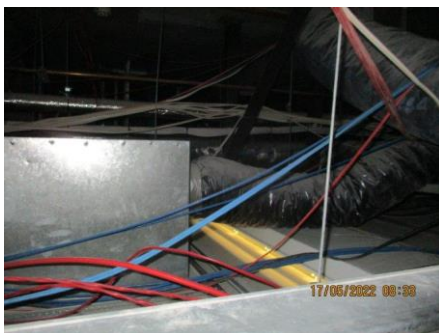
Visual Inspection	
SMF Identified:	Assume Yes
Location:	Internal
Level 2, Emergency Department, ceiling space – flexible ductwork insulation. Typical throughout Emergency Department.

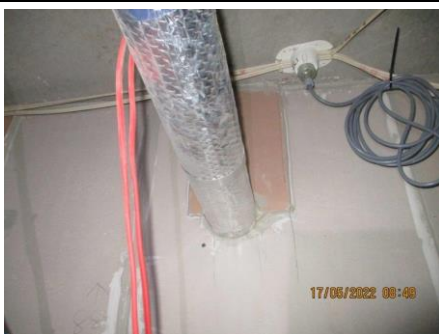
Visual Inspection	
SMF Identified:	Assume Yes
Location:	Internal
Level 2, Emergency Department, ceiling space – pipework insulation. Typical throughout Emergency Department.

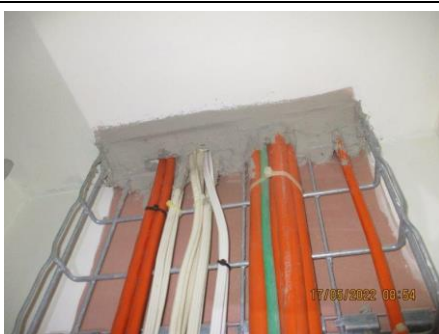
Visual Inspection	
SMF Identified:	Yes
Location:	Internal
Level 2, Emergency Department, DB S2B, penetrations – SMF insulation.

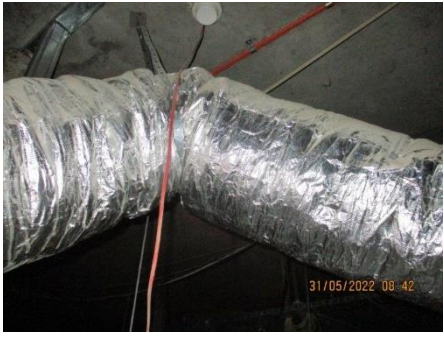
<table border="1"> <thead> <tr> <th colspan="2">Visual Inspection</th> </tr> </thead> <tbody> <tr> <td>SMF Identified:</td> <td>Yes</td> </tr> <tr> <td>Location:</td> <td>Internal</td> </tr> <tr> <td colspan="2">Level 2, Pathology Department, ceiling space, SMF flexible ductwork insulation.</td> </tr> </tbody> </table>	Visual Inspection		SMF Identified:	Yes	Location:	Internal	Level 2, Pathology Department, ceiling space, SMF flexible ductwork insulation.	
Visual Inspection									
SMF Identified:	Yes								
Location:	Internal								
Level 2, Pathology Department, ceiling space, SMF flexible ductwork insulation.

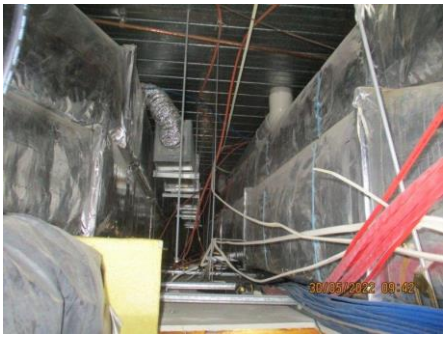
<table border="1"> <thead> <tr> <th colspan="2">Visual Inspection</th> </tr> </thead> <tbody> <tr> <td>SMF Identified:</td> <td>Yes</td> </tr> <tr> <td>Location:</td> <td>Internal</td> </tr> <tr> <td colspan="2">Level 2, Nexus ceiling space – flexible ductwork insulation. Typical throughout Nexus.</td> </tr> </tbody> </table>	Visual Inspection		SMF Identified:	Yes	Location:	Internal	Level 2, Nexus ceiling space – flexible ductwork insulation. Typical throughout Nexus.

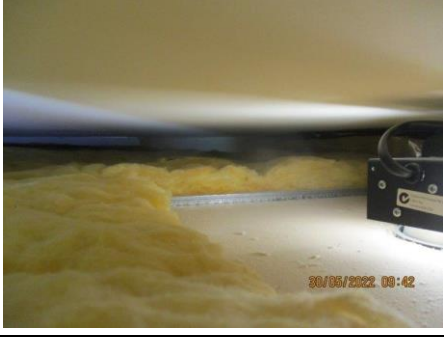
<table border="1"> <thead> <tr> <th colspan="2">Visual Inspection</th> </tr> </thead> <tbody> <tr> <td>SMF Identified:</td> <td>Yes</td> </tr> <tr> <td>Location:</td> <td>Internal</td> </tr> <tr> <td colspan="2">Level 2, Nexus ceiling space – SMF batts on top of ceiling tiles. Typical throughout Nexus.</td> </tr> </tbody> </table>	Visual Inspection		SMF Identified:	Yes	Location:	Internal	Level 2, Nexus ceiling space – SMF batts on top of ceiling tiles. Typical throughout Nexus.	
Visual Inspection									
SMF Identified:	Yes								
Location:	Internal								
Level 2, Nexus ceiling space – SMF batts on top of ceiling tiles. Typical throughout Nexus.

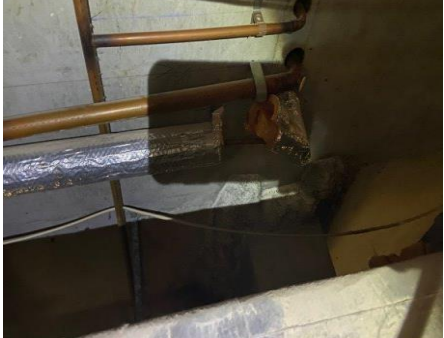
<table border="1"> <thead> <tr> <th colspan="2">Visual Inspection</th> </tr> </thead> <tbody> <tr> <td>SMF Identified:</td> <td>Yes</td> </tr> <tr> <td>Location:</td> <td>Internal</td> </tr> <tr> <td colspan="2">Level 2, Executive Suite, Room 2340 (Storeroom) throughout, ceiling space – pipework insulation. Typical throughout Executive Suite</td> </tr> </tbody> </table>	Visual Inspection		SMF Identified:	Yes	Location:	Internal	Level 2, Executive Suite, Room 2340 (Storeroom) throughout, ceiling space – pipework insulation. Typical throughout Executive Suite

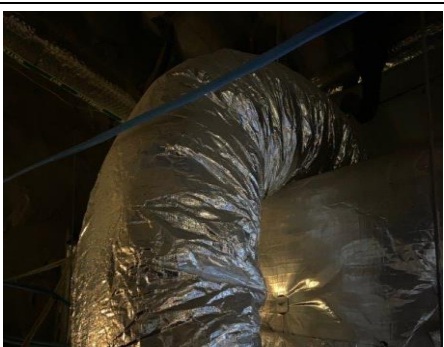
<table border="1"> <thead> <tr> <th colspan="2">Visual Inspection</th> </tr> </thead> <tbody> <tr> <td>SMF Identified:</td> <td>Yes</td> </tr> <tr> <td>Location:</td> <td>Internal</td> </tr> <tr> <td colspan="2">Level 2, Executive Suite, Room 2340 (Storeroom) throughout, ceiling space – flexible ductwork insulation. Typical throughout Executive Suite</td> </tr> </tbody> </table>	Visual Inspection		SMF Identified:	Yes	Location:	Internal	Level 2, Executive Suite, Room 2340 (Storeroom) throughout, ceiling space – flexible ductwork insulation. Typical throughout Executive Suite	
Visual Inspection									
SMF Identified:	Yes								
Location:	Internal								
Level 2, Executive Suite, Room 2340 (Storeroom) throughout, ceiling space – flexible ductwork insulation. Typical throughout Executive Suite

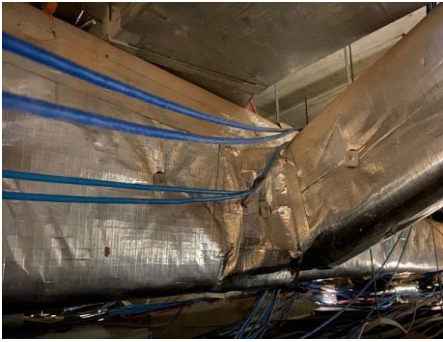
<table border="1"> <thead> <tr> <th colspan="2">Visual Inspection</th> </tr> </thead> <tbody> <tr> <td>SMF Identified:</td> <td>Yes</td> </tr> <tr> <td>Location:</td> <td>Internal</td> </tr> <tr> <td colspan="2">Level 2, Executive Suite, Room 2340 (Storeroom) throughout, ceiling space – air conditioning ductwork insulation. Typical throughout Executive Suite</td> </tr> </tbody> </table>	Visual Inspection		SMF Identified:	Yes	Location:	Internal	Level 2, Executive Suite, Room 2340 (Storeroom) throughout, ceiling space – air conditioning ductwork insulation. Typical throughout Executive Suite	
Visual Inspection									
SMF Identified:	Yes								
Location:	Internal								
Level 2, Executive Suite, Room 2340 (Storeroom) throughout, ceiling space – air conditioning ductwork insulation. Typical throughout Executive Suite

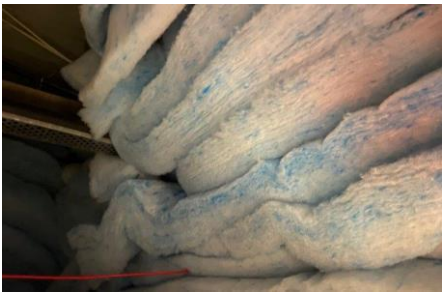
<table border="1"> <thead> <tr> <th colspan="2">Visual Inspection</th> </tr> </thead> <tbody> <tr> <td>SMF Identified:</td> <td>Yes</td> </tr> <tr> <td>Location:</td> <td>Internal</td> </tr> <tr> <td colspan="2">Level 2, Executive Suite, Office 2360A, ceiling space – blue insulation batts.</td> </tr> </tbody> </table>	Visual Inspection		SMF Identified:	Yes	Location:	Internal	Level 2, Executive Suite, Office 2360A, ceiling space – blue insulation batts.

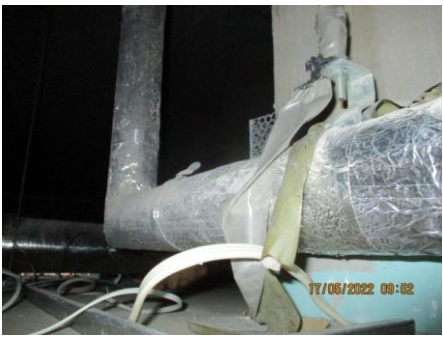
<table border="1"> <thead> <tr> <th colspan="2">Visual Inspection</th> </tr> </thead> <tbody> <tr> <td>SMF Identified:</td> <td>Yes</td> </tr> <tr> <td>Location:</td> <td>Internal</td> </tr> <tr> <td colspan="2">Level 2, Central Sterilisation Department, throughout, ceiling space – pipework insulation. Typical throughout Central Sterilisation Department.</td> </tr> </tbody> </table>	Visual Inspection		SMF Identified:	Yes	Location:	Internal	Level 2, Central Sterilisation Department, throughout, ceiling space – pipework insulation. Typical throughout Central Sterilisation Department.	
Visual Inspection									
SMF Identified:	Yes								
Location:	Internal								
Level 2, Central Sterilisation Department, throughout, ceiling space – pipework insulation. Typical throughout Central Sterilisation Department.

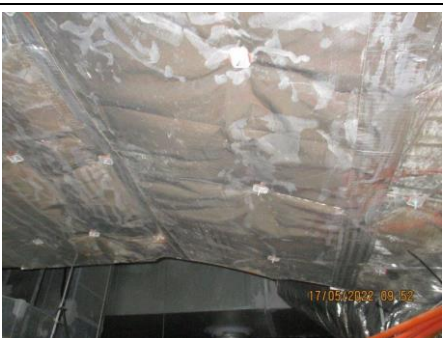
<table border="1"> <thead> <tr> <th colspan="2">Visual Inspection</th> </tr> </thead> <tbody> <tr> <td>SMF Identified:</td> <td>Assume Yes</td> </tr> <tr> <td>Location:</td> <td>Internal</td> </tr> <tr> <td colspan="2">Level 2, Central Sterilisation Department, throughout, ceiling space – ductwork insulation. Typical throughout Central Sterilisation Department.</td> </tr> </tbody> </table>	Visual Inspection		SMF Identified:	Assume Yes	Location:	Internal	Level 2, Central Sterilisation Department, throughout, ceiling space – ductwork insulation. Typical throughout Central Sterilisation Department.	
Visual Inspection									
SMF Identified:	Assume Yes								
Location:	Internal								
Level 2, Central Sterilisation Department, throughout, ceiling space – ductwork insulation. Typical throughout Central Sterilisation Department.
