**RE : DEMOLITION WORK PLAN MD - 2753**  
**AT : JOHN HUNTER HEALTH & INNOVATION PRECINCT**

## Demolition Work Plan (DWP)

JHHIP – Stage 1

# HAZARDOUS MATERIALS SURVEY REPORT

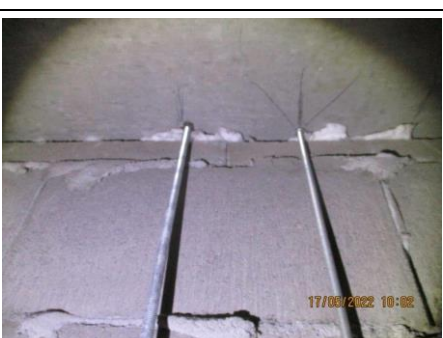
<table border="1"> <thead> <tr> <th colspan="2">Visual Inspection</th> </tr> </thead> <tbody> <tr> <td>SMF Identified:</td> <td>Yes</td> </tr> <tr> <td>Location:</td> <td>Internal</td> </tr> <tr> <td colspan="2">Level 2, Central Sterilisation Department, throughout, ceiling space – white “Kaowool” insulation between blockwork/slab. Typical throughout Central Sterilisation Department.</td> </tr> </tbody> </table>	Visual Inspection		SMF Identified:	Yes	Location:	Internal	Level 2, Central Sterilisation Department, throughout, ceiling space – white “Kaowool” insulation between blockwork/slab. Typical throughout Central Sterilisation Department.

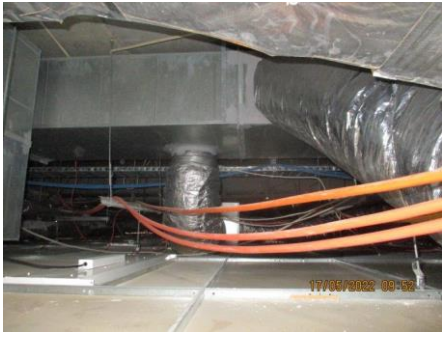
<table border="1"> <thead> <tr> <th colspan="2">Visual Inspection</th> </tr> </thead> <tbody> <tr> <td>SMF Identified:</td> <td>Yes</td> </tr> <tr> <td>Location:</td> <td>Internal</td> </tr> <tr> <td colspan="2">                     Level 2, Central Sterilisation Department, throughout, ceiling space – flexible duct insulation                      Typical throughout Central Sterilisation Department.                 </td> </tr> </tbody> </table>	Visual Inspection		SMF Identified:	Yes	Location:	Internal	Level 2, Central Sterilisation Department, throughout, ceiling space – flexible duct insulation Typical throughout Central Sterilisation Department.	
Visual Inspection									
SMF Identified:	Yes								
Location:	Internal								
Level 2, Central Sterilisation Department, throughout, ceiling space – flexible duct insulation Typical throughout Central Sterilisation Department.

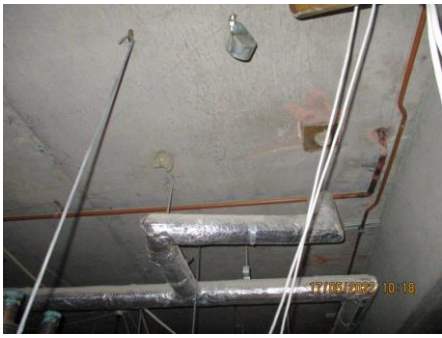
Visual Inspection									
SMF Identified:	Yes								
Location:	Internal								
Level 2, Central Sterilisation Department, throughout, ceiling space – “Kaowool” insulation within various penetrations. Typical throughout Central Sterilisation Department.

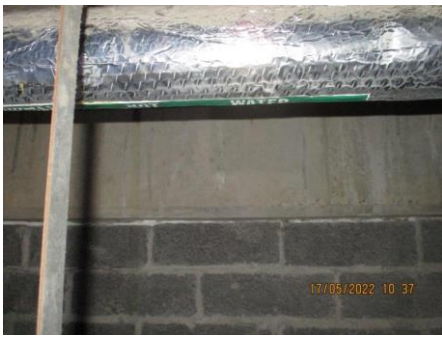
SMF Identified:	Yes								
Location:	Internal								
Level 2, Ward H2, Storeroom adjacent corridor and fire door exit, ceiling space – pipework insulation. Typical throughout Ward H2.

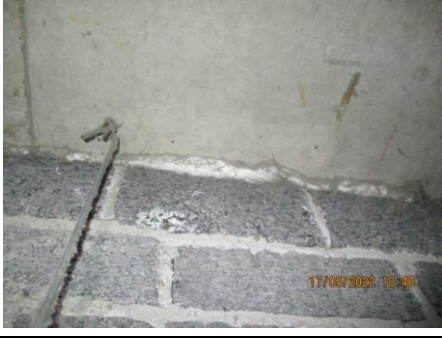
Location:	Internal								
Level 2, Ward H2, Storeroom adjacent corridor and fire door exit, ceiling space – “Kaowool” between blockwork and concrete slab. Typical throughout Ward H2.

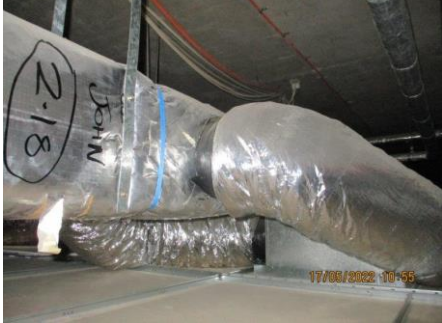
<table border="1"> <thead> <tr> <th colspan="2">Visual Inspection</th> </tr> </thead> <tbody> <tr> <td>SMF Identified:</td> <td>Yes</td> </tr> <tr> <td>Location:</td> <td>Internal</td> </tr> <tr> <td colspan="2">                     Level 2, Ward H2, corridor adjacent enquires desk – flexible ductwork insulation.                      Typical throughout Ward H2.                 </td> </tr> </tbody> </table>	Visual Inspection		SMF Identified:	Yes	Location:	Internal	Level 2, Ward H2, corridor adjacent enquires desk – flexible ductwork insulation. Typical throughout Ward H2.	
Visual Inspection									
SMF Identified:	Yes								
Location:	Internal								
Level 2, Ward H2, corridor adjacent enquires desk – flexible ductwork insulation. Typical throughout Ward H2.

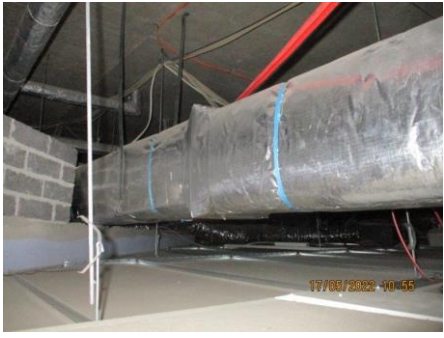
<table border="1"> <thead> <tr> <th colspan="2">Visual Inspection</th> </tr> </thead> <tbody> <tr> <td>SMF Identified:</td> <td>Yes</td> </tr> <tr> <td>Location:</td> <td>Internal</td> </tr> <tr> <td colspan="2">Level 2, Ward H2, corridor adjacent enquires desk – air conditioning ductwork insulation. Typical throughout Ward H2.</td> </tr> </tbody> </table>	Visual Inspection		SMF Identified:	Yes	Location:	Internal	Level 2, Ward H2, corridor adjacent enquires desk – air conditioning ductwork insulation. Typical throughout Ward H2.	
Visual Inspection									
SMF Identified:	Yes								
Location:	Internal								
Level 2, Ward H2, corridor adjacent enquires desk – air conditioning ductwork insulation. Typical throughout Ward H2.

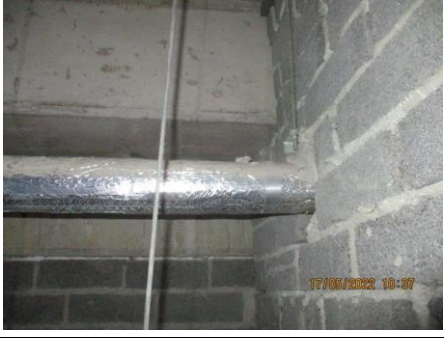
Visual Inspection									
SMF Identified:	Yes								
Location:	Internal								
Level 2, Ward H2, corridor adjacent enquires desk – pipework insulation. Typical throughout Ward H2.

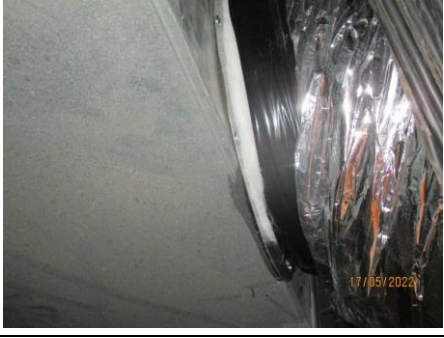
<table border="1"> <thead> <tr> <th colspan="2">Visual Inspection</th> </tr> </thead> <tbody> <tr> <td>SMF Identified:</td> <td>Yes</td> </tr> <tr> <td>Location:</td> <td>Internal</td> </tr> <tr> <td colspan="2">Level 2, Pharmacy, throughout, ceiling space – flexible ductwork insulation. Typical throughout Pharmacy.</td> </tr> </tbody> </table>	Visual Inspection		SMF Identified:	Yes	Location:	Internal	Level 2, Pharmacy, throughout, ceiling space – flexible ductwork insulation. Typical throughout Pharmacy.	
Visual Inspection									
SMF Identified:	Yes								
Location:	Internal								
Level 2, Pharmacy, throughout, ceiling space – flexible ductwork insulation. Typical throughout Pharmacy.

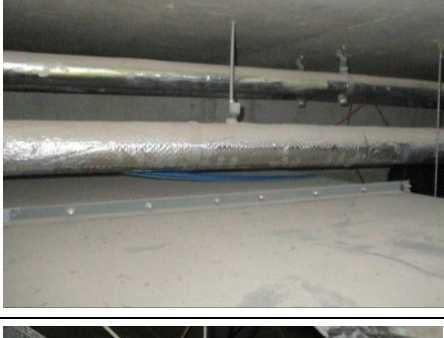
Visual Inspection									
SMF Identified:	Yes								
Location:	Internal								
Level 2, Pharmacy, throughout, ceiling space – pipework insulation. Typical throughout Pharmacy.

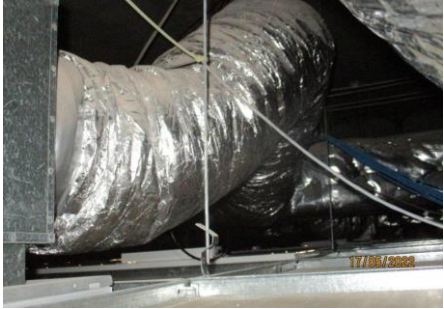
<table border="1"> <thead> <tr> <th colspan="2">Visual Inspection</th> </tr> </thead> <tbody> <tr> <td>SMF Identified:</td> <td>Yes</td> </tr> <tr> <td>Location:</td> <td>Internal</td> </tr> <tr> <td colspan="2">Level 2, Pharmacy, throughout, Drug Information Room (2662) ceiling space – flexible ductwork insulation. Typical throughout Pharmacy.</td> </tr> </tbody> </table>	Visual Inspection		SMF Identified:	Yes	Location:	Internal	Level 2, Pharmacy, throughout, Drug Information Room (2662) ceiling space – flexible ductwork insulation. Typical throughout Pharmacy.	
Visual Inspection									
SMF Identified:	Yes								
Location:	Internal								
Level 2, Pharmacy, throughout, Drug Information Room (2662) ceiling space – flexible ductwork insulation. Typical throughout Pharmacy.

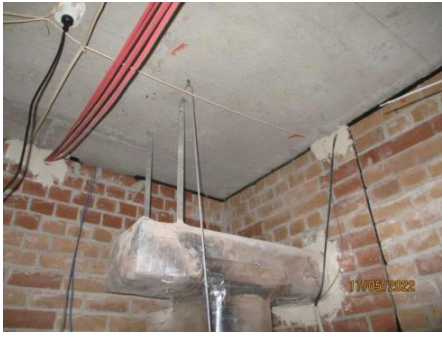
<table border="1"> <thead> <tr> <th colspan="2">Visual Inspection</th> </tr> </thead> <tbody> <tr> <td>SMF Identified:</td> <td>Yes</td> </tr> <tr> <td>Location:</td> <td>Internal</td> </tr> <tr> <td colspan="2">Level 2, Pharmacy, throughout, Drug Information Room (2662) ceiling space – air conditioning ductwork insulation. Typical throughout Pharmacy.</td> </tr> </tbody> </table>	Visual Inspection		SMF Identified:	Yes	Location:	Internal	Level 2, Pharmacy, throughout, Drug Information Room (2662) ceiling space – air conditioning ductwork insulation. Typical throughout Pharmacy.	
Visual Inspection									
SMF Identified:	Yes								
Location:	Internal								
Level 2, Pharmacy, throughout, Drug Information Room (2662) ceiling space – air conditioning ductwork insulation. Typical throughout Pharmacy.

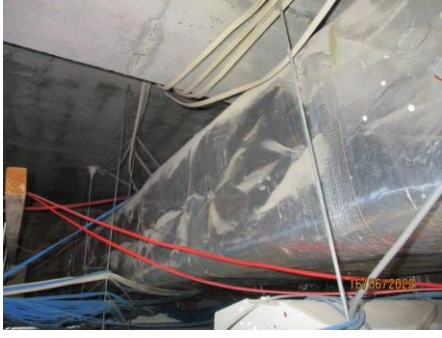
Visual Inspection									
SMF Identified:	Yes								
Location:	Internal								
Level 2, Medical Imaging ceiling space – air conditioning ductwork insulation. Typical throughout Medical Imaging.

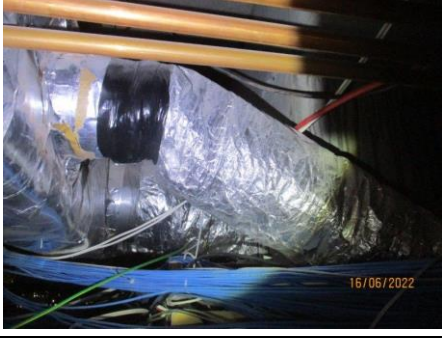
<table border="1"> <thead> <tr> <th colspan="2">Visual Inspection</th> </tr> </thead> <tbody> <tr> <td>SMF Identified:</td> <td>Yes</td> </tr> <tr> <td>Location:</td> <td>Internal</td> </tr> <tr> <td colspan="2">Level 2, Medical Imaging ceiling space – flexible air conditioning ductwork insulation. Typical throughout Medical Imaging.</td> </tr> </tbody> </table>	Visual Inspection		SMF Identified:	Yes	Location:	Internal	Level 2, Medical Imaging ceiling space – flexible air conditioning ductwork insulation. Typical throughout Medical Imaging.	
Visual Inspection									
SMF Identified:	Yes								
Location:	Internal								
Level 2, Medical Imaging ceiling space – flexible air conditioning ductwork insulation. Typical throughout Medical Imaging.

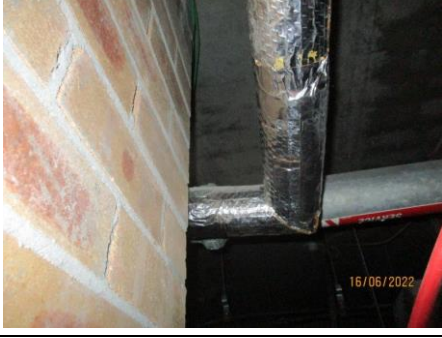
<table border="1"> <thead> <tr> <th colspan="2">Visual Inspection</th> </tr> </thead> <tbody> <tr> <td>SMF Identified:</td> <td>Yes</td> </tr> <tr> <td>Location:</td> <td>Internal</td> </tr> <tr> <td colspan="2">Level 2, Medical Imaging ceiling space – pipe insulation. Typical throughout Medical Imaging.</td> </tr> </tbody> </table>	Visual Inspection		SMF Identified:	Yes	Location:	Internal	Level 2, Medical Imaging ceiling space – pipe insulation. Typical throughout Medical Imaging.	
Visual Inspection									
SMF Identified:	Yes								
Location:	Internal								
Level 2, Medical Imaging ceiling space – pipe insulation. Typical throughout Medical Imaging.

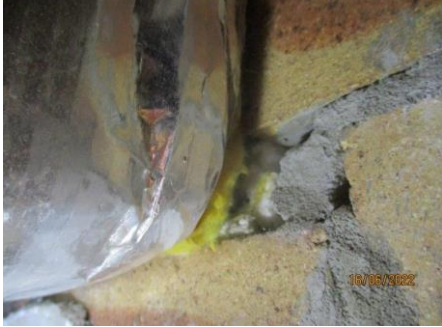
Visual Inspection									
SMF Identified:	Yes								
Location:	Internal								
Level 2, Medical Imaging ceiling space – “Kaowool” between blockwork and concrete slab and within penetrations. Typical throughout Medical Imaging.

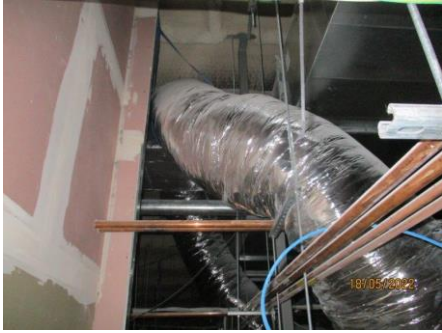
<table border="1"> <tr> <th colspan="2">Visual Inspection</th> </tr> <tr> <td>SMF Identified:</td> <td>Yes</td> </tr> <tr> <td>Location:</td> <td>Internal</td> </tr> <tr> <td colspan="2"> <p>Level 3, Neonatal Intensive Care Unit, adjacent Clean Utility Room (3646) ceiling space – flexible ductwork insulation. Typical throughout NICU.</p> </td> </tr> </table>	Visual Inspection		SMF Identified:	Yes	Location:	Internal	<p>Level 3, Neonatal Intensive Care Unit, adjacent Clean Utility Room (3646) ceiling space – flexible ductwork insulation. Typical throughout NICU.</p>	
Visual Inspection									
SMF Identified:	Yes								
Location:	Internal								
<p>Level 3, Neonatal Intensive Care Unit, adjacent Clean Utility Room (3646) ceiling space – flexible ductwork insulation. Typical throughout NICU.</p>

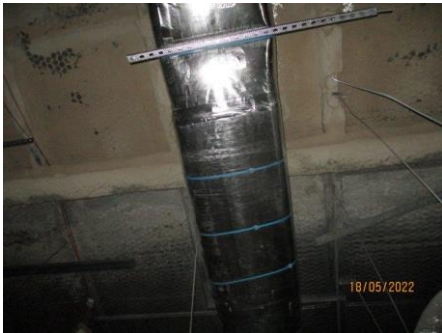
Visual Inspection									
SMF Identified:	Yes								
Location:	Internal								
<p>Level 3, Neonatal Intensive Care Unit, adjacent Clean Utility Room (3646) ceiling space – air conditioning ductwork insulation. Typical throughout NICU.</p>

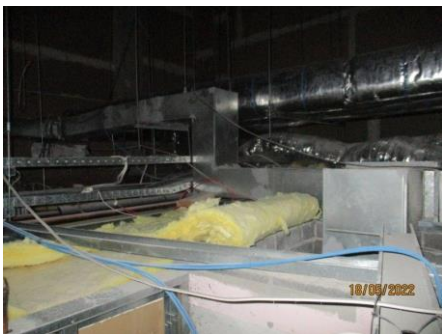
<table border="1"> <tr> <th colspan="2">Visual Inspection</th> </tr> <tr> <td>SMF Identified:</td> <td>Yes</td> </tr> <tr> <td>Location:</td> <td>Internal</td> </tr> <tr> <td colspan="2"> <p>Level 3, Neonatal Intensive Care Unit, adjacent Clean Utility Room (3646) ceiling space – yellow insulation batts Typical throughout NICU.</p> </td> </tr> </table>	Visual Inspection		SMF Identified:	Yes	Location:	Internal	<p>Level 3, Neonatal Intensive Care Unit, adjacent Clean Utility Room (3646) ceiling space – yellow insulation batts Typical throughout NICU.</p>	
Visual Inspection									
SMF Identified:	Yes								
Location:	Internal								
<p>Level 3, Neonatal Intensive Care Unit, adjacent Clean Utility Room (3646) ceiling space – yellow insulation batts Typical throughout NICU.</p>

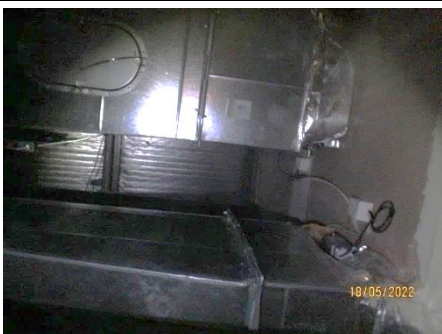
<table border="1"> <tr> <th colspan="2">Visual Inspection</th> </tr> <tr> <td>SMF Identified:</td> <td>Assume Yes</td> </tr> <tr> <td>Location:</td> <td>Internal</td> </tr> <tr> <td colspan="2"> <p>Level 3, Neonatal Intensive Care Unit, adjacent Clean Utility Room (3646) ceiling space – sarking insulation. Typical throughout NICU.</p> </td> </tr> </table>	Visual Inspection		SMF Identified:	Assume Yes	Location:	Internal	<p>Level 3, Neonatal Intensive Care Unit, adjacent Clean Utility Room (3646) ceiling space – sarking insulation. Typical throughout NICU.</p>	
Visual Inspection									
SMF Identified:	Assume Yes								
Location:	Internal								
<p>Level 3, Neonatal Intensive Care Unit, adjacent Clean Utility Room (3646) ceiling space – sarking insulation. Typical throughout NICU.</p>

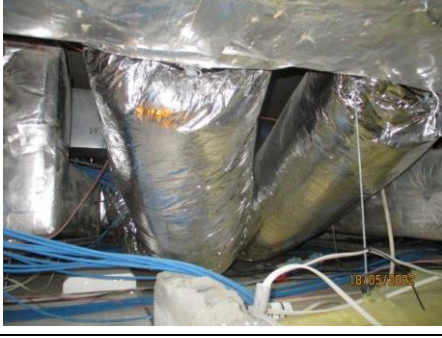
Visual Inspection									
SMF Identified:	Yes								
Location:	Internal								
Level 3, Birthing Suite, nurses' station, ceiling space – sprayed SMF insulation to beams and ductwork. Typical throughout Birthing Suite.

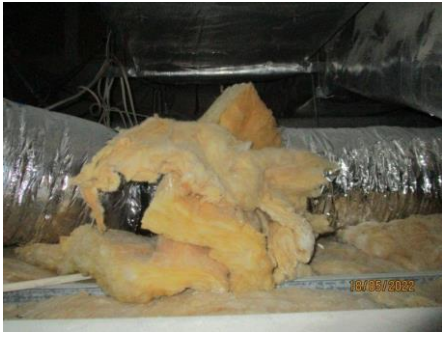
<table border="1"> <thead> <tr> <th colspan="2">Visual Inspection</th> </tr> </thead> <tbody> <tr> <td>SMF Identified:</td> <td>Yes</td> </tr> <tr> <td>Location:</td> <td>Internal</td> </tr> <tr> <td colspan="2">Level 3, Birthing Suite, corridor adjacent nurses' station, ceiling space – SMF insulation batts.</td> </tr> </tbody> </table>	Visual Inspection		SMF Identified:	Yes	Location:	Internal	Level 3, Birthing Suite, corridor adjacent nurses' station, ceiling space – SMF insulation batts.	
Visual Inspection									
SMF Identified:	Yes								
Location:	Internal								
Level 3, Birthing Suite, corridor adjacent nurses' station, ceiling space – SMF insulation batts.

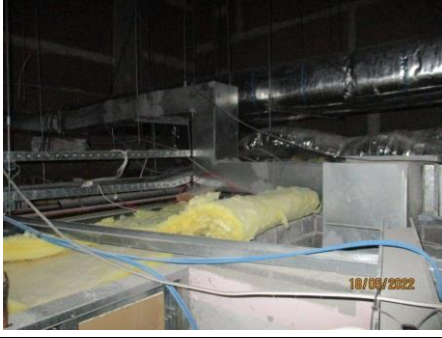
Visual Inspection									
SMF Identified:	Yes								
Location:	Internal								
Level 3, Birthing Suite, corridor adjacent nurses' station, ceiling space – air conditioning ductwork.

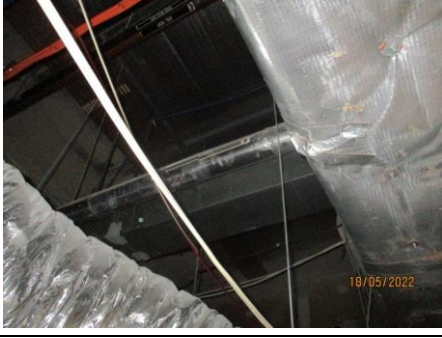
<table border="1"> <thead> <tr> <th colspan="2">Visual Inspection</th> </tr> </thead> <tbody> <tr> <td>SMF Identified:</td> <td>Yes</td> </tr> <tr> <td>Location:</td> <td>Internal</td> </tr> <tr> <td colspan="2">Level 3, Birthing Suite, corridor adjacent nurses' station, ceiling space – pipework insulation.</td> </tr> </tbody> </table>	Visual Inspection		SMF Identified:	Yes	Location:	Internal	Level 3, Birthing Suite, corridor adjacent nurses' station, ceiling space – pipework insulation.	
Visual Inspection									
SMF Identified:	Yes								
Location:	Internal								
Level 3, Birthing Suite, corridor adjacent nurses' station, ceiling space – pipework insulation.

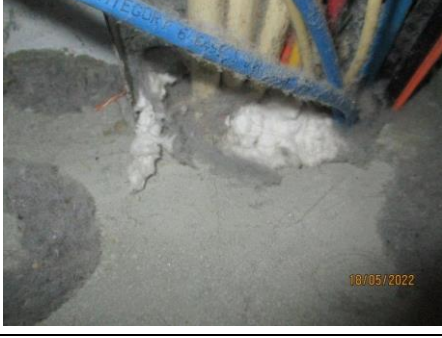
Visual Inspection									
SMF Identified:	Yes								
Location:	Internal								
Level 3, Birthing suite, Communication Cupboard, electrical penetration in floor – "Kaowool". Typical application of "Kaowool" within hospital.

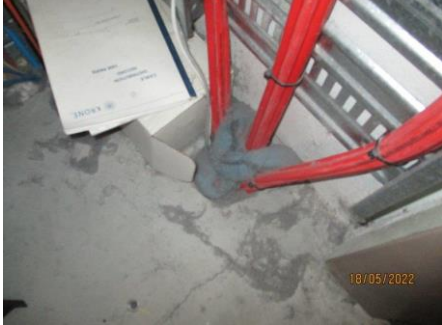
<table border="1"> <thead> <tr> <th colspan="2">Visual Inspection</th> </tr> </thead> <tbody> <tr> <td>SMF Identified:</td> <td>Yes</td> </tr> <tr> <td>Location:</td> <td>Internal</td> </tr> <tr> <td colspan="2">Level 3, Birthing Suite, Communication Cupboard, penetration – SMF pillow insulation and expanding foam.</td> </tr> </tbody> </table>	Visual Inspection		SMF Identified:	Yes	Location:	Internal	Level 3, Birthing Suite, Communication Cupboard, penetration – SMF pillow insulation and expanding foam.	
Visual Inspection									
SMF Identified:	Yes								
Location:	Internal								
Level 3, Birthing Suite, Communication Cupboard, penetration – SMF pillow insulation and expanding foam.

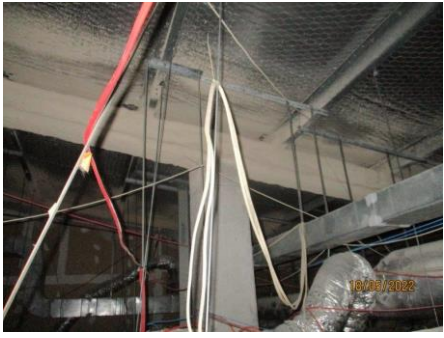
<table border="1"> <thead> <tr> <th colspan="2">Visual Inspection</th> </tr> </thead> <tbody> <tr> <td>SMF Identified:</td> <td>Yes</td> </tr> <tr> <td>Location:</td> <td>Internal</td> </tr> <tr> <td colspan="2">Level 3, Intensive Care Unit, waiting area, throughout, ceiling space – sarking beneath roof.</td> </tr> </tbody> </table>	Visual Inspection		SMF Identified:	Yes	Location:	Internal	Level 3, Intensive Care Unit, waiting area, throughout, ceiling space – sarking beneath roof.	
Visual Inspection									
SMF Identified:	Yes								
Location:	Internal								
Level 3, Intensive Care Unit, waiting area, throughout, ceiling space – sarking beneath roof.

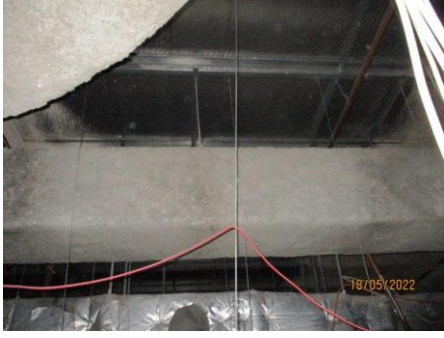
<table border="1"> <thead> <tr> <th colspan="2">Visual Inspection</th> </tr> </thead> <tbody> <tr> <td>SMF Identified:</td> <td>Yes</td> </tr> <tr> <td>Location:</td> <td>Internal</td> </tr> <tr> <td colspan="2">Level 3, Intensive Care Unit, waiting area, throughout, ceiling space – air conditioning ductwork.</td> </tr> </tbody> </table>	Visual Inspection		SMF Identified:	Yes	Location:	Internal	Level 3, Intensive Care Unit, waiting area, throughout, ceiling space – air conditioning ductwork.

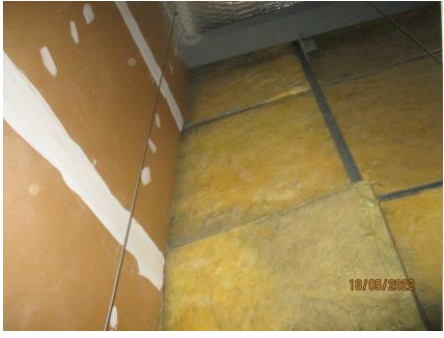
<table border="1"> <thead> <tr> <th colspan="2">Visual Inspection</th> </tr> </thead> <tbody> <tr> <td>SMF Identified:</td> <td>Yes</td> </tr> <tr> <td>Location:</td> <td>Internal</td> </tr> <tr> <td colspan="2">Level 3, Intensive Care Unit, corridor adjacent Boardroom, ceiling space – insulation batts to walls.</td> </tr> </tbody> </table>	Visual Inspection		SMF Identified:	Yes	Location:	Internal	Level 3, Intensive Care Unit, corridor adjacent Boardroom, ceiling space – insulation batts to walls.	
Visual Inspection									
SMF Identified:	Yes								
Location:	Internal								
Level 3, Intensive Care Unit, corridor adjacent Boardroom, ceiling space – insulation batts to walls.

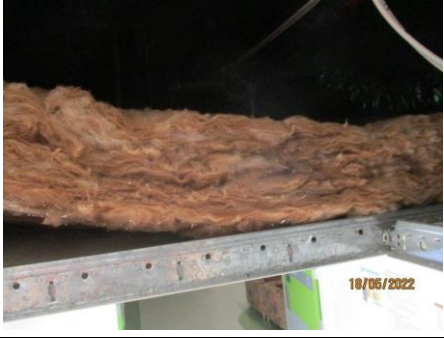
<table border="1"> <thead> <tr> <th colspan="2">Visual Inspection</th> </tr> </thead> <tbody> <tr> <td>SMF Identified:</td> <td>Yes</td> </tr> <tr> <td>Location:</td> <td>Internal</td> </tr> <tr> <td colspan="2">Level 3, Paediatric Intensive Care Unit, throughout, ceiling space – insulation batts</td> </tr> </tbody> </table>	Visual Inspection		SMF Identified:	Yes	Location:	Internal	Level 3, Paediatric Intensive Care Unit, throughout, ceiling space – insulation batts

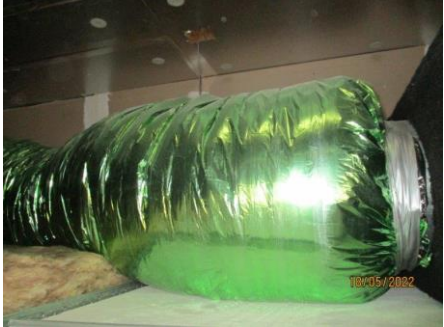
<table border="1"> <thead> <tr> <th colspan="2">Visual Inspection</th> </tr> </thead> <tbody> <tr> <td>SMF Identified:</td> <td>Assume Yes</td> </tr> <tr> <td>Location:</td> <td>Internal</td> </tr> <tr> <td colspan="2">Level 3, Paediatric Intensive Care Unit, throughout, ceiling space – flexible ductwork.</td> </tr> </tbody> </table>	Visual Inspection		SMF Identified:	Assume Yes	Location:	Internal	Level 3, Paediatric Intensive Care Unit, throughout, ceiling space – flexible ductwork.	
Visual Inspection									
SMF Identified:	Assume Yes								
Location:	Internal								
Level 3, Paediatric Intensive Care Unit, throughout, ceiling space – flexible ductwork.

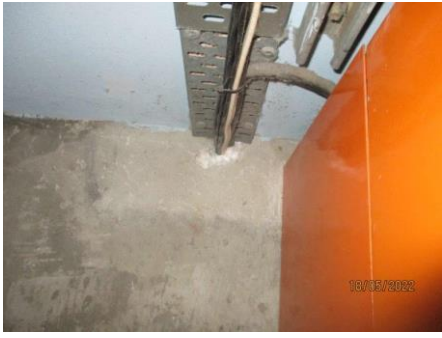
<table border="1"> <tr> <th colspan="2">Visual Inspection</th> </tr> <tr> <td>SMF Identified:</td> <td>Assume Yes</td> </tr> <tr> <td>Location:</td> <td>Internal</td> </tr> <tr> <td colspan="2">Level 3, Ward H3, electrical distribution board cupboard – “Kaowool”.</td> </tr> </table>	Visual Inspection		SMF Identified:	Assume Yes	Location:	Internal	Level 3, Ward H3, electrical distribution board cupboard – “Kaowool”.	
Visual Inspection									
SMF Identified:	Assume Yes								
Location:	Internal								
Level 3, Ward H3, electrical distribution board cupboard – “Kaowool”.

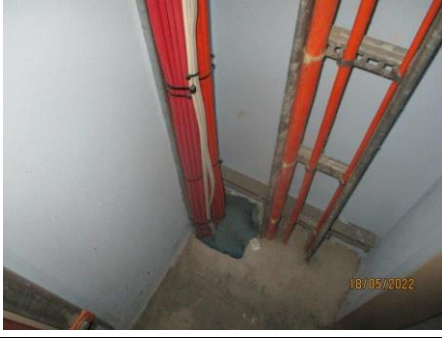
<table border="1"> <tr> <th colspan="2">Visual Inspection</th> </tr> <tr> <td>SMF Identified:</td> <td>Assume Yes</td> </tr> <tr> <td>Location:</td> <td>Internal</td> </tr> <tr> <td colspan="2">Level 3, Ward H3, electrical distribution board cupboard – pillow insulation.</td> </tr> </table>	Visual Inspection		SMF Identified:	Assume Yes	Location:	Internal	Level 3, Ward H3, electrical distribution board cupboard – pillow insulation.

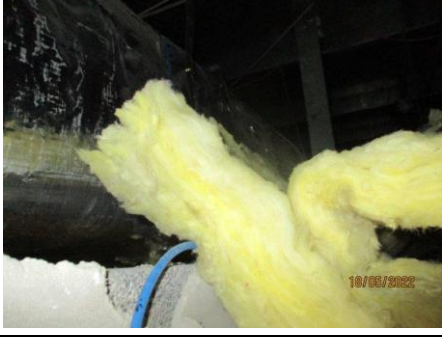
<table border="1"> <tr> <th colspan="2">Visual Inspection</th> </tr> <tr> <td>SMF Identified:</td> <td>Assume Yes</td> </tr> <tr> <td>Location:</td> <td>Internal</td> </tr> <tr> <td colspan="2">Level 3, Ward H3, corridor, throughout, ceiling space – insulation batts.</td> </tr> </table>	Visual Inspection		SMF Identified:	Assume Yes	Location:	Internal	Level 3, Ward H3, corridor, throughout, ceiling space – insulation batts.	
Visual Inspection									
SMF Identified:	Assume Yes								
Location:	Internal								
Level 3, Ward H3, corridor, throughout, ceiling space – insulation batts.

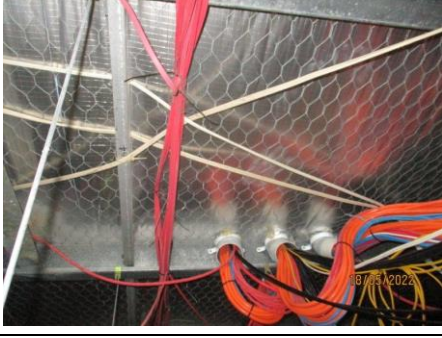
<table border="1"> <tr> <th colspan="2">Visual Inspection</th> </tr> <tr> <td>SMF Identified:</td> <td>Assume Yes</td> </tr> <tr> <td>Location:</td> <td>Internal</td> </tr> <tr> <td colspan="2">Level 3, Ward H3, corridor, throughout, ceiling space – sarking insulation.</td> </tr> </table>	Visual Inspection		SMF Identified:	Assume Yes	Location:	Internal	Level 3, Ward H3, corridor, throughout, ceiling space – sarking insulation.

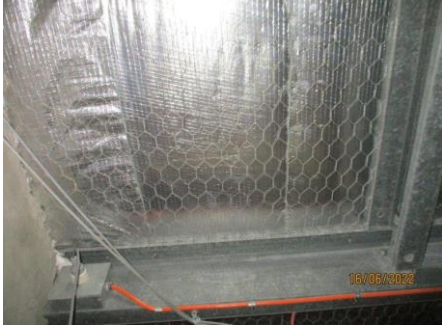
<table border="1"> <tr> <th colspan="2">Visual Inspection</th> </tr> <tr> <td>SMF Identified:</td> <td>Assume Yes</td> </tr> <tr> <td>Location:</td> <td>Internal</td> </tr> <tr> <td colspan="2">Level 3, Ward G3, throughout, ceiling space – sarking insulation. Typical throughout Ward G3.</td> </tr> </table>	Visual Inspection		SMF Identified:	Assume Yes	Location:	Internal	Level 3, Ward G3, throughout, ceiling space – sarking insulation. Typical throughout Ward G3.	
Visual Inspection									
SMF Identified:	Assume Yes								
Location:	Internal								
Level 3, Ward G3, throughout, ceiling space – sarking insulation. Typical throughout Ward G3.

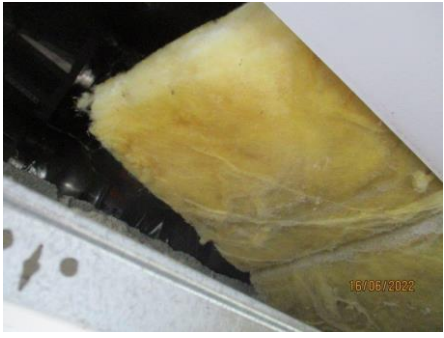
<table border="1"> <tr> <th colspan="2">Visual Inspection</th> </tr> <tr> <td>SMF Identified:</td> <td>Assume Yes</td> </tr> <tr> <td>Location:</td> <td>Internal</td> </tr> <tr> <td colspan="2">                     Level 3, Ward G3, throughout, ceiling space – Yellow SMF Batt insulation.                      Typical throughout Ward G3.                 </td> </tr> </table>	Visual Inspection		SMF Identified:	Assume Yes	Location:	Internal	Level 3, Ward G3, throughout, ceiling space – Yellow SMF Batt insulation. Typical throughout Ward G3.	
Visual Inspection									
SMF Identified:	Assume Yes								
Location:	Internal								
Level 3, Ward G3, throughout, ceiling space – Yellow SMF Batt insulation. Typical throughout Ward G3.

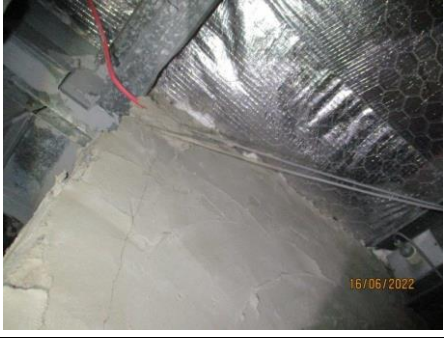
<table border="1"> <tr> <th colspan="2">Visual Inspection</th> </tr> <tr> <td>SMF Identified:</td> <td>Yes</td> </tr> <tr> <td>Location:</td> <td>Internal</td> </tr> <tr> <td colspan="2">                     Level 3, Ward G3, throughout, space – “Kaowool” between blockwork and concrete slab and within penetrations.                      Typical throughout Ward G3.                 </td> </tr> </table>	Visual Inspection		SMF Identified:	Yes	Location:	Internal	Level 3, Ward G3, throughout, space – “Kaowool” between blockwork and concrete slab and within penetrations. Typical throughout Ward G3.

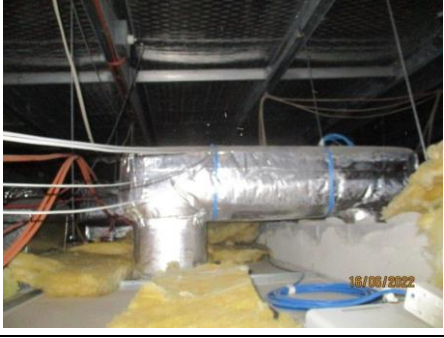
<table border="1"> <tr> <th colspan="2">Visual Inspection</th> </tr> <tr> <td>SMF Identified:</td> <td>Yes</td> </tr> <tr> <td>Location:</td> <td>Internal</td> </tr> <tr> <td colspan="2">                     Level 3, Ward G3, throughout, space – ductwork insulation.                      Typical throughout Ward G3.                 </td> </tr> </table>	Visual Inspection		SMF Identified:	Yes	Location:	Internal	Level 3, Ward G3, throughout, space – ductwork insulation. Typical throughout Ward G3.	
Visual Inspection									
SMF Identified:	Yes								
Location:	Internal								
Level 3, Ward G3, throughout, space – ductwork insulation. Typical throughout Ward G3.

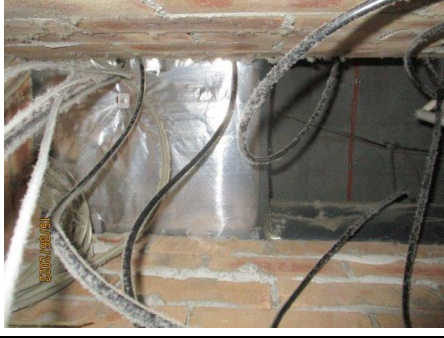
<table border="1"> <tr> <th colspan="2">Visual Inspection</th> </tr> <tr> <td>SMF Identified:</td> <td>Yes</td> </tr> <tr> <td>Location:</td> <td>Internal</td> </tr> <tr> <td colspan="2">                     Level 3, Coronary Care Unit, throughout, space – ductwork insulation.                      Typical throughout Coronary Care Unit.                 </td> </tr> </table>	Visual Inspection		SMF Identified:	Yes	Location:	Internal	Level 3, Coronary Care Unit, throughout, space – ductwork insulation. Typical throughout Coronary Care Unit.	
Visual Inspection									
SMF Identified:	Yes								
Location:	Internal								
Level 3, Coronary Care Unit, throughout, space – ductwork insulation. Typical throughout Coronary Care Unit.

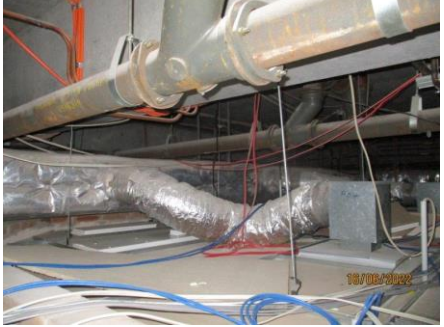
<table border="1"> <tr> <th colspan="2">Visual Inspection</th> </tr> <tr> <td>SMF Identified:</td> <td>Yes</td> </tr> <tr> <td>Location:</td> <td>Internal</td> </tr> <tr> <td colspan="2">                     Level 3, Coronary Care Unit, throughout, space flexible – ductwork insulation.                      Typical throughout Coronary Care Unit.                 </td> </tr> </table>	Visual Inspection		SMF Identified:	Yes	Location:	Internal	Level 3, Coronary Care Unit, throughout, space flexible – ductwork insulation. Typical throughout Coronary Care Unit.

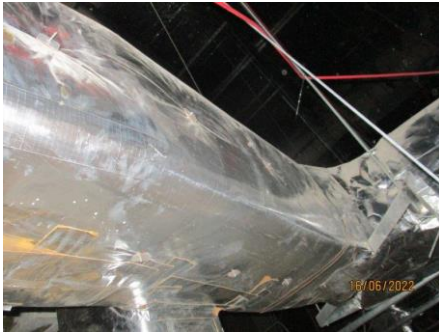
<table border="1"> <thead> <tr> <th colspan="2">Visual Inspection</th> </tr> </thead> <tbody> <tr> <td>SMF Identified:</td> <td>Yes</td> </tr> <tr> <td>Location:</td> <td>Internal</td> </tr> <tr> <td colspan="2">                     Level 3, Maternity, Gynaecology and Endocrinology Department, throughout, space – duct insulation.                      Typical throughout Maternity, Gynaecology and Endocrinology Department,                 </td> </tr> </tbody> </table>	Visual Inspection		SMF Identified:	Yes	Location:	Internal	Level 3, Maternity, Gynaecology and Endocrinology Department, throughout, space – duct insulation. Typical throughout Maternity, Gynaecology and Endocrinology Department,	
Visual Inspection									
SMF Identified:	Yes								
Location:	Internal								
Level 3, Maternity, Gynaecology and Endocrinology Department, throughout, space – duct insulation. Typical throughout Maternity, Gynaecology and Endocrinology Department,

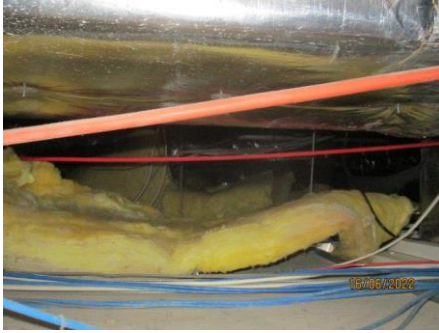
<table border="1"> <thead> <tr> <th colspan="2">Visual Inspection</th> </tr> </thead> <tbody> <tr> <td>SMF Identified:</td> <td>Yes</td> </tr> <tr> <td>Location:</td> <td>Internal</td> </tr> <tr> <td colspan="2">                     Level 3, Maternity, Gynaecology and Endocrinology Department, throughout, space – yellow SMF batt insulation.                      Typical throughout Maternity, Gynaecology and Endocrinology Department,                 </td> </tr> </tbody> </table>	Visual Inspection		SMF Identified:	Yes	Location:	Internal	Level 3, Maternity, Gynaecology and Endocrinology Department, throughout, space – yellow SMF batt insulation. Typical throughout Maternity, Gynaecology and Endocrinology Department,	
Visual Inspection									
SMF Identified:	Yes								
Location:	Internal								
Level 3, Maternity, Gynaecology and Endocrinology Department, throughout, space – yellow SMF batt insulation. Typical throughout Maternity, Gynaecology and Endocrinology Department,

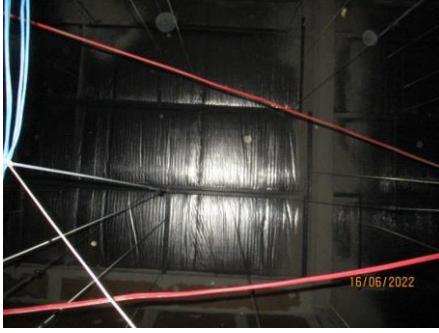
<table border="1"> <thead> <tr> <th colspan="2">Visual Inspection</th> </tr> </thead> <tbody> <tr> <td>SMF Identified:</td> <td>Yes</td> </tr> <tr> <td>Location:</td> <td>Internal</td> </tr> <tr> <td colspan="2">                     Level 3, Maternity, Gynaecology and Endocrinology Department, throughout, space – sarking insulation.                      Typical throughout Maternity, Gynaecology and Endocrinology Department,                 </td> </tr> </tbody> </table>	Visual Inspection		SMF Identified:	Yes	Location:	Internal	Level 3, Maternity, Gynaecology and Endocrinology Department, throughout, space – sarking insulation. Typical throughout Maternity, Gynaecology and Endocrinology Department,	
Visual Inspection									
SMF Identified:	Yes								
Location:	Internal								
Level 3, Maternity, Gynaecology and Endocrinology Department, throughout, space – sarking insulation. Typical throughout Maternity, Gynaecology and Endocrinology Department,

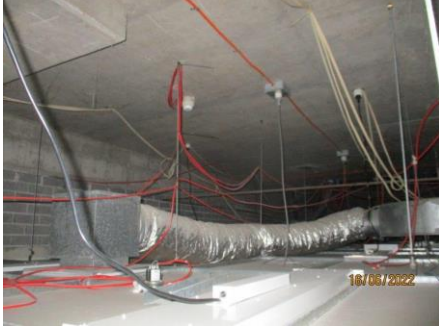
<table border="1"> <thead> <tr> <th colspan="2">Visual Inspection</th> </tr> </thead> <tbody> <tr> <td>SMF Identified:</td> <td>Yes</td> </tr> <tr> <td>Location:</td> <td>Internal</td> </tr> <tr> <td colspan="2">                     Level 3, Circulation Areas, Ward K3 adjacent lifts, throughout, ceiling space – flexible duct insulation.                      Typical throughout Circulation Areas.                 </td> </tr> </tbody> </table>	Visual Inspection		SMF Identified:	Yes	Location:	Internal	Level 3, Circulation Areas, Ward K3 adjacent lifts, throughout, ceiling space – flexible duct insulation. Typical throughout Circulation Areas.	
Visual Inspection									
SMF Identified:	Yes								
Location:	Internal								
Level 3, Circulation Areas, Ward K3 adjacent lifts, throughout, ceiling space – flexible duct insulation. Typical throughout Circulation Areas.

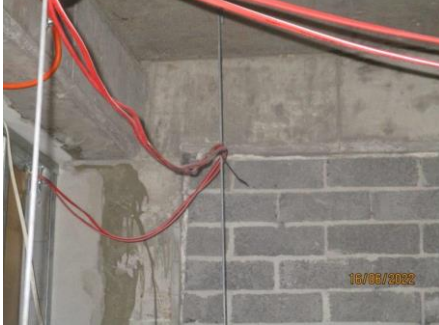
<table border="1"> <thead> <tr> <th colspan="2">Visual Inspection</th> </tr> </thead> <tbody> <tr> <td>SMF Identified:</td> <td>Yes</td> </tr> <tr> <td>Location:</td> <td>Internal</td> </tr> <tr> <td colspan="2">                     Level 3, Circulation Areas, Ward K3 adjacent lifts, ceiling space, white "Kaowool" insulation between block walls and concrete slab. Also present within penetrations.                      Typical throughout Circulation Areas.                 </td> </tr> </tbody> </table>	Visual Inspection		SMF Identified:	Yes	Location:	Internal	Level 3, Circulation Areas, Ward K3 adjacent lifts, ceiling space, white "Kaowool" insulation between block walls and concrete slab. Also present within penetrations. Typical throughout Circulation Areas.

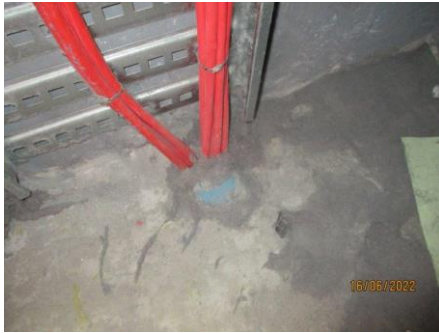
Visual Inspection	
SMF Identified:	Yes
Location:	Internal
<p>Level 3, Circulation Areas, Ward K3 adjacent lifts, blue insulation pillows within floor and ceiling penetrations. Typical throughout Circulation Areas.</p>

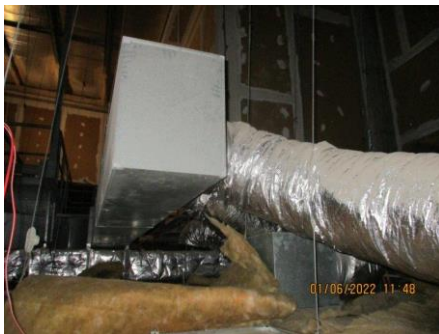
Visual Inspection	
SMF Identified:	Yes
Location:	Internal
<p>Level 3, Research Laboratory, ceiling space, SMF flexible ductwork insulation. Typical throughout Research Laboratory.</p>

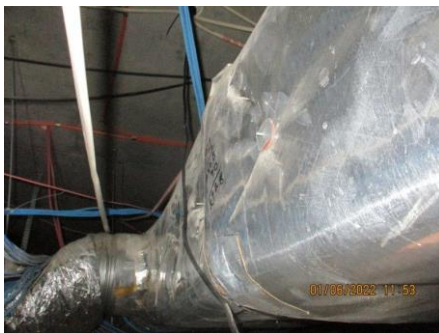
Visual Inspection	
SMF Identified:	Yes
Location:	Internal
<p>Level 3, Research Laboratory, ceiling space, SMF ductwork insulation. Typical throughout Research Laboratory.</p>

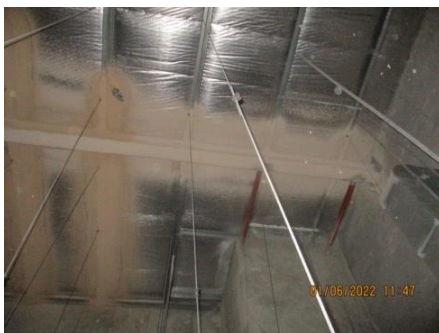
Visual Inspection	
SMF Identified:	Yes
Location:	Internal
<p>Level 3, Research Laboratory, ceiling space, SMF sarking insulation. Typical throughout Research Laboratory.</p>

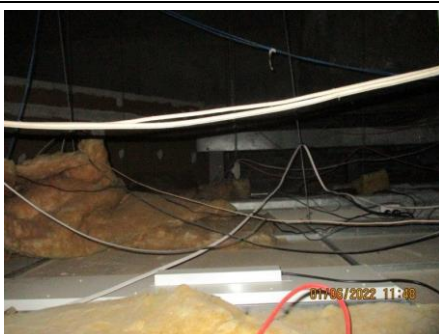
Visual Inspection	
SMF Identified:	Yes
Location:	Internal
<p>Level 3, Research Laboratory, ceiling space, SMF batt insulation on top of ceiling tiles. Typical throughout Research Laboratory.</p>

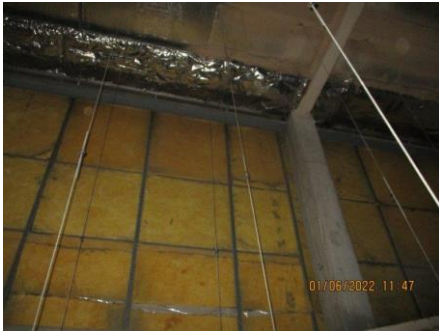
<table border="1"> <tr> <th colspan="2">Visual Inspection</th> </tr> <tr> <td>SMF Identified:</td> <td>Yes</td> </tr> <tr> <td>Location:</td> <td>Internal</td> </tr> <tr> <td colspan="2"> <p>Level 3, Research Laboratory, ceiling space, SMF batt insulation within wall cavities. Typical throughout Research Laboratory.</p> </td> </tr> </table>	Visual Inspection		SMF Identified:	Yes	Location:	Internal	<p>Level 3, Research Laboratory, ceiling space, SMF batt insulation within wall cavities. Typical throughout Research Laboratory.</p>	
Visual Inspection									
SMF Identified:	Yes								
Location:	Internal								
<p>Level 3, Research Laboratory, ceiling space, SMF batt insulation within wall cavities. Typical throughout Research Laboratory.</p>

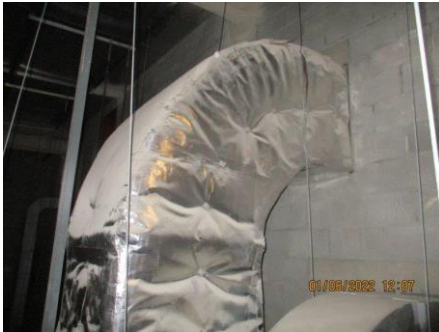
<table border="1"> <tr> <th colspan="2">Visual Inspection</th> </tr> <tr> <td>SMF Identified:</td> <td>Yes</td> </tr> <tr> <td>Location:</td> <td>Internal</td> </tr> <tr> <td colspan="2"> <p>Level 3, Above AGSU, Admin, Transplant and Research Department – Accessed via gantry walkway. SMF ductwork insulation - Typical throughout ceiling voids.</p> </td> </tr> </table>	Visual Inspection		SMF Identified:	Yes	Location:	Internal	<p>Level 3, Above AGSU, Admin, Transplant and Research Department – Accessed via gantry walkway. SMF ductwork insulation - Typical throughout ceiling voids.</p>

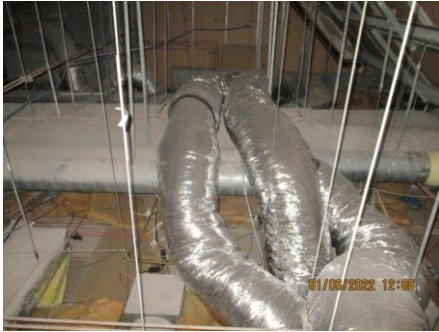
<table border="1"> <tr> <th colspan="2">Visual Inspection</th> </tr> <tr> <td>SMF Identified:</td> <td>Yes</td> </tr> <tr> <td>Location:</td> <td>Internal</td> </tr> <tr> <td colspan="2"> <p>Level 3, Above AGSU, Admin, Transplant and Research Department – Accessed via gantry walkway. Flexible SMF ductwork insulation - Typical throughout ceiling voids.</p> </td> </tr> </table>	Visual Inspection		SMF Identified:	Yes	Location:	Internal	<p>Level 3, Above AGSU, Admin, Transplant and Research Department – Accessed via gantry walkway. Flexible SMF ductwork insulation - Typical throughout ceiling voids.</p>	
Visual Inspection									
SMF Identified:	Yes

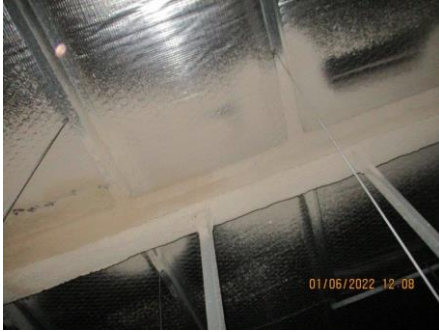
<table border="1"> <tr> <th colspan="2">Visual Inspection</th> </tr> <tr> <td>SMF Identified:</td> <td>Yes</td> </tr> <tr> <td>Location:</td> <td>Internal</td> </tr> <tr> <td colspan="2"> <p>Level 3, Above AGSU, Admin, Transplant and Research Department – Accessed via gantry walkway. SMF sarking insulation - Typical throughout ceiling voids.</p> </td> </tr> </table>	Visual Inspection		SMF Identified:	Yes	Location:	Internal	<p>Level 3, Above AGSU, Admin, Transplant and Research Department – Accessed via gantry walkway. SMF sarking insulation - Typical throughout ceiling voids.</p>	
Visual Inspection									
SMF Identified:	Yes								
Location:	Internal								
<p>Level 3, Above AGSU, Admin, Transplant and Research Department – Accessed via gantry walkway. SMF sarking insulation - Typical throughout ceiling voids.</p>

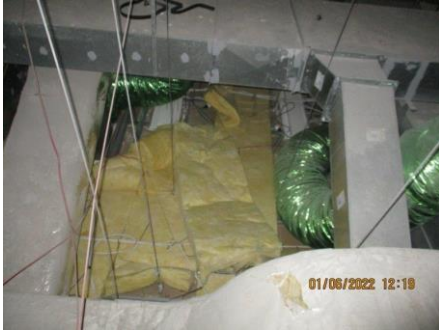
<table border="1"> <tr> <th colspan="2">Visual Inspection</th> </tr> <tr> <td>SMF Identified:</td> <td>Yes</td> </tr> <tr> <td>Location:</td> <td>Internal</td> </tr> <tr> <td colspan="2"> <p>Level 3, Above AGSU, Admin, Transplant and Research Department – Accessed via gantry walkway. SMF batt insulation across ceiling tiles beneath - Typical throughout ceiling voids.</p> </td> </tr> </table>	Visual Inspection		SMF Identified:	Yes	Location:	Internal	<p>Level 3, Above AGSU, Admin, Transplant and Research Department – Accessed via gantry walkway. SMF batt insulation across ceiling tiles beneath - Typical throughout ceiling voids.</p>	
Visual Inspection									
SMF Identified:	Yes								
Location:	Internal								
<p>Level 3, Above AGSU, Admin, Transplant and Research Department – Accessed via gantry walkway. SMF batt insulation across ceiling tiles beneath - Typical throughout ceiling voids.</p>

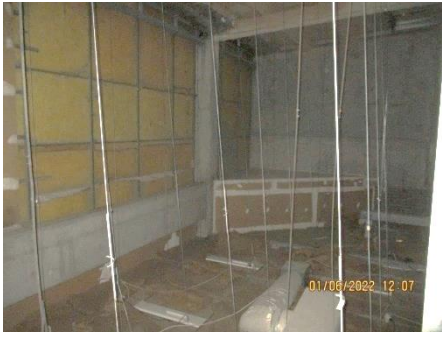
<b>Visual Inspection</b>	
	<b>SMF Identified:</b>	Yes
	<b>Location:</b>	Internal
	<p>Level 3, Above AGSU, Admin, Transplant and Research Department – Accessed via gantry walkway. SMF batt insulation within wall cavities - Typical throughout ceiling voids.</p>

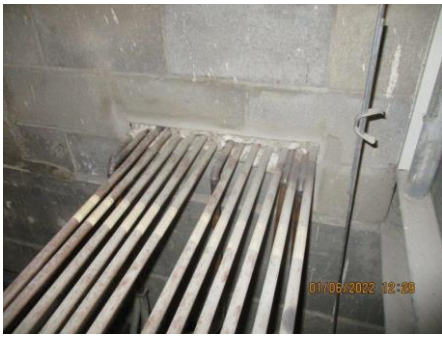
<b>Visual Inspection</b>	
	<b>SMF Identified:</b>	Yes
	<b>Location:</b>	Internal
	<p>Level 3, Above AGSU, Admin, Transplant and Research Department – Accessed via gantry walkway. Kaowool within service penetrations - Typical throughout ceiling voids.</p>

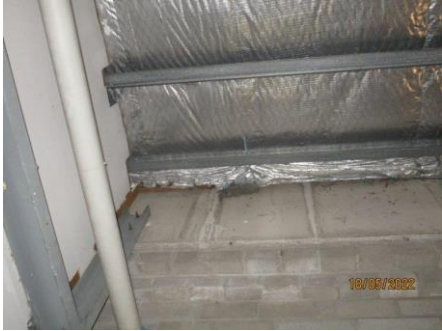
<b>Visual Inspection</b>	
	<b>SMF Identified:</b>	Yes
	<b>Location:</b>	Internal
	<p>Level 4, Plant Rooms above departments, throughout, ceiling – sarking insulation beneath roof. Typical throughout Plant Rooms.</p>

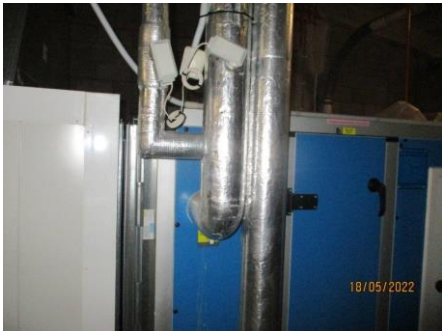
<b>Visual Inspection</b>	
	<b>SMF Identified:</b>	Yes
	<b>Location:</b>	Internal
	<p>Level 4, Plant Rooms above departments – pipework insulation. Typical throughout Plant Rooms.</p>

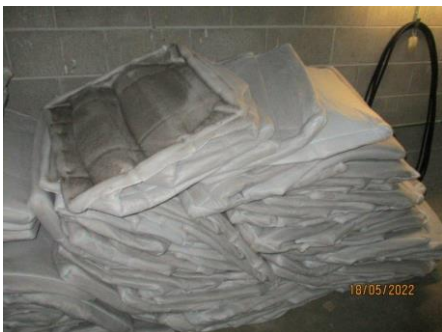
<b>Visual Inspection</b>	
	<b>SMF Identified:</b>	Yes
	<b>Location:</b>	Internal
	<p>Level 4, Plant Rooms above departments, throughout, wall cavities – filters for Air Handling Units.</p>

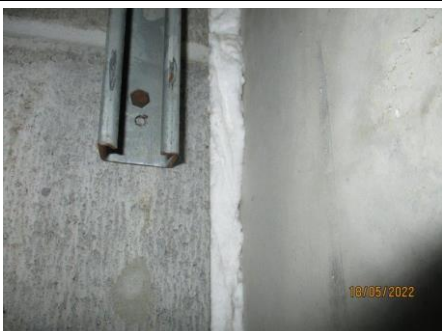
<b>Visual Inspection</b>	
	<b>SMF Identified:</b>	Yes
	<b>Location:</b>	Internal
	<p>Level 4, Plant Rooms above departments, between blockwork, brickwork and ceiling slab – “Kaowool”. Typical throughout Plant Rooms.</p>

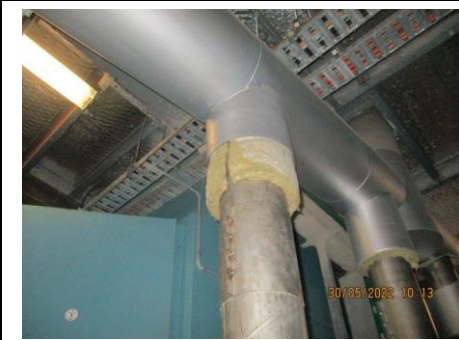
Visual Inspection	
SMF Identified:	Yes
Location:	Internal
Level 4, Plant Room above departments, insulation around flue pipes, beneath metal cladding. Typical throughout Plant Rooms.

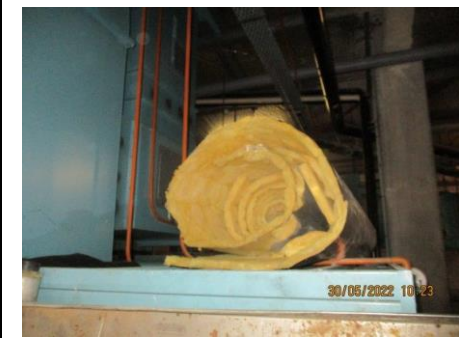
Visual Inspection	
SMF Identified:	Yes
Location:	Internal
Level 4, Plant Room above departments, insulation around flue pipes, beneath metal cladding. SMF blanket insulation. Typical throughout Plant Rooms.

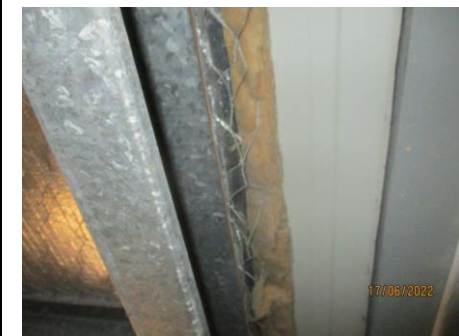
Visual Inspection	
SMF Identified:	Yes
Location:	Internal
Level 4, Plant Rooms above Wards F-K, throughout, ceiling – sarking insulation beneath roof. Typical throughout Plant Rooms.

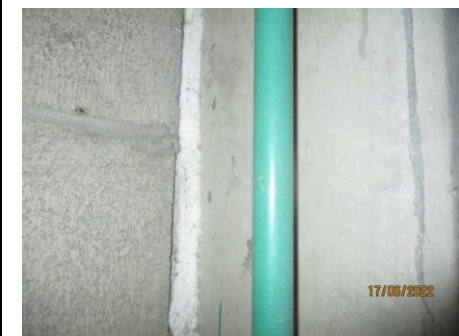
Visual Inspection	
SMF Identified:	Yes
Location:	Internal
Level 4, Plant Rooms above Wards F-K, between blockwork – “Kaowool”. Typical throughout Plant Rooms.

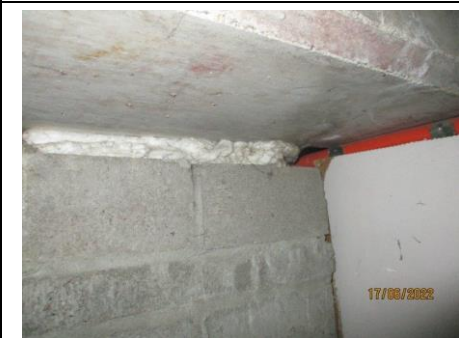
Visual Inspection	
SMF Identified:	Yes
Location:	Internal
Level 4, Plant Rooms above Wards F-K, between blockwork and ceiling slab – “Kaowool”. Typical throughout Plant Rooms.

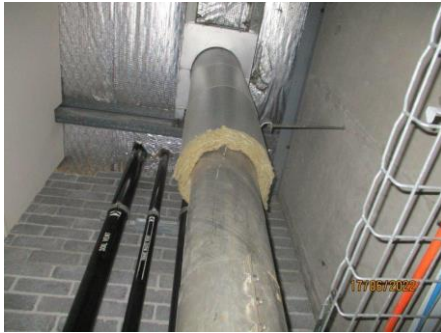
Visual Inspection	
SMF Identified:	Yes
Location:	Internal
<p>Level 4, Plant Rooms above Wards F-K, insulation around flue pipes, beneath metal cladding. Typical throughout Plant Rooms.</p>

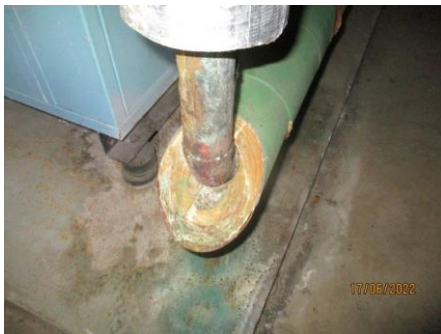
Visual Inspection	
SMF Identified:	Yes
Location:	Internal
<p>Level 4, Plant Rooms above Wards F-K, pipe insulation, beneath metal cladding. Typical throughout Plant Rooms.</p>

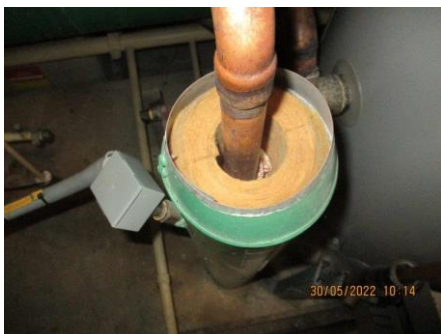
Visual Inspection	
SMF Identified:	Yes
Location:	Internal
<p>Level 4, Plant Rooms above Departments, pipe insulation, beneath metal cladding. Typical throughout Plant Rooms.</p>

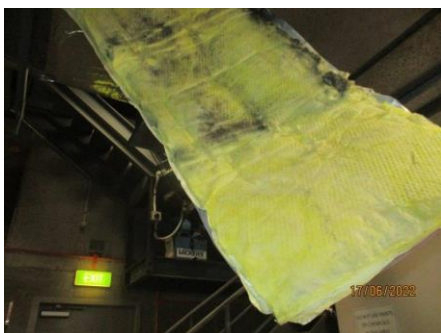
Visual Inspection	
SMF Identified:	Yes
Location:	Internal
<p>Level 4, Plant Rooms above Wards F-K, blanket insulation around ducting. Typical throughout Plant Rooms.</p>

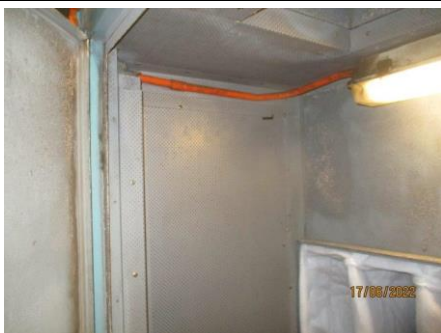
Visual Inspection	
SMF Identified:	Yes
Location:	Internal
<p>Level 4, Plant Rooms above Wards F-K, insulation within ducting. Typical throughout Plant Rooms and within ducting.</p>

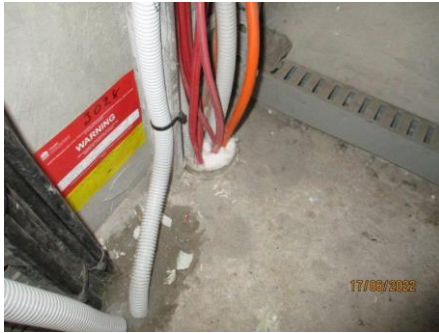
Visual Inspection	
SMF Identified:	Yes
Location:	Internal
Level 4, Plant Rooms above Wards F-K, Kaowool insulation within penetrations. Typical throughout Plant Rooms.

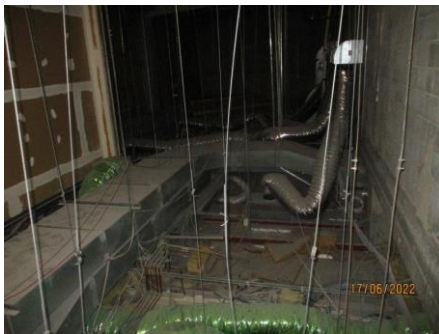
Visual Inspection	
SMF Identified:	Yes
Location:	Internal
Level 4, open ceiling void above operating theatres and offices, flexible duct insulation and batt insulation

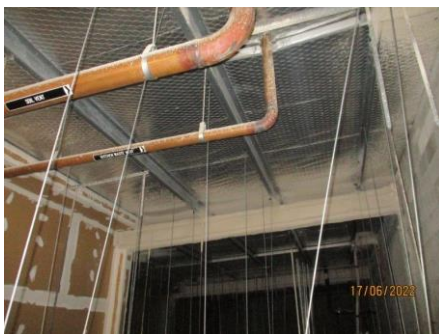
Visual Inspection	
SMF Identified:	Yes
Location:	Internal
Level 4, open ceiling void above operating theatres and offices, sarking insulation beneath roof.

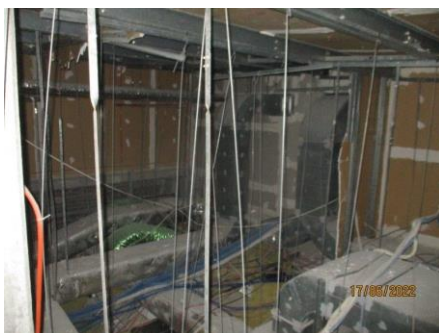
Visual Inspection	
SMF Identified:	Yes
Location:	Internal
Level 4, open ceiling void above operating theatres and offices, flexible duct insulation and batt insulation

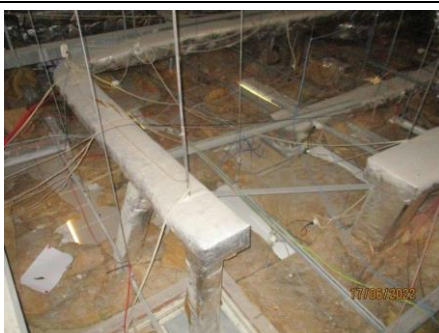
Visual Inspection	
SMF Identified:	Yes
Location:	Internal
Level 4, open ceiling void above operating theatres and offices, duct insulation and batt insulation

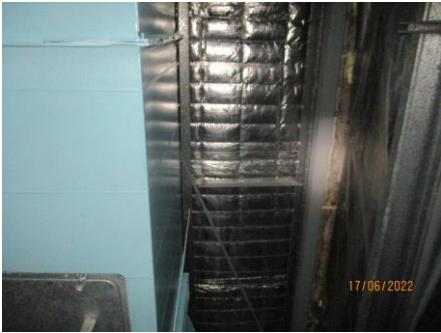
<b>Visual Inspection</b>	
	<b>SMF Identified:</b>	Yes
	<b>Location:</b>	Internal
	<p>Level 4, Roof Plant Rooms, sarking insulation beneath metal roof. Typical throughout Plant Rooms.</p>

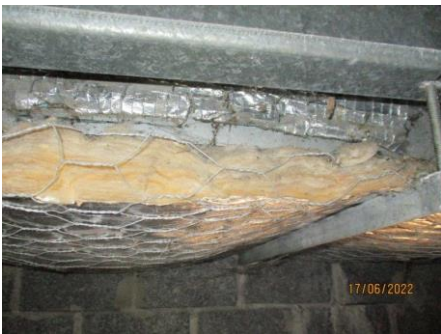
<b>Visual Inspection</b>	
	<b>SMF Identified:</b>	Yes
	<b>Location:</b>	Internal
	<p>Level 4, Small Plant Room adjacent roof access, SMF sarking insulation beneath metal roof.</p>

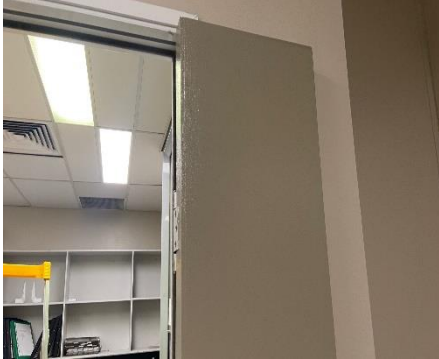
<table border="1"> <tr> <td colspan="2">Sample No.: PRJ000914-LCP001</td> </tr> <tr> <td>Lead Detected:</td> <td>No &lt;0.005% w/w</td> </tr> <tr> <td>Location:</td> <td>Internal</td> </tr> <tr> <td colspan="2">Level 0, north-east end, Mortuary, Laboratory Room 0036 &amp; 0037, throughout, paint to walls</td> </tr> <tr> <td>Extent:</td> <td>Throughout</td> </tr> </table>	Sample No.: PRJ000914-LCP001		Lead Detected:	No <0.005% w/w	Location:	Internal	Level 0, north-east end, Mortuary, Laboratory Room 0036 & 0037, throughout, paint to walls		Extent:	Throughout
Sample No.: PRJ000914-LCP001											
Lead Detected:	No <0.005% w/w										
Location:	Internal										
Level 0, north-east end, Mortuary, Laboratory Room 0036 & 0037, throughout, paint to walls											
Extent:	Throughout
