**RE : DEMOLITION WORK PLAN MD - 2753**  
**AT : JOHN HUNTER HEALTH & INNOVATION PRECINCT**

## Demolition Work Plan (DWP)

JHHIP – Stage 1

# HAZARDOUS MATERIALS SURVEY REPORT

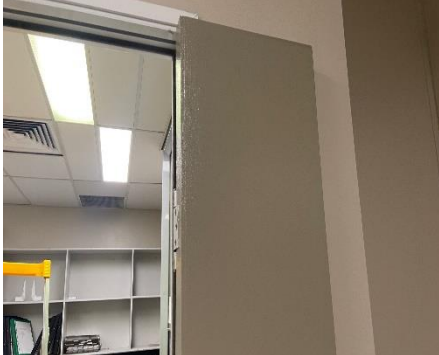
<table border="1"> <tr> <td colspan="2">Sample No.: PRJ000914-LCP002</td> </tr> <tr> <td>Lead Detected:</td> <td>No &lt;0.005% w/w</td> </tr> <tr> <td>Location:</td> <td>Internal</td> </tr> <tr> <td colspan="2">Level 0, north-east end, Mortuary, Laboratory Room 0036, door between rooms (door 3366) – grey upper/blue lower paint.</td> </tr> <tr> <td>Extent:</td> <td>2 Units</td> </tr> </table>	Sample No.: PRJ000914-LCP002		Lead Detected:	No <0.005% w/w	Location:	Internal	Level 0, north-east end, Mortuary, Laboratory Room 0036, door between rooms (door 3366) – grey upper/blue lower paint.		Extent:	2 Units

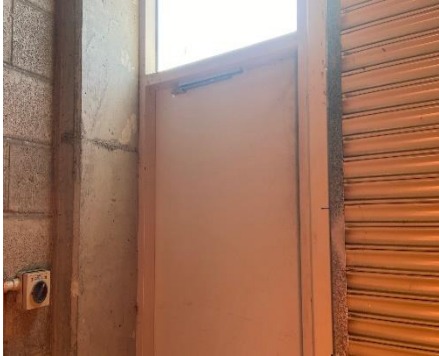
<table border="1"> <tr> <td colspan="2">Sample No.: PRJ000914-LCP003</td> </tr> <tr> <td>Lead Detected:</td> <td>No 0.052% w/w</td> </tr> <tr> <td>Location:</td> <td>Internal</td> </tr> <tr> <td colspan="2">Level 0, north-east end, Mortuary, loading dock adjacent roller door, fire door – white upper paint.</td> </tr> <tr> <td>Extent:</td> <td>1 Unit</td> </tr> </table>	Sample No.: PRJ000914-LCP003		Lead Detected:	No 0.052% w/w	Location:	Internal	Level 0, north-east end, Mortuary, loading dock adjacent roller door, fire door – white upper paint.		Extent:	1 Unit
Sample No.: PRJ000914-LCP003											
Lead Detected:	No 0.052% w/w

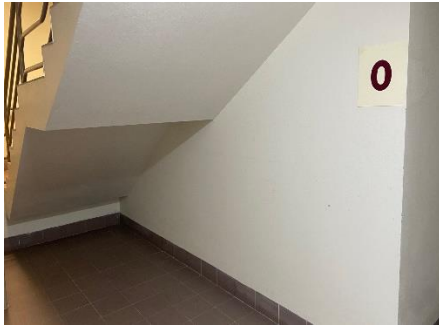
Sample No.: PRJ000914-LCP019	
Lead Detected:	No <0.005% w/w
Location:	Internal
Level 0, Back of House, Engineering, Corridor/fire stars walls – white upper paint.	
Extent:	Throughout

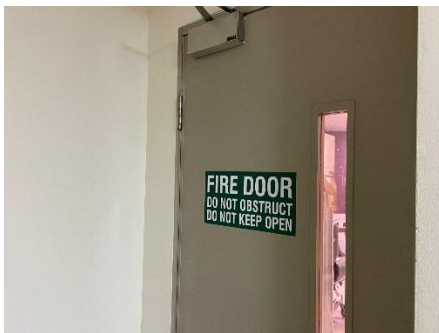
Sample No.: PRJ000914-LCP020	
Lead Detected:	Yes 0.016% w/w
Location:	Internal
Level 0, Back of House, Engineering, Corridor/fire stars, fire door and frame, grey paint	
Extent:	1 Unit

Risk Assessment		Description
Positive	<b>Low to High</b>	<p>Access to the material should be restricted.</p> <p>All asbestos and other hazardous materials likely or liable to be disturbed by the proposed works should be removed prior to, or during demolition, refurbishment or decommissioning.</p>
<p>The asbestos information contained within this report is insufficient to meet the requirement for risk assessment for a management plan. The following recommendations are provided for any ACM remaining in-situ at the end of the project regardless of their risk rating:</p> <ul style="list-style-type: none"> <li>○ All materials must be documented in a Register and managed in accordance with a site-specific Asbestos Management Plan (AMP) or Hazardous Material Management Plan (HMMP);</li> <li>○ The asbestos register must be updated at least every five years or earlier if required by changes to a materials' status or condition, further materials are identified or the AMP is revised;</li> <li>○ Any asbestos removal works must be carried out in accordance with the relevant legislation; and where required by appropriately licensed contractors for the removal, air monitoring and clearance works.</li> <li>○ Prior to any renovation or demolition work, a Destructive Asbestos Survey Report should be prepared to determine the presence of further materials within inaccessible areas and if required, for excluded materials.</li> </ul>

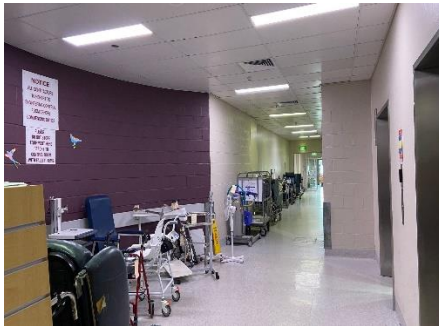
Sample No.: PRJ000914-LCP021	
Lead Detected:	No 0.009% w/w
Location:	Internal
Level 0, Back of House, Engineering, Corridor/lift lobby walls – purple upper paint.	
Extent:	10 sqm

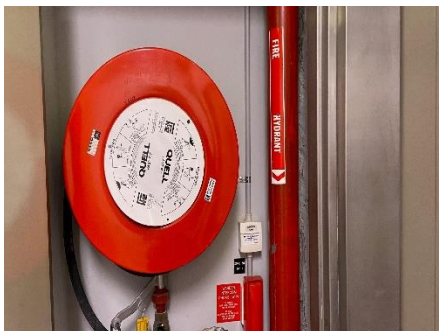
Sample No.: PRJ000914-LCP022	
Lead Detected:	No 0.04% w/w
Location:	Internal
Level 0, Back of House, Engineering, Corridor, fire hose reel cupboard, red paint to hydrant pipework. Typical of red fire hydrant pipework throughout building	
Extent:	2 lin m

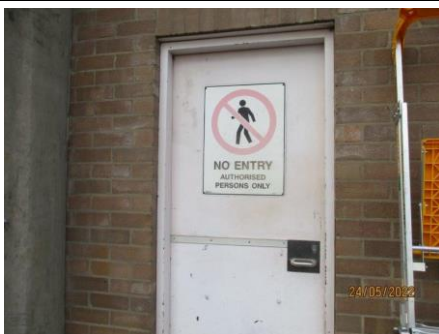
Sample No.: PRJ000914-LCP023	
Lead Detected:	No 0.098% w/w
Location:	Internal
Level 0, Plant Room entrance, pink/faded white paint to door and frame.	
Extent:	3 units

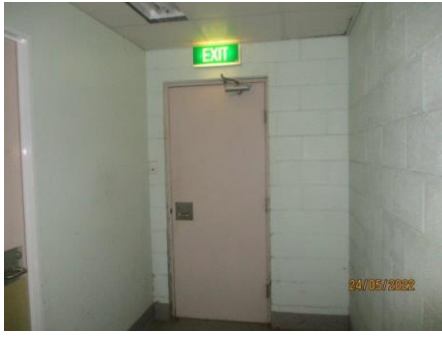
<table border="1"> <tr> <td colspan="2">Sample No.: PRJ000914-LCP024</td> </tr> <tr> <td>Lead Detected:</td> <td>No 0.01% w/w</td> </tr> <tr> <td>Location:</td> <td>Internal</td> </tr> <tr> <td colspan="2">Level 0, Lobby adjacent Room 3267 Dark room, green paint to walls.</td> </tr> <tr> <td>Extent:</td> <td>10 sqm</td> </tr> </table>	Sample No.: PRJ000914-LCP024		Lead Detected:	No 0.01% w/w	Location:	Internal	Level 0, Lobby adjacent Room 3267 Dark room, green paint to walls.		Extent:	10 sqm
Sample No.: PRJ000914-LCP024											
Lead Detected:	No 0.01% w/w										
Location:	Internal										
Level 0, Lobby adjacent Room 3267 Dark room, green paint to walls.											
Extent:	10 sqm

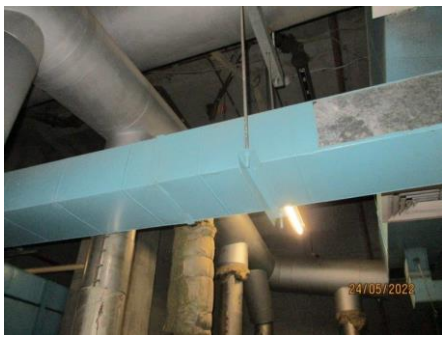
<table border="1"> <tr> <td colspan="2">Sample No.: PRJ000914-LCP025</td> </tr> <tr> <td>Lead Detected:</td> <td>Yes 0.15% w/w</td> </tr> <tr> <td>Location:</td> <td>Internal</td> </tr> <tr> <td colspan="2">Level 0, Plant Room, throughout, Air Handling Units and ductwork– blue upper paint.</td> </tr> <tr> <td>Extent:</td> <td>Throughout</td> </tr> </table>	Sample No.: PRJ000914-LCP025		Lead Detected:	Yes 0.15% w/w	Location:	Internal	Level 0, Plant Room, throughout, Air Handling Units and ductwork– blue upper paint.		Extent:	Throughout

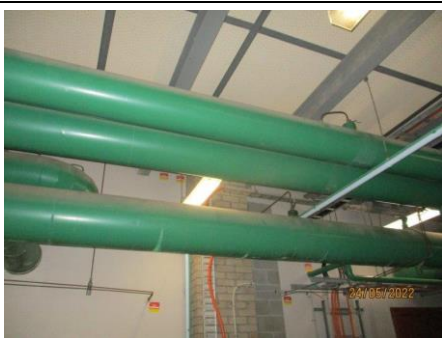
<table border="1"> <tr> <td colspan="2">Sample No.: PRJ000914-LCP026</td> </tr> <tr> <td>Lead Detected:</td> <td>No 0.03% w/w</td> </tr> <tr> <td>Location:</td> <td>Internal</td> </tr> <tr> <td colspan="2">Level 0, Plant Room, throughout, Green paint to metal pipework cladding</td> </tr> <tr> <td>Extent:</td> <td>Throughout</td> </tr> </table>	Sample No.: PRJ000914-LCP026		Lead Detected:	No 0.03% w/w	Location:	Internal	Level 0, Plant Room, throughout, Green paint to metal pipework cladding		Extent:	Throughout
Sample No.: PRJ000914-LCP026											
Lead Detected:	No 0.03% w/w										
Location:	Internal										
Level 0, Plant Room, throughout, Green paint to metal pipework cladding

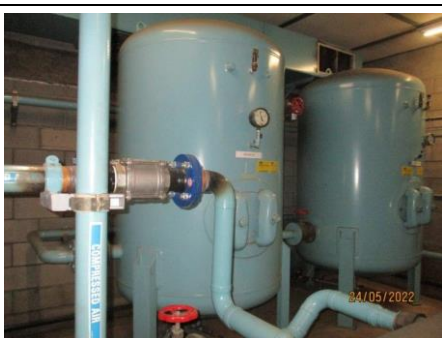
<table border="1"> <tr> <td colspan="2">Sample No.: PRJ000914-LCP027</td> </tr> <tr> <td>Lead Detected:</td> <td>Yes 0.15% w/w</td> </tr> <tr> <td>Location:</td> <td>Internal</td> </tr> <tr> <td colspan="2">Level 0, Compressor Room, throughout, Blue paint to compressed air pipework and tanks</td> </tr> <tr> <td>Extent:</td> <td>Throughout</td> </tr> </table>	Sample No.: PRJ000914-LCP027		Lead Detected:	Yes 0.15% w/w	Location:	Internal	Level 0, Compressor Room, throughout, Blue paint to compressed air pipework and tanks		Extent:	Throughout
Sample No.: PRJ000914-LCP027											
Lead Detected:	Yes 0.15% w/w										
Location:	Internal										
Level 0, Compressor Room, throughout, Blue paint to compressed air pipework and tanks											
Extent:	Throughout

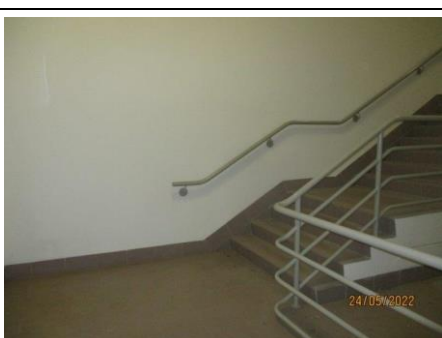
<table border="1"> <tr> <td colspan="2">Sample No.: PRJ000914-LCP028</td> </tr> <tr> <td>Lead Detected:</td> <td>No &lt;0.005% w/w</td> </tr> <tr> <td>Location:</td> <td>Internal</td> </tr> <tr> <td colspan="2">Level 0, Fire escape at rear of 0025 plant room, white paint to walls.</td> </tr> <tr> <td>Extent:</td> <td>Throughout</td> </tr> </table>	Sample No.: PRJ000914-LCP028		Lead Detected:	No <0.005% w/w	Location:	Internal	Level 0, Fire escape at rear of 0025 plant room, white paint to walls.		Extent:	Throughout

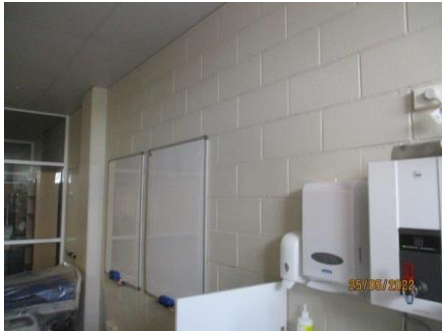
Sample No.: PRJ000914-LCP029
	Lead Detected: No <0.005% w/w
	Location: Internal
	Level 0, Room 0055, white paint to walls
	Extent: Throughout

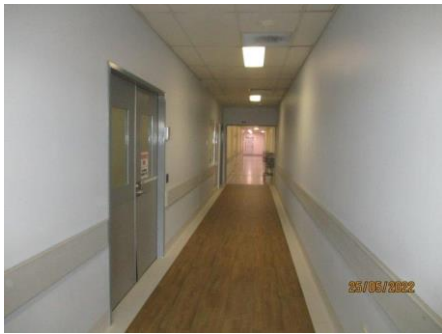
Sample No.: PRJ000914-LCP030
	Lead Detected: No <0.005% w/w
	Location: Internal
	Level 0, Corridor adjacent mortuary, grey paint to walls
	Extent: Throughout

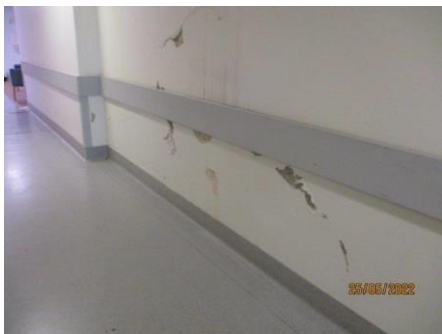
Sample No.: PRJ000914-LCP031
	Lead Detected: No <0.005% w/w
	Location: Internal
	Level 0, Corridor adjacent mortuary, white paint to walls
	Extent: Throughout

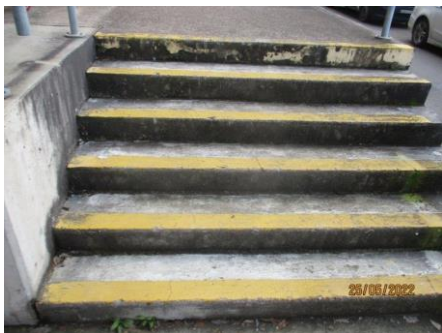
Sample No.: PRJ000914-LCP032
	Lead Detected: Yes 2.2 % w/w
	Location: External
	Level 0, Yellow line marking paint on steps. Representative of line marking paint on site.
	Extent: 10 lin m

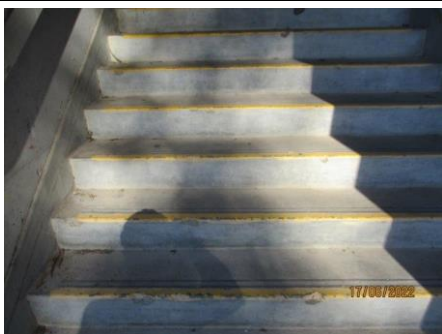
Same as Sample No.: PRJ000914-LCP032
	Lead Detected: Yes 2.2 % w/w
	Location: External
	Level 0, Fire escapes, Yellow line marking paint on steps. Representative of line marking paint on site.
	Extent: 10 lin m per set of stairs

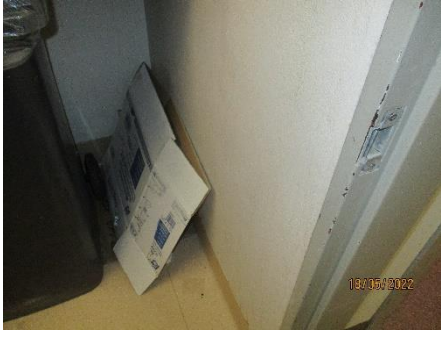
<b>Sample No.:</b> PRJ000914-LCP0015	
	<b>Lead Detected:</b>	No 0.007% w/w
	<b>Location:</b>	Internal
	Level 1, G1, throughout, walls – white upper paint.	
<b>Extent:</b>		Throughout

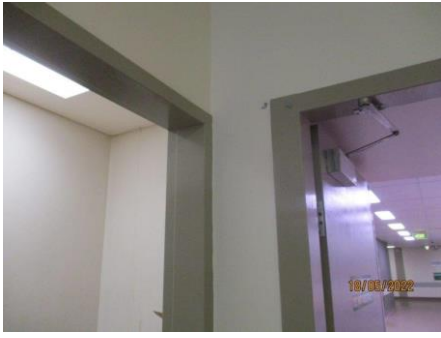
<b>Sample No.:</b> PRJ000914-LCP0016	
	<b>Lead Detected:</b>	No 0.10% w/w
	<b>Location:</b>	Internal
	Level 1, G1, throughout, doors/door frames – grey upper paint.	
<b>Extent:</b>		Throughout

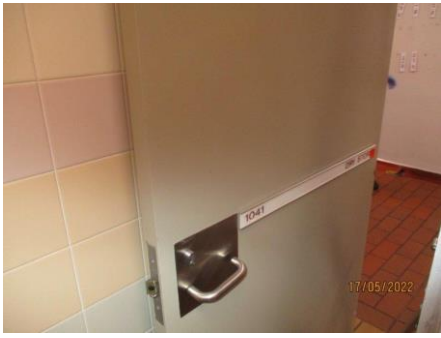
<b>Sample No.:</b> Same as: PRJ000914-LCP002	
	<b>Lead Detected:</b>	No <0.005% w/w
	<b>Location:</b>	Internal
	Level 1, Kitchen, Dry Storeroom (1041) door, grey upper paint.	
<b>Extent:</b>		1 Unit

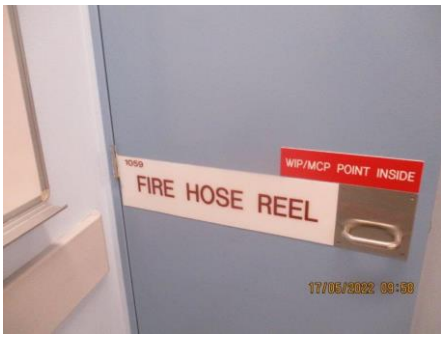
<b>Sample No.:</b> PRJ000914-LCP007	
	<b>Lead Detected:</b>	Yes 0.15% w/w
	<b>Location:</b>	Internal
	Level 1, Central Sterilisation Department, fire hose reel cupboard (1059) door and columns – blue upper paint.	
<b>Extent:</b>		3 sqm

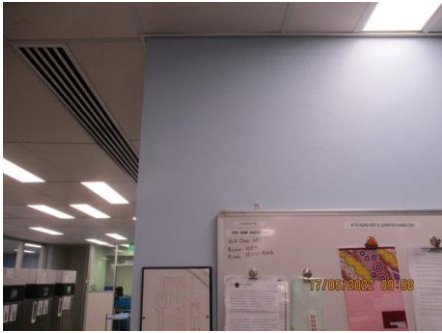
<b>Sample No.: PRJ000914-LCP008</b>	
	<b>Lead Detected:</b>	No <0.005% w/w
	<b>Location:</b>	Internal
	Level 1, Central Sterilisation Department, fire hose reel cupboard (1059), walls throughout – light blue upper paint.	
<b>Extent:</b>	Throughout

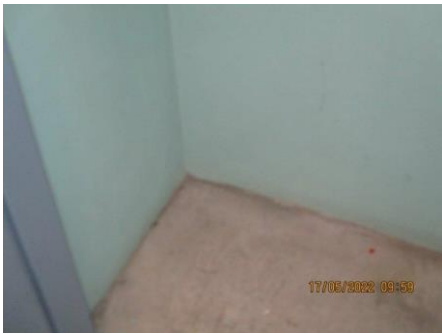
<b>Sample No.: PRJ000914-LCP009</b>	
	<b>Lead Detected:</b>	No <0.005% w/w
	<b>Location:</b>	Internal
	Level 1, Central Sterilisation Department, fire hose reel cupboard (1059), walls – aqua upper paint.	
<b>Extent:</b>	2 sqm

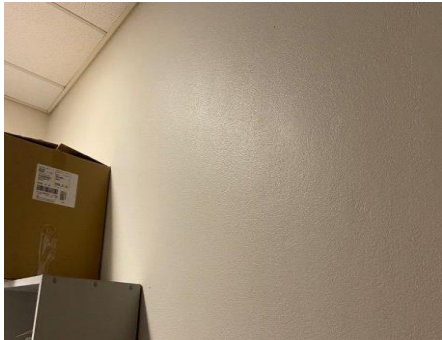
Sample No.: PRJ000914-LCP004	
	Lead Detected:	No <0.005% w/w
	Location:	Internal
	Level 2, Executive Suite, Room 2340 (Storeroom) throughout, walls – white upper paint.	
Extent:		Throughout

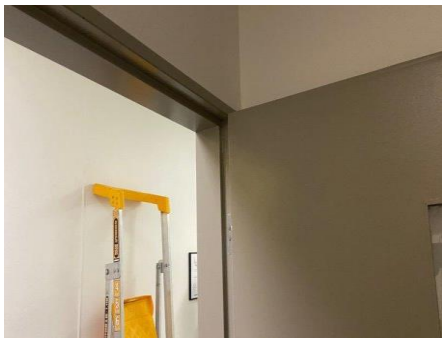
Sample No.: PRJ000914-LCP005	
	Lead Detected:	No <0.005% w/w
	Location:	Internal
	Level 2, Executive Suite, Room 2340 (Storeroom), door, grey upper paint.	
Extent:		1 Unit

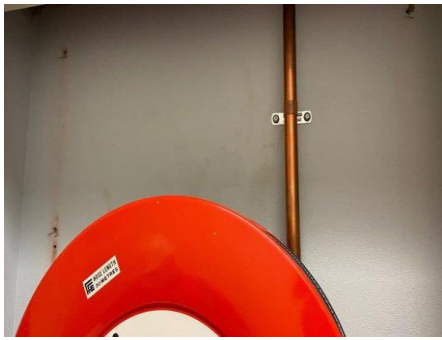
Sample No.: PRJ000914-LCP006	
	Lead Detected:	No <0.005% w/w
	Location:	Internal
	Level 2, Executive Suite, corridor, fire hose reel cupboard, back wall – blue upper paint.	
Extent:		2 sqm

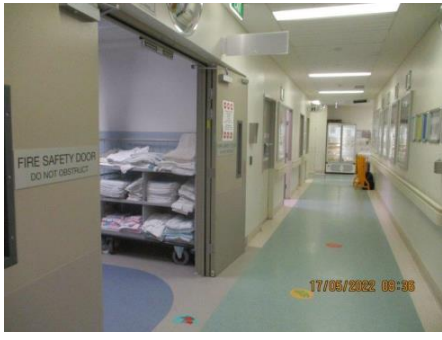
Sample No.: Same as: PRJ000914-LCP003	
	Lead Detected:	No 0.052% w/w
	Location:	Internal
	Level 2, Emergency Department, walls – white upper paint.	
Extent:		Throughout

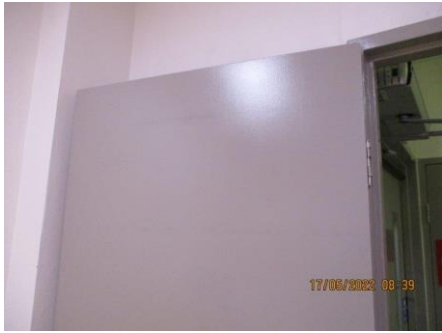
Sample No.: Same as: PRJ000914-LCP002	
	Lead Detected:	No <0.005% w/w
	Location:	Internal
	Level 2, Emergency Department, doors/door frames – grey upper paint.	
Extent:		Throughout

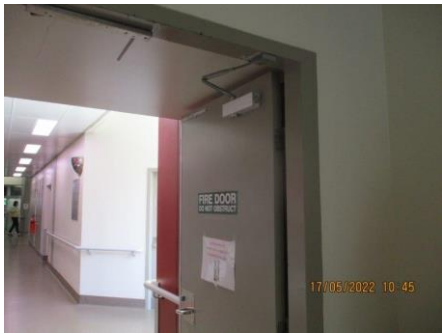
Sample No.: Same as: PRJ000914-LCP002	
	Lead Detected:	No <0.005% w/w
	Location:	Internal
	Level 2, Ward H2, corridor, throughout – grey upper paint to doors/door frames.	
Extent:		Throughout

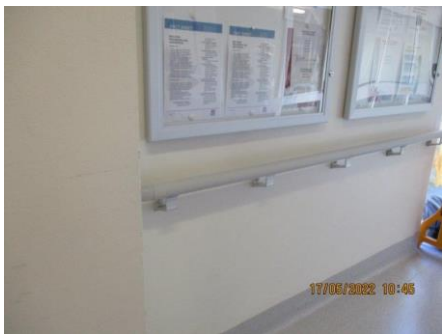
Sample No.: Same as: PRJ000914-LCP003	
	Lead Detected:	No <0.052% w/w
	Location:	Internal
	Level 2, Ward H2, corridor, throughout – white upper paint to walls.	
Extent:		Throughout

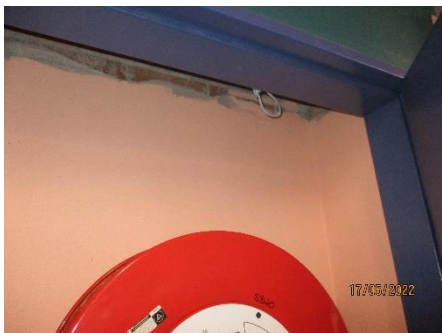
Sample No.: PRJ000914-LCP010	
	Lead Detected:	No <0.005% w/w
	Location:	Internal
	Level 2, Pharmacy, fire hose reel cupboard (2657) walls – pink upper paint	
Extent:		2 sqm

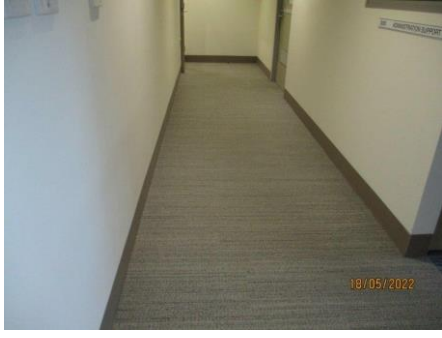
Sample No.: Same as: PRJ000914-LCP0012	
	Lead Detected:	No <0.005% w/w
	Location:	Internal
	Level 3, Neonatal Intensive Care Unit, throughout – white upper paint (modern).	
Extent:	Throughout

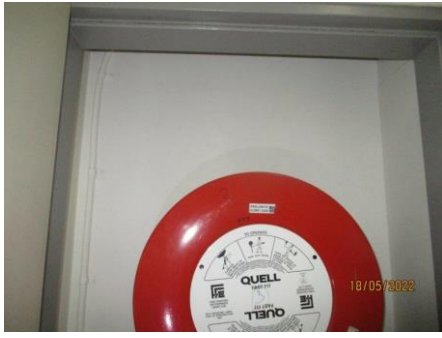
Sample No.: PRJ000914-LCP0012	
	Lead Detected:	No <0.005% w/w
	Location:	Internal
	Level 3, Neonatal Intensive Care Unit, fire hose reel WIP/MCP cupboard, walls – white upper paint.	
Extent:	2 sqm

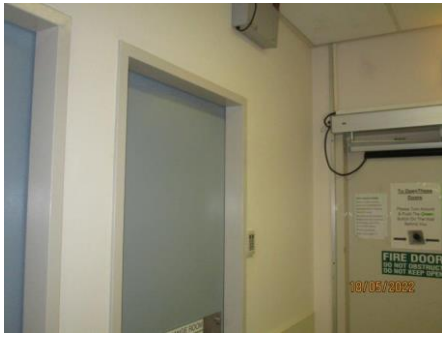
Sample No.: Same as: PRJ000914-LCP0012	
	Lead Detected:	No <0.005% w/w
	Location:	Internal
	Level 3, Birthing, throughout, walls – white upper paint.	
Extent:	Throughout

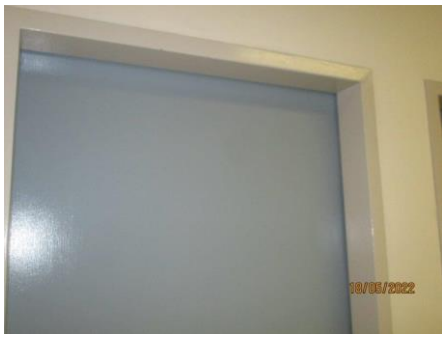
Sample No.: Same as: PRJ000914-LCP002	
	Lead Detected:	No <0.005% w/w
	Location:	Internal
	Level 3, Birthing, throughout, doors/door frames – grey upper paint.	
Extent:	Throughout

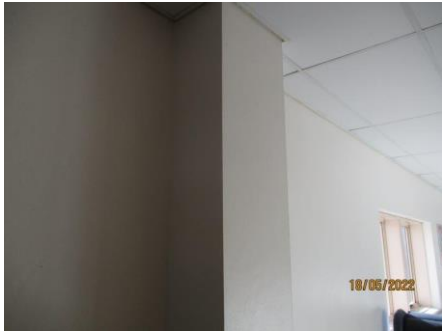
<b>Sample No.:</b> PRJ000914-LCP017	
	<b>Lead Detected:</b>	No <0.005% w/w
	<b>Location:</b>	Internal
	Level 3, Ward H3, throughout, corridor, walls – white upper paint.	
	<b>Extent:</b>	Throughout

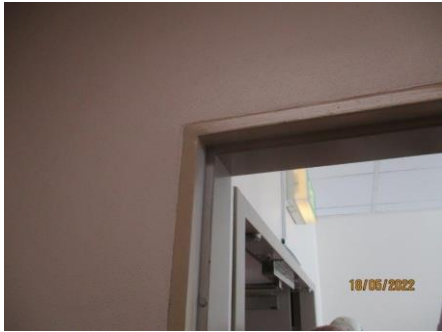
<b>Sample No.:</b> PRJ000914-LCP018	
	<b>Lead Detected:</b>	Yes 0.12% w/w
	<b>Location:</b>	Internal
	Level 3, Ward H3, Garbage/Dirty Linen Room adjacent fire door exit, doors – grey upper paint.	
	<b>Extent:</b>	2 units

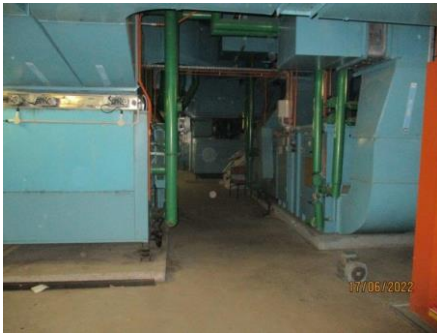
<table border="1"> <tr> <td colspan="2">Same as Sample No.: PRJ000914-LCP013</td> </tr> <tr> <td>Lead Detected:</td> <td>Yes 0.12% w/w</td> </tr> <tr> <td>Location:</td> <td>Internal</td> </tr> <tr> <td colspan="2">Level 4, Plant Rooms, throughout, Air Handling Units – blue upper paint.</td> </tr> <tr> <td>Extent:</td> <td>Ducting throughout</td> </tr> </table>	Same as Sample No.: PRJ000914-LCP013		Lead Detected:	Yes 0.12% w/w	Location:	Internal	Level 4, Plant Rooms, throughout, Air Handling Units – blue upper paint.		Extent:	Ducting throughout
Same as Sample No.: PRJ000914-LCP013											
Lead Detected:	Yes 0.12% w/w										
Location:	Internal										
Level 4, Plant Rooms, throughout, Air Handling Units – blue upper paint.

Extent:	Ducting throughout

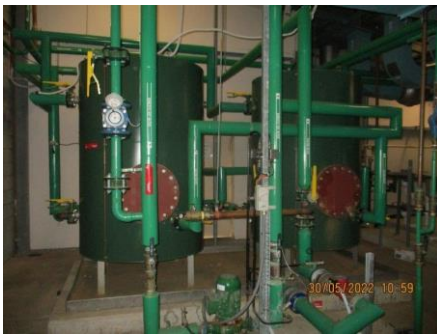
<table border="1"> <tr> <td colspan="2">Same as Sample No.: PRJ000914-LCP026</td> </tr> <tr> <td>Lead Detected:</td> <td>No 0.03% w/w</td> </tr> <tr> <td>Location:</td> <td>Internal</td> </tr> <tr> <td colspan="2">Level 4, Plant Rooms, throughout, Green paint to metal pipework cladding</td> </tr> <tr> <td>Extent:</td> <td>Throughout</td> </tr> </table>	Same as Sample No.: PRJ000914-LCP026		Lead Detected:	No 0.03% w/w	Location:	Internal	Level 4, Plant Rooms, throughout, Green paint to metal pipework cladding		Extent:	Throughout
Same as Sample No.: PRJ000914-LCP026											
Lead Detected:	No 0.03% w/w										
Location:	Internal										
Level 4, Plant Rooms, throughout, Green paint to metal pipework cladding											
Extent:	Throughout

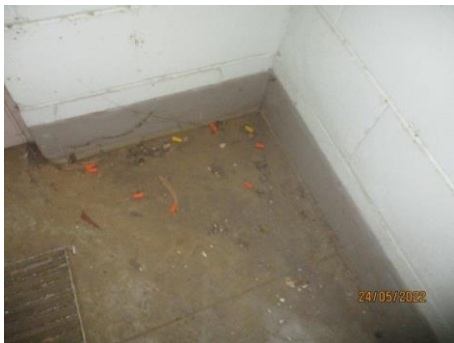
<b>Sample No.:</b> PRJ000914-LCD007	
	<b>Lead Detected:</b>	No 100 mg/kg
	<b>Location:</b>	Internal
	Level 0, Lobby adjacent 3267 Dark room, settled dust to floor	
	<b>Extent:</b>	6 sqm

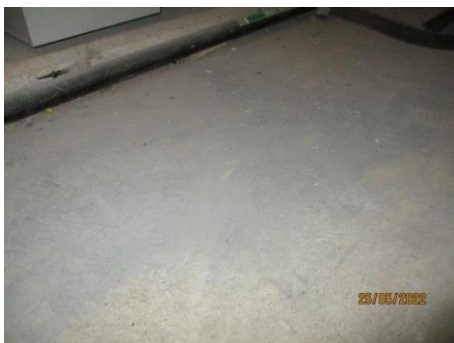
<b>Sample No.:</b> PRJ000914-LCD008	
	<b>Lead Detected:</b>	No 34 mg/kg
	<b>Location:</b>	Internal
	Level 0, Plant room 0066, settled dust to floor	
	<b>Extent:</b>	Throughout

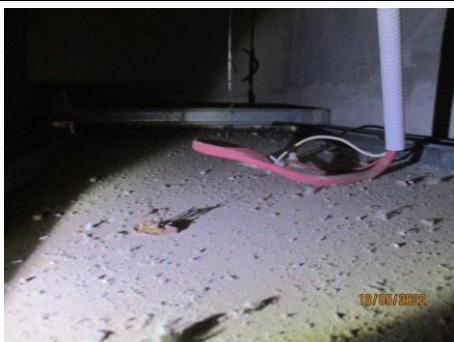
<b>Sample No.:</b> PRJ000914-LCD005	
	<b>Lead Detected:</b>	No 30 mg/kg
	<b>Location:</b>	Internal
	Level 1, G1, throughout, ceiling space – dust along horizontal surfaces.	
	<b>Extent:</b>	Throughout

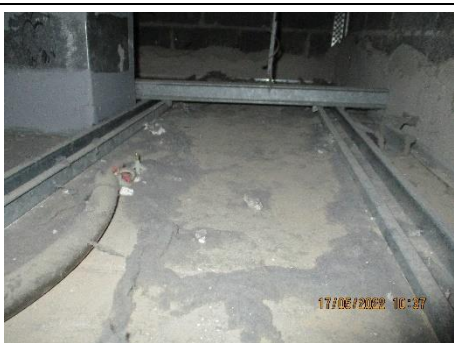
<b>Sample No.:</b> PRJ000914-LCD001	
	<b>Lead Detected:</b>	No 74 mg/kg
	<b>Location:</b>	Internal
	Level 2, Ward H2, Storeroom adjacent corridor and fire door exit, ceiling space on tiles – dust along horizontal surfaces.	
	<b>Extent:</b>	Throughout

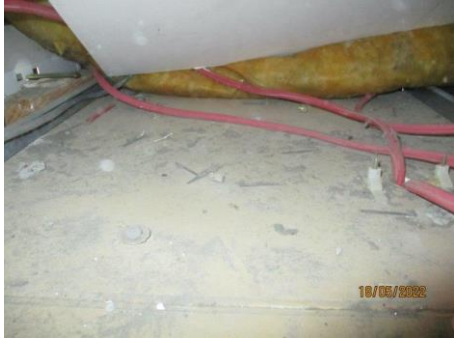
Sample No.: PRJ000914-LCD006	
	Lead Detected:	No 94 mg/kg
	Location:	Internal
	Level 3, Ward H3, Garbage/Dirty Linen Room, throughout, ceiling space – dust along horizontal surfaces.	
	Extent:	Throughout

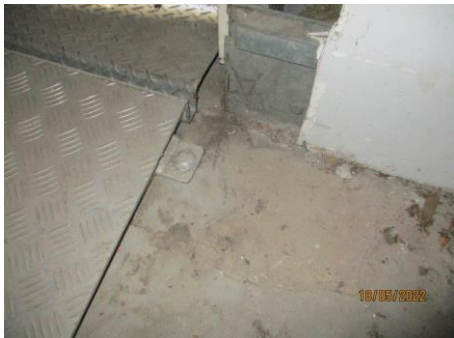
Sample No.: PRJ000914-LCD002	
	Lead Detected:	No 41 mg/kg
	Location:	Internal
	Level 4, Plant room, throughout, ground – dust along horizontal surfaces.	
	Extent:	Throughout

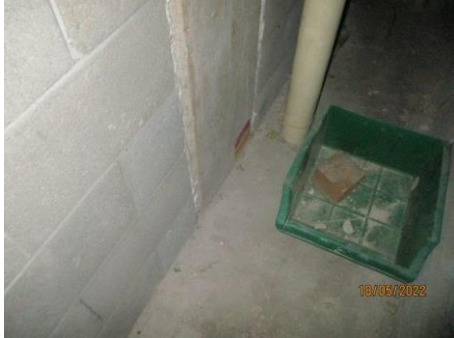
Sample No.: PRJ000914-LCD003	
	Lead Detected:	No 27 mg/kg
	Location:	Internal
	Level 4, Plant room, throughout, ground – dust along horizontal surfaces.	
	Extent:	Throughout

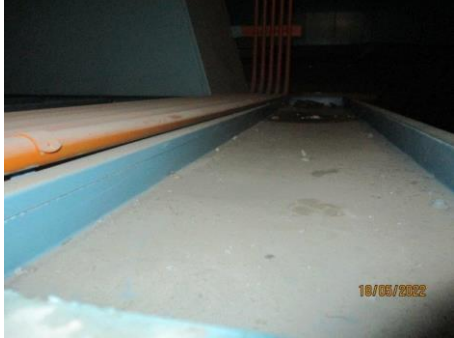
Sample No.: PRJ000914-LCD004	
	Lead Detected:	No 260 mg/kg
	Location:	Internal
	Level 4, Plant room, top of Air Handling Units – dust along horizontal surfaces.	
	Extent:	Throughout
